# Manhole Inspection Report

Date:	<b>04/21/2018</b>	Weather:		Coding:	<b>RZMACP</b>
MH#:	<b>M-906-015</b>	Owner:	<b>NA</b>	Len. Surveyed:	<b>13.0</b>
P.O.#:		Surveyor:	<b>John Kuglmaier</b>	Rim to Invert:	<b>13.3</b>
Customer:	<b>8.7</b>	Cert. #:	<b>U-1215-07002349</b>	Wall Material:	<b>Concrete (reinforced)</b>

Street:	<b>10th St. 283' East of Hobart Rd.</b>	Project:	<b>Hobart, IN</b>
City:	<b>Hobart, IN</b>	GPS Northing:	<b>0.0</b>
Location:		GPS Easting:	<b>0.0</b>
Drain Area:	<b>Southeast</b>	GPS Accuracy:	<b>Nearest Meter</b>
Cover Shape:	<b>Circular</b>	Evidence of Surcharge:	<b>Yes</b>
Cover Size:	<b>22.5</b>	Potential for Runoff:	<b>None</b>
Comments:

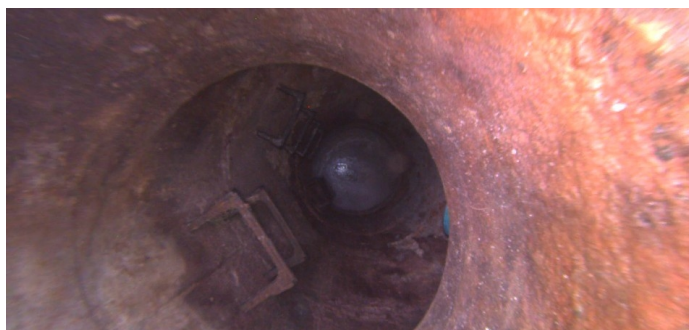
Code: **MGP**  
Description: **General Photo**

Distance (ft): **.0**  
Structural Grade: **0**  
O&M Grade: **0**  
Clock Start/From:  
Clock To:  
1st Value:  
2nd Value:  
Value Percent:  
Step: **NO**  
Remarks:

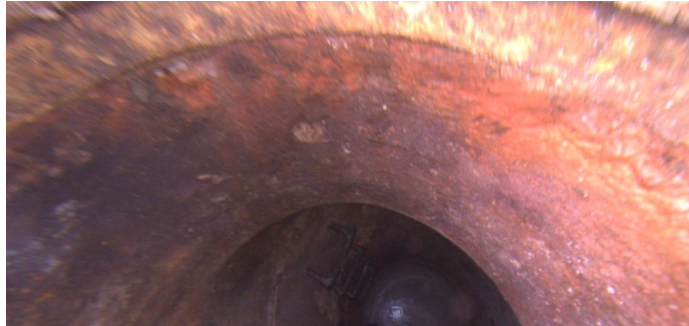
Code: **DAZ**  
Description: **Deposits Attached Other**

Distance (ft): **.0**  
Structural Grade: **0**  
O&M Grade: **2**  
Clock Start/From: **12**  
Clock To: **12**  
1st Value:  
2nd Value:  
Value Percent: **5.000**  
Step: **NO**  
Remarks: **Mixed materials**

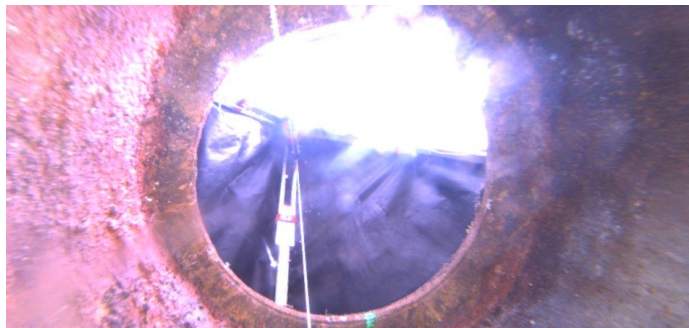
Code: **MGP**  
Description: **General Photo**

Distance (ft): **2.1**  
Structural Grade: **0**  
O&M Grade: **0**  
Clock Start/From:  
Clock To:  
1st Value:  
2nd Value:  
Value Percent:  
Step: **NO**  
Remarks:

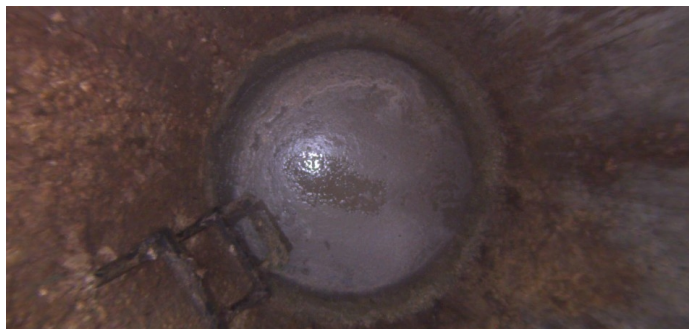
Code: **DAGS**  
Description: **Deposits Attached Grease**

Distance (ft): **8.9**  
Structural Grade: **0**  
O&M Grade: **2**  
Clock Start/From: **12**  
Clock To: **12**  
1st Value:  
2nd Value:  
Value Percent: **5.000**  
Step: **NO**  
Remarks:

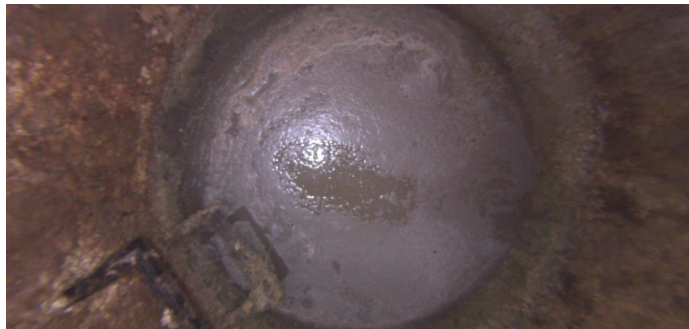
Code: **MGO**  
Description: **General Observation**

Distance (ft): **10.3**  
Structural Grade: **0**  
O&M Grade: **0**  
Clock Start/From:  
Clock To:  
1st Value:  
2nd Value:  
Value Percent:  
Step: **NO**  
Remarks: **Surcharge**

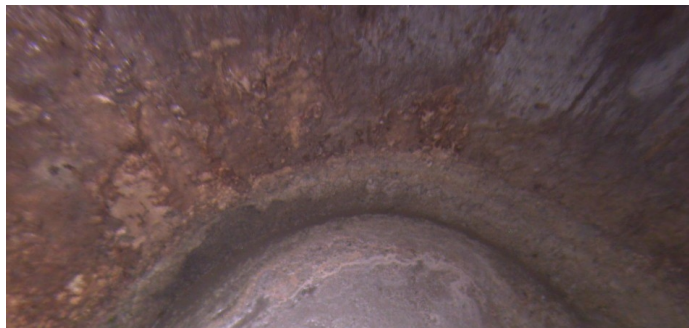
Code: **DAZ**  
Description: **Deposits Attached Other**

Distance (ft): **10.9**  
Structural Grade: **0**  
O&M Grade: **2**  
Clock Start/From: **12**  
Clock To: **12**  
1st Value:  
2nd Value:  
Value Percent: **5.000**  
Step: **NO**  
Remarks: **Mixed materials**

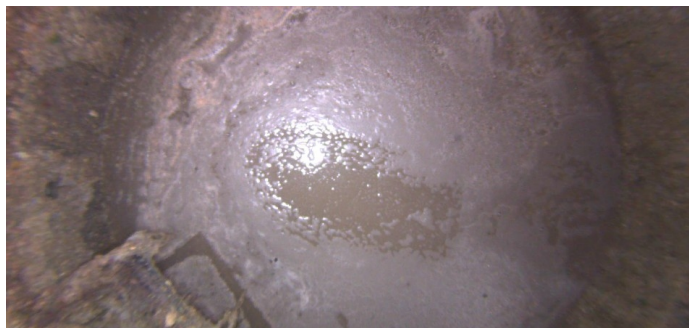
Code: **MSA**  
Description: **Abandoned Survey**

Distance (ft): **11.5**  
Structural Grade: **0**  
O&M Grade: **0**  
Clock Start/From:  
Clock To:  
1st Value:  
2nd Value:  
Value Percent:  
Step: **NO**  
Remarks: **Surcharge**
