Manhole Inspection Report

Date:	04/22/2018	Weather:		Coding:	RZMACP
MH#:	M-906-017	Owner:	NA	Len. Surveyed:	7.8
P.O.#:		Surveyor:	Jen Costello	Rim to Invert:	7.5
Customer:	8.7	Cert. #:	U-907-5518	Wall Material:	Concrete (reinforced)

Street:	North of 10th St. 452' East of Sulliva	Project:	Hobart, IN
City:	Hobart, IN	GPS Northing:	0.0
Location:		GPS Easting:	0.0
Drain Area:	Southeast	GPS Accuracy:	Nearest Meter
Cover Shape:	Circular	Evidence of Surcharge:	No
Cover Size:	22.5	Potential for Runoff:	None
Comments:

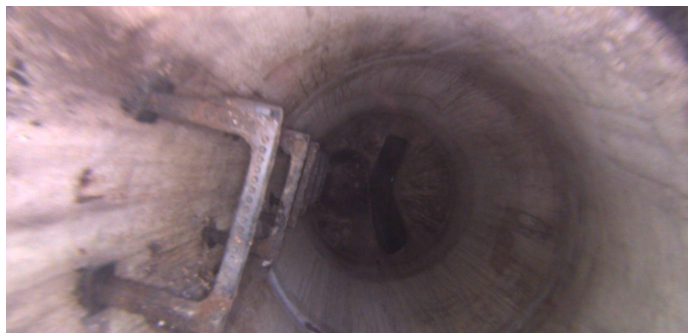
Code: **MGO**
Description: **General Observation**

Distance (ft): **.0**
Structural Grade: **0**
O&M Grade: **0**
Clock Start/From:
Clock To:
1st Value:
2nd Value:
Value Percent:
Step: **NO**
Remarks: **access mh**

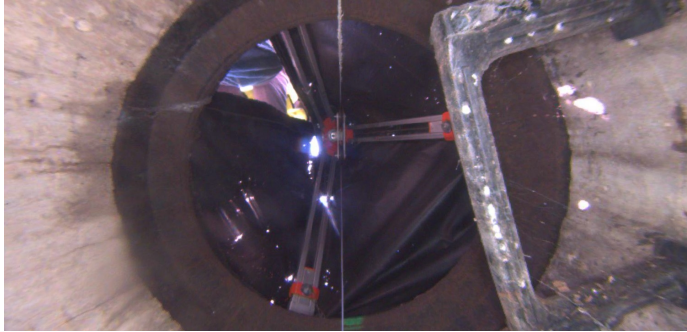
Code: **MGP**
Description: **General Photo**

Distance (ft): **2.2**
Structural Grade: **0**
O&M Grade: **0**
Clock Start/From:
Clock To:
1st Value:
2nd Value:
Value Percent:
Step: **NO**
Remarks: **underside of frame**

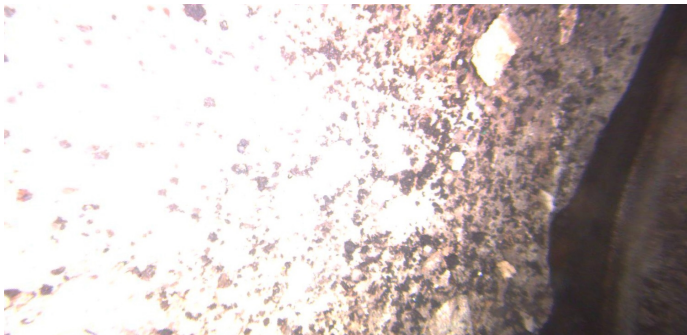
Code: **MGO**
Description: **General Observation**

Distance (ft): **7.8**
Structural Grade: **0**
O&M Grade: **0**
Clock Start/From:
Clock To:
1st Value:
2nd Value:
Value Percent:
Step: **NO**
Remarks: **end survey**
