Manhole Inspection Report

Date:	04/19/2018	Weather:		Coding:	RZMACP
MH#:	M-907-001	Owner:	NA	Len. Surveyed:	11.0
P.O.#:		Surveyor:	Jen Costello	Rim to Invert:	11.6
Customer:		Cert. #:	U-907-5518	Wall Material:	Concrete (reinforced)

Street:	On Hobart Rd. 1312' South of 10th S	Project:	Hobart, IN
City:	Hobart, IN	GPS Northing:	0.0
Location:		GPS Easting:	0.0
Drain Area:	Southeast	GPS Accuracy:	Nearest Meter
Cover Shape:	Circular	Evidence of Surcharge:	No
Cover Size:	22.5	Potential for Runoff:	None
Comments:

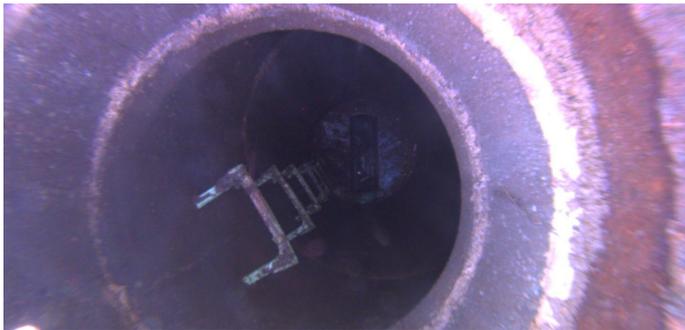
Code: **MGO**
Description: **General Observation**

Distance (ft): **.0**
Structural Grade: **0**
O&M Grade: **0**
Clock Start/From:
Clock To:
1st Value:
2nd Value:
Value Percent:
Step: **NO**
Remarks: **ACCESS MH**

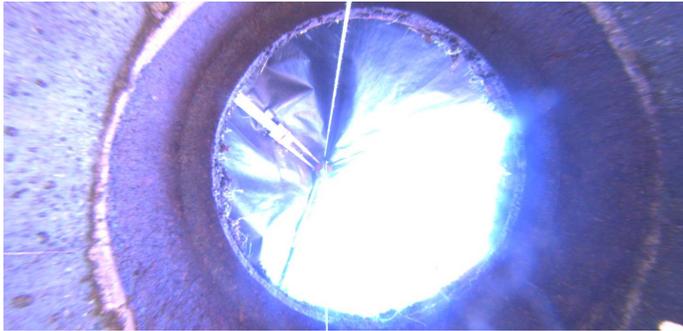
Code: **MGP**
Description: **General Photo**

Distance (ft): **1.9**
Structural Grade: **0**
O&M Grade: **0**
Clock Start/From:
Clock To:
1st Value:
2nd Value:
Value Percent:
Step: **NO**
Remarks: **UNDERSIDE OF FRAME**

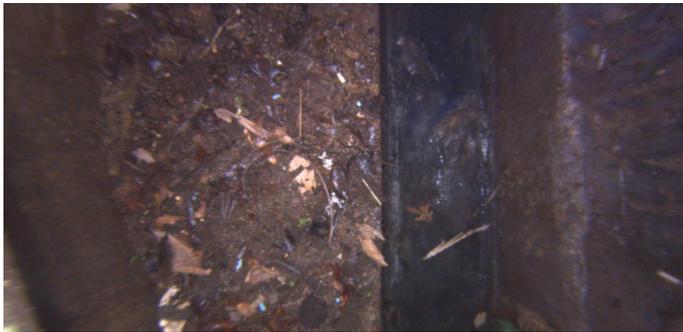
Code: **DSF**
Description: **Deposits Settled Fine**

Distance (ft): **9.9**
Structural Grade: **0**
O&M Grade: **2**
Clock Start/From: **6**
Clock To: **12**
1st Value:
2nd Value:
Value Percent: **5.000**
Step: **NO**
Remarks:

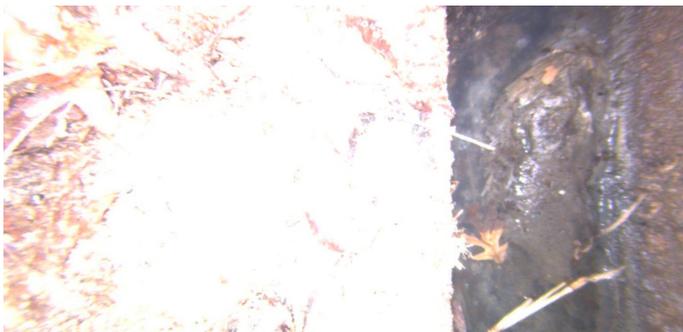
Code: **MGO**
Description: **General Observation**

Distance (ft): **11.0**
Structural Grade: **0**
O&M Grade: **0**
Clock Start/From:
Clock To:
1st Value:
2nd Value:
Value Percent:
Step: **NO**
Remarks: **END SURVEY**
