# Manhole Inspection Report

Date:	<b>04/19/2018</b>	Weather:		Coding:	<b>RZMACP</b>
MH#:	<b>M-907-003</b>	Owner:	<b>NA</b>	Len. Surveyed:	<b>12.4</b>
P.O.#:		Surveyor:	<b>Jen Costello</b>	Rim to Invert:	<b>12.4</b>
Customer:		Cert. #:	<b>U-907-5518</b>	Wall Material:	<b>Concrete (reinforced)</b>

Street:	<b>On Hobart Rd. 733' South of 10th St.</b>	Project:	<b>Hobart, IN</b>
City:	<b>Hobart, IN</b>	GPS Northing:	<b>2909950.749</b>
Location:		GPS Easting:	<b>2909950.749</b>
Drain Area:	<b>Southeast</b>	GPS Accuracy:	<b>Sub-Meter</b>
Cover Shape:	<b>Circular</b>	Evidence of Surcharge:	<b>No</b>
Cover Size:	<b>22.5</b>	Potential for Runoff:	<b>None</b>
Comments:

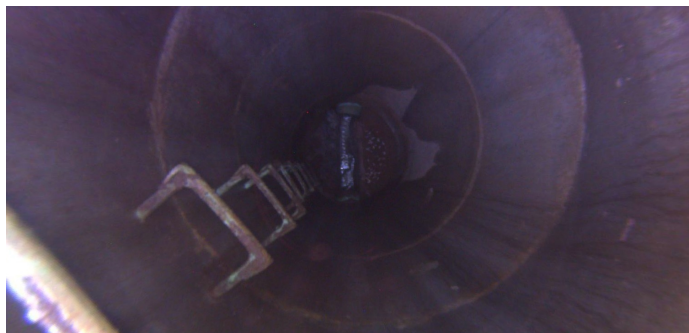
Code: **MGO**  
Description: **General Observation**

Distance (ft): **.0**  
Structural Grade: **0**  
O&M Grade: **0**  
Clock Start/From:  
Clock To:  
1st Value:  
2nd Value:  
Value Percent:  
Step: **NO**  
Remarks: **ACCESS MH**

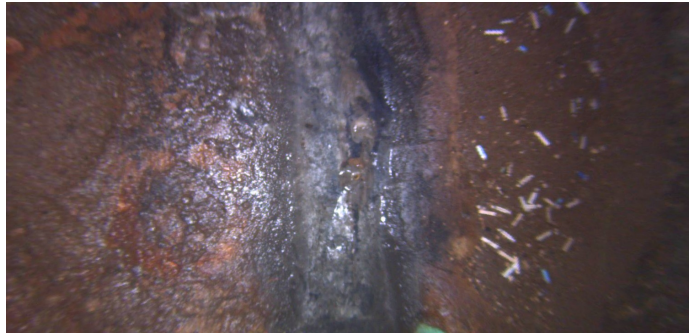
Code:	<b>DSF</b>
Description:	<b>Deposits Settled Fine</b>
Distance (ft):	<b>11.2</b>
Structural Grade:	<b>0</b>
O&M Grade:	<b>2</b>
Clock Start/From:	<b>12</b>
Clock To:	<b>12</b>
1st Value:	
2nd Value:	
Value Percent:	<b>5.000</b>
Step:	<b>NO</b>
Remarks:

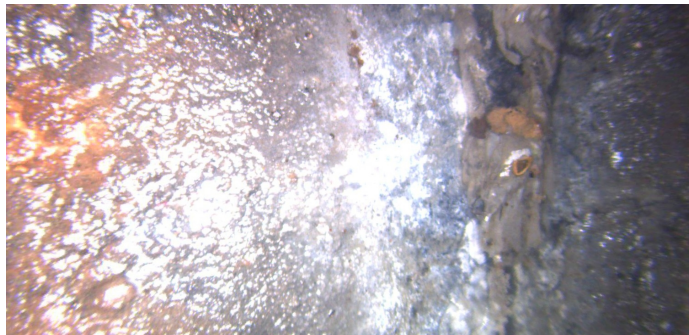
Code:	<b>MGO</b>
Description:	<b>General Observation</b>
Distance (ft):	<b>12.4</b>
Structural Grade:	<b>0</b>
O&M Grade:	<b>0</b>
Clock Start/From:	
Clock To:	
1st Value:	
2nd Value:	
Value Percent:	
Step:	<b>NO</b>
Remarks:	<b>END SURVEY</b>
