# Manhole Inspection Report

Date:	04/22/2018	Weather:		Coding:	RZMACP
MH#:	M-907-004	Owner:	NA	Len. Surveyed:	10.5
P.O.#:		Surveyor:	Jen Costello	Rim to Invert:	11.9
Customer:	8.7	Cert. #:	U-907-5518	Wall Material:	Concrete (reinforced)

Street:	On Hobart Rd. 484' South of 10th St.	Project:	Hobart, IN
City:	Hobart, IN	GPS Northing:	0.0
Location:		GPS Easting:	0.0
Drain Area:	Southeast	GPS Accuracy:	Nearest Meter
Cover Shape:	Circular	Evidence of Surcharge:	No
Cover Size:	22.5	Potential for Runoff:	None
Comments:

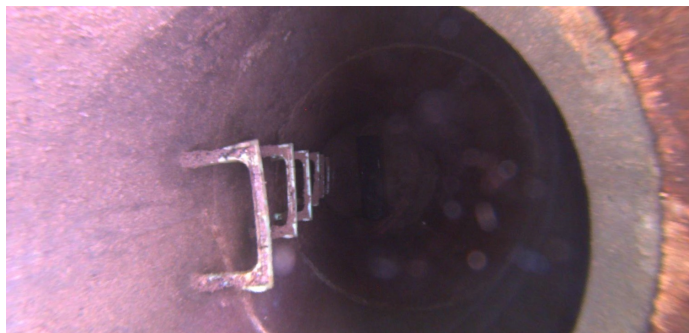
Code: **MGO**  
Description: **General Observation**

Distance (ft): **.0**  
Structural Grade: **0**  
O&M Grade: **0**  
Clock Start/From:  
Clock To:  
1st Value:  
2nd Value:  
Value Percent:  
Step: **NO**  
Remarks: **ACCESS MH**

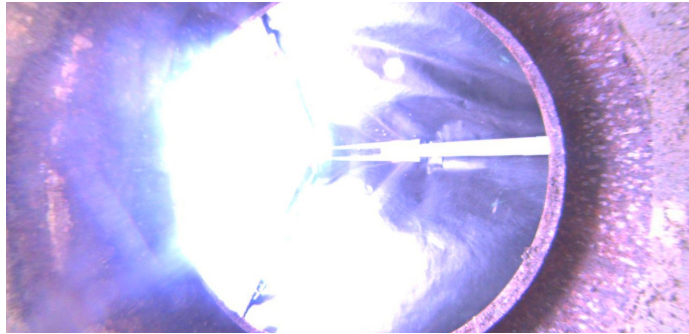
Code:	<b>MGP</b>
Description:	<b>General Photo</b>
Distance (ft):	<b>1.9</b>
Structural Grade:	<b>0</b>
O&M Grade:	<b>0</b>
Clock Start/From:	
Clock To:	
1st Value:	
2nd Value:	
Value Percent:	
Step:	<b>NO</b>
Remarks:	<b>UNDERSIDE OF FRAME</b>

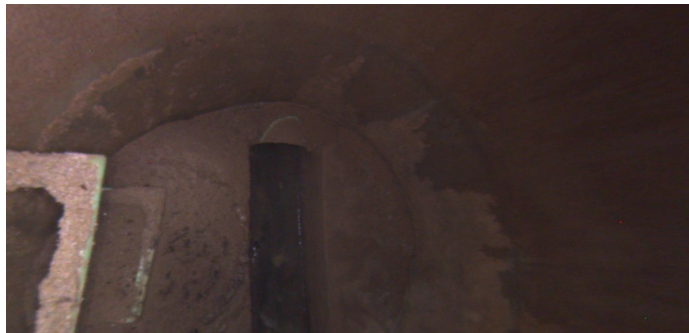
Code:	<b>IS</b>
Description:	<b>Infil Stain</b>
Distance (ft):	<b>7.6</b>
Structural Grade:	<b>0</b>
O&M Grade:	<b>0</b>
Clock Start/From:	<b>12</b>
Clock To:	<b>6</b>
1st Value:	
2nd Value:	
Value Percent:	
Step:	<b>NO</b>
Remarks:

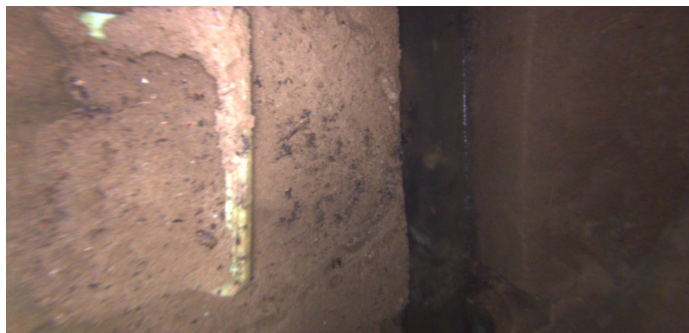
Code:	<b>DSF</b>
Description:	<b>Deposits Settled Fine</b>
Distance (ft):	<b>9.5</b>
Structural Grade:	<b>0</b>
O&M Grade:	<b>2</b>
Clock Start/From:	<b>6</b>
Clock To:	<b>12</b>
1st Value:	
2nd Value:	
Value Percent:	<b>10.000</b>
Step:	<b>NO</b>
Remarks:
