Manhole Inspection Report

Date:	04/19/2018	Weather:		Coding:	RZMACP
MH#:	M-907-006	Owner:	NA	Len. Surveyed:	8.3
P.O.#:		Surveyor:	Jen Costello	Rim to Invert:	11.3
Customer:		Cert. #:	U-907-5518	Wall Material:	Concrete (reinforced)

Street:	On Hobart Rd. 2070' South of 10th S	Project:	Hobart, IN
City:	Hobart, IN	GPS Northing:	2909994.353
Location:		GPS Easting:	2909994.353
Drain Area:	Southeast	GPS Accuracy:	Sub-Meter
Cover Shape:	Circular	Evidence of Surcharge:	No
Cover Size:	22.5	Potential for Runoff:	None
Comments:

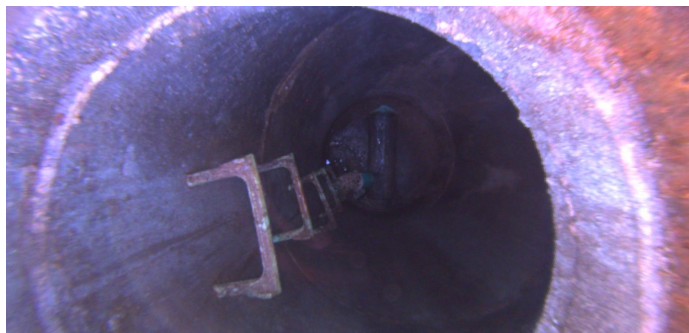
Code: **MGO**
Description: **General Observation**

Distance (ft): **.0**
Structural Grade: **0**
O&M Grade: **0**
Clock Start/From:
Clock To:
1st Value:
2nd Value:
Value Percent:
Step: **NO**
Remarks: **access MH**

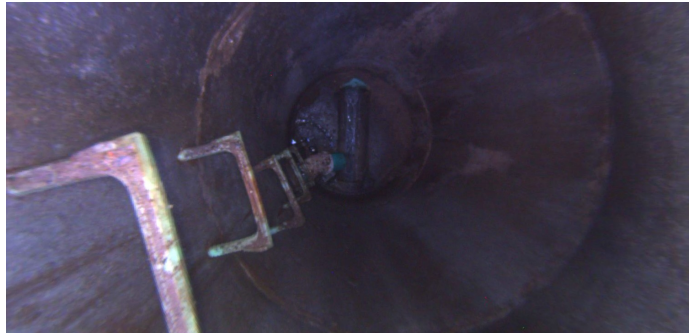
Code: **SRI**
Description: **Surface Roughness Increased**

Distance (ft): **.8**
Structural Grade: **1**
O&M Grade: **0**
Clock Start/From: **12**
Clock To: **12**
1st Value:
2nd Value:
Value Percent:
Step: **NO**
Remarks:

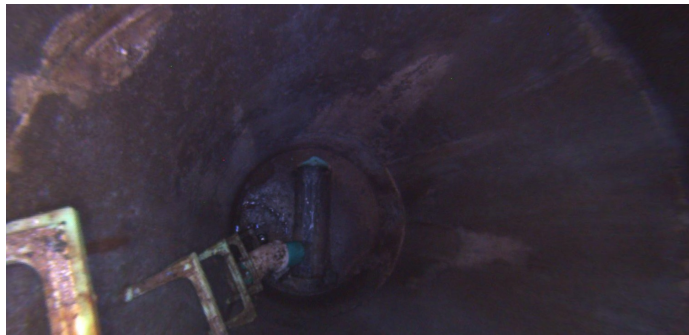
Code: **IS**
Description: **Infil Stain**

Distance (ft): **2.2**
Structural Grade: **0**
O&M Grade: **0**
Clock Start/From: **12**
Clock To: **12**
1st Value:
2nd Value:
Value Percent:
Step: **NO**
Remarks:

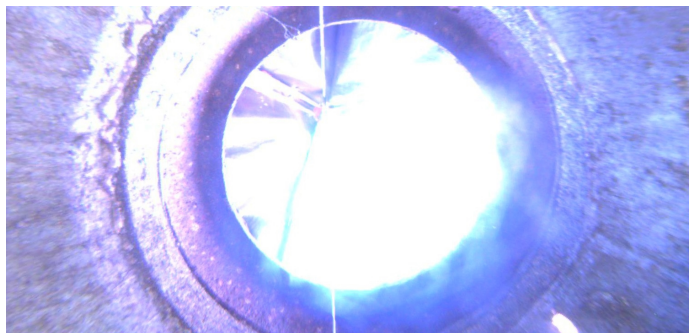
Code: **MGO**
Description: **General Observation**

Distance (ft): **2.4**
Structural Grade: **0**
O&M Grade: **0**
Clock Start/From:
Clock To:
1st Value:
2nd Value:
Value Percent:
Step: **NO**
Remarks: **UNDERSIDE OF FRAME**

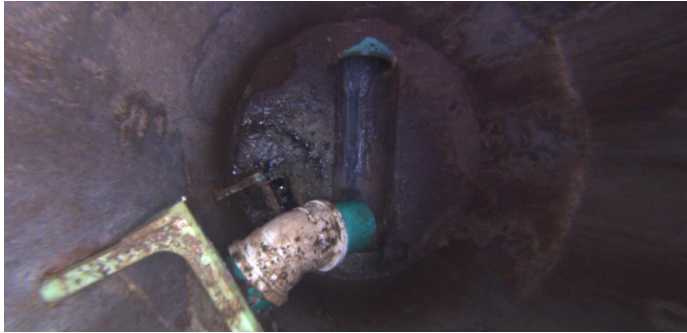
Code: **IW**
Description: **Infil Weeper**

Distance (ft): **6.2**
Structural Grade: **0**
O&M Grade: **2**
Clock Start/From: **12**
Clock To: **12**
1st Value:
2nd Value:
Value Percent:
Step: **NO**
Remarks:

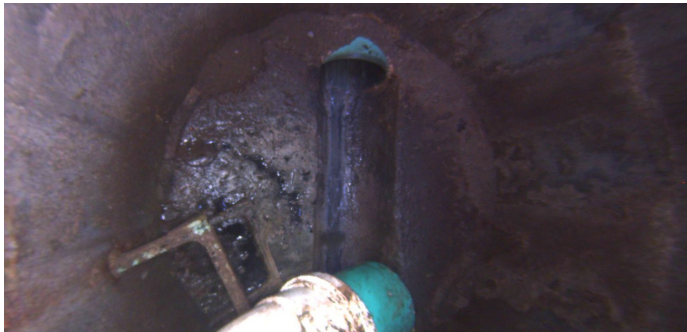
Code: **OBP**
Description: **Obstacle External Pipe or Cable**

Distance (ft): **7.6**
Structural Grade: **0**
O&M Grade: **2**
Clock Start/From: **6**
Clock To: **7**
1st Value:
2nd Value:
Value Percent: **10.000**
Step: **NO**
Remarks:

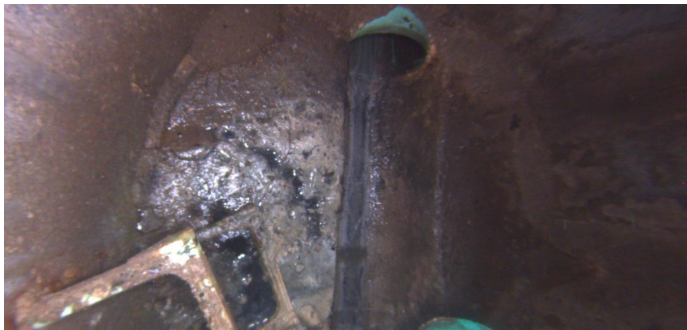
Code: **MSA**
Description: **Abandoned Survey**

Distance (ft): **8.3**
Structural Grade: **0**
O&M Grade: **0**
Clock Start/From:
Clock To:
1st Value:
2nd Value:
Value Percent:
Step: **NO**
Remarks: **OBP**

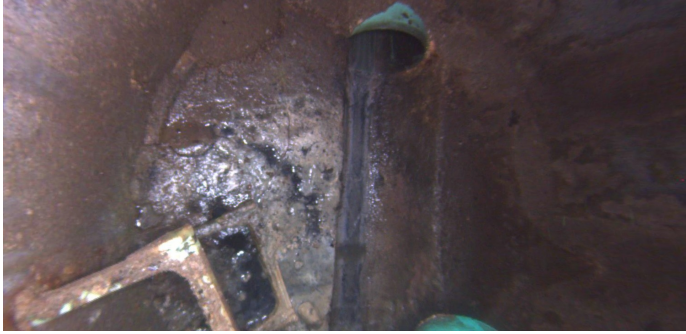
Code:	SRI
Description:	Surface Roughness Increased
Distance (ft):	8.3
Structural Grade:	1
O&M Grade:	0
Clock Start/From:	12
Clock To:	12
1st Value:	
2nd Value:	
Value Percent:	
Step:	NO
Remarks:
