Manhole Inspection Report

Date:	04/19/2018	Weather:		Coding:	RZMACP
MH#:	M-907-007	Owner:	NA	Len. Surveyed:	10.9
P.O.#:		Surveyor:	Jen Costello	Rim to Invert:	11.7
Customer:		Cert. #:	U-907-5518	Wall Material:	Concrete (reinforced)

Street:	On Hobart Rd. 1711' South of 10th S	Project:	Hobart, IN
City:	Hobart, IN	GPS Northing:	2909981.81
Location:		GPS Easting:	2909981.81
Drain Area:	Southeast	GPS Accuracy:	Sub-Meter
Cover Shape:	Circular	Evidence of Surcharge:	No
Cover Size:	22.5	Potential for Runoff:	None
Comments:

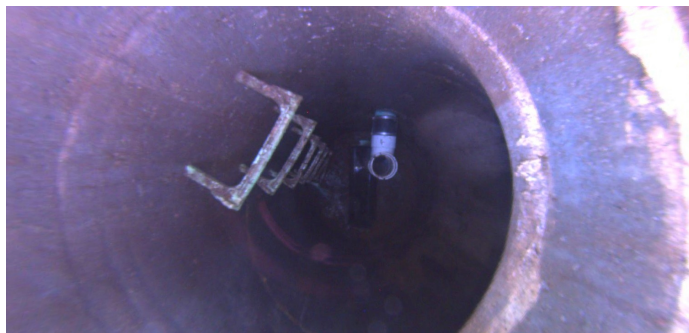
Code: **MGO**
Description: **General Observation**

Distance (ft): **.0**
Structural Grade: **0**
O&M Grade: **0**
Clock Start/From:
Clock To:
1st Value:
2nd Value:
Value Percent:
Step: **NO**
Remarks: **ACCESS MH**

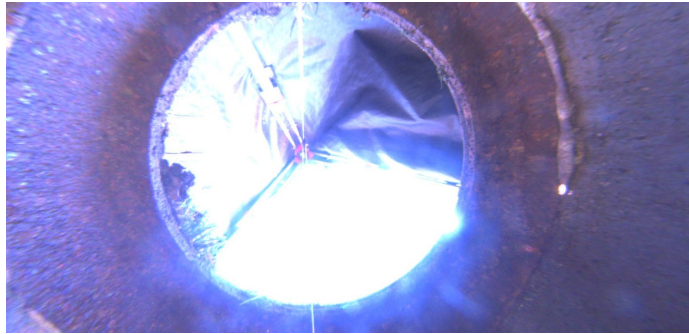
Code:	MGO
Description:	General Observation
Distance (ft):	1.6
Structural Grade:	0
O&M Grade:	0
Clock Start/From:	
Clock To:	
1st Value:	
2nd Value:	
Value Percent:	
Step:	NO
Remarks:	UNDERSIDE OF FRAME

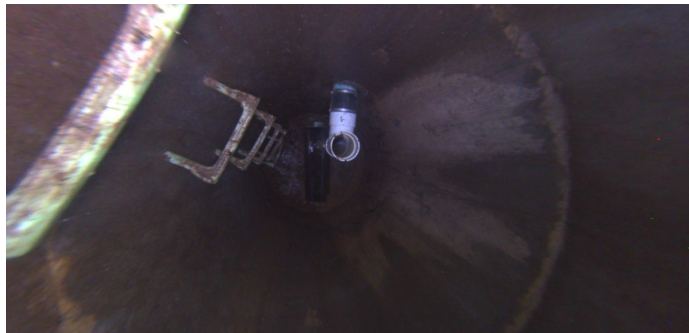
Code:	IS
Description:	Infil Stain
Distance (ft):	2.7
Structural Grade:	0
O&M Grade:	0
Clock Start/From:	12
Clock To:	12
1st Value:	
2nd Value:	
Value Percent:	
Step:	NO
Remarks:

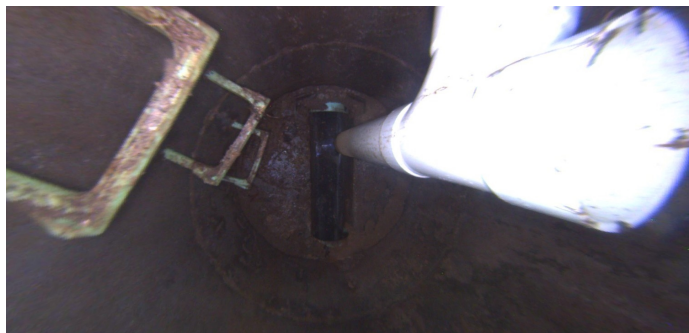
Code:	OBP
Description:	Obstacle External Pipe or Cable
Distance (ft):	6.5
Structural Grade:	0
O&M Grade:	4
Clock Start/From:	12
Clock To:	1
1st Value:	
2nd Value:	
Value Percent:	30.000
Step:	NO
Remarks:

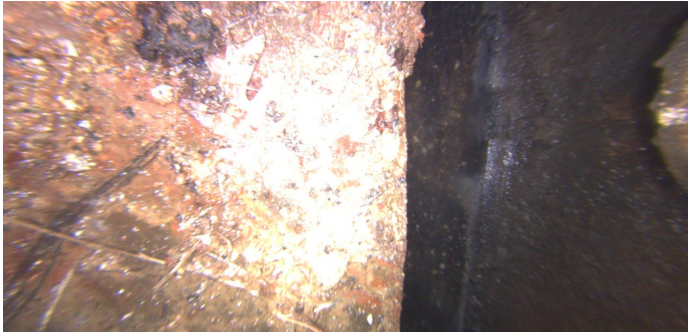
Code:	MGO
Description:	General Observation
Distance (ft):	10.9
Structural Grade:	0
O&M Grade:	0
Clock Start/From:	
Clock To:	
1st Value:	
2nd Value:	
Value Percent:	
Step:	NO
Remarks:	END SURVEY
