Manhole Inspection Report

Date:	04/22/2018	Weather:		Coding:	RZMACP
MH#:	M-907-009	Owner:	NA	Len. Surveyed:	15.0
P.O.#:		Surveyor:	Jen Costello	Rim to Invert:	15.5
Customer:	8.7	Cert. #:	U-907-5518	Wall Material:	Concrete (reinforced)

Street:	10th St. and Union St. Hobart High S	Project:	Hobart, IN
City:	Hobart, IN	GPS Northing:	0.0
Location:		GPS Easting:	0.0
Drain Area:	Southeast	GPS Accuracy:	Nearest Meter
Cover Shape:	Circular	Evidence of Surcharge:	No
Cover Size:	22.5	Potential for Runoff:	None
Comments:

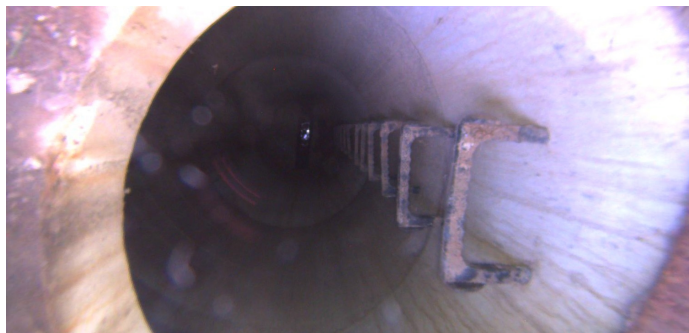
Code: **MGO**
Description: **General Observation**

Distance (ft): **.0**
Structural Grade: **0**
O&M Grade: **0**
Clock Start/From:
Clock To:
1st Value:
2nd Value:
Value Percent:
Step: **NO**
Remarks: **access mh**

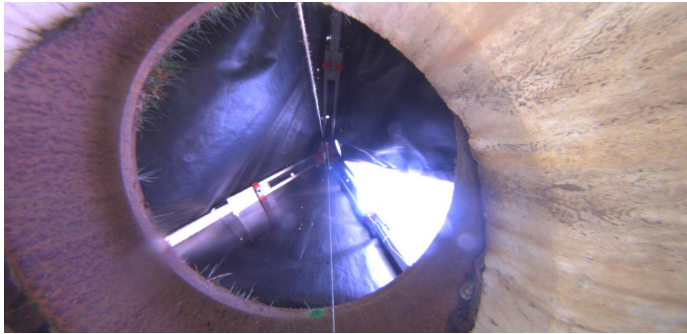
Code: **MGO**
Description: **General Observation**

Distance (ft): **1.8**
Structural Grade: **0**
O&M Grade: **0**
Clock Start/From:
Clock To:
1st Value:
2nd Value:
Value Percent:
Step: **NO**
Remarks: **underside of frame**

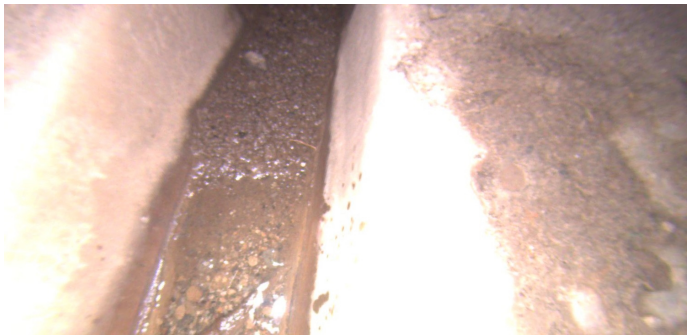
Code: **DSF**
Description: **Deposits Settled Fine**

Distance (ft): **15.0**
Structural Grade: **0**
O&M Grade: **2**
Clock Start/From: **5**
Clock To: **7**
1st Value:
2nd Value:
Value Percent: **5.000**
Step: **NO**
Remarks:

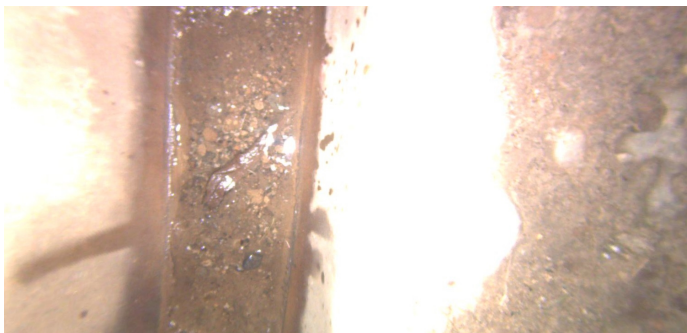
Code: **MGO**
Description: **General Observation**

Distance (ft): **15.0**
Structural Grade: **0**
O&M Grade: **0**
Clock Start/From:
Clock To:
1st Value:
2nd Value:
Value Percent:
Step: **NO**
Remarks: **end survey**
