Manhole Inspection Report

Date:	04/22/2018	Weather:		Coding:	RZMACP
MH#:	M-907-009A	Owner:	NA	Len. Surveyed:	14.8
P.O.#:		Surveyor:	Jen Costello	Rim to Invert:	14.7
Customer:	8.7	Cert. #:	U-907-5518	Wall Material:	Concrete (reinforced)

Street:	10th St. and Union St. Hobart High S	Project:	Hobart, IN
City:	Hobart, IN	GPS Northing:	0.0
Location:		GPS Easting:	0.0
Drain Area:	Southeast	GPS Accuracy:	Nearest Meter
Cover Shape:	Circular	Evidence of Surcharge:	No
Cover Size:	22.5	Potential for Runoff:	None
Comments:

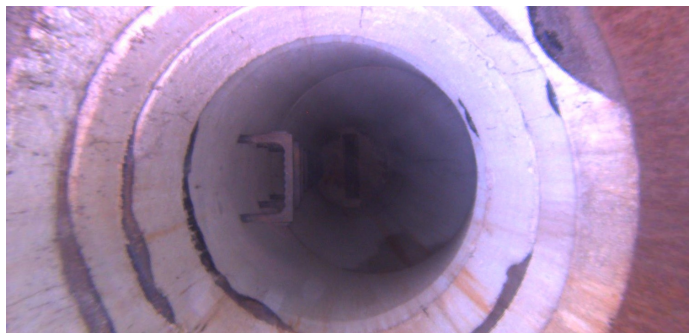
Code: **MGO**
Description: **General Observation**

Distance (ft): **.0**
Structural Grade: **0**
O&M Grade: **0**
Clock Start/From:
Clock To:
1st Value:
2nd Value:
Value Percent:
Step: **NO**
Remarks: **ACCESS MH**

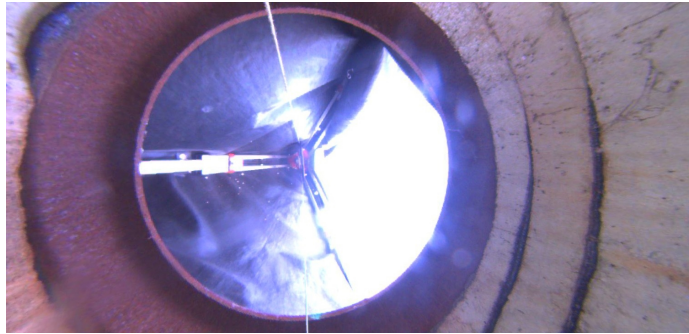
Code: **MGO**
Description: **General Observation**

Distance (ft): **2.2**
Structural Grade: **0**
O&M Grade: **0**
Clock Start/From:
Clock To:
1st Value:
2nd Value:
Value Percent:
Step: **NO**
Remarks: **UNDERSIDE OF FRAME**

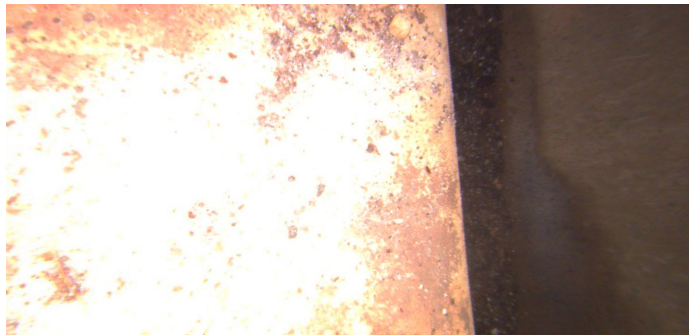
Code: **MGO**
Description: **General Observation**

Distance (ft): **14.8**
Structural Grade: **0**
O&M Grade: **0**
Clock Start/From:
Clock To:
1st Value:
2nd Value:
Value Percent:
Step: **NO**
Remarks: **END SURVEY**

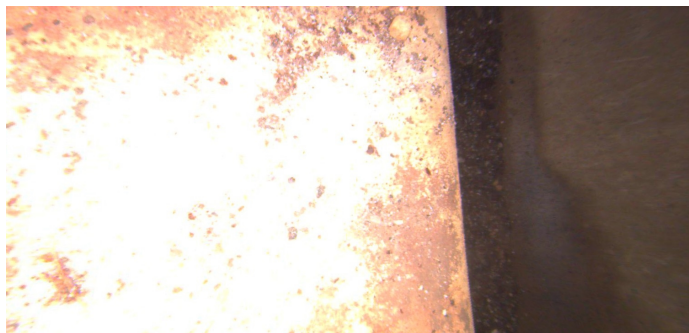
Code: **DSF**
Description: **Deposits Settled Fine**

Distance (ft): **14.8**
Structural Grade: **0**
O&M Grade: **2**
Clock Start/From: **6**
Clock To:
1st Value:
2nd Value:
Value Percent: **5.000**
Step: **NO**
Remarks:
