Manhole Inspection Report

Date:	04/21/2018	Weather:		Coding:	RZMACP
MH#:	M-907-011	Owner:	NA	Len. Surveyed:	5.9
P.O.#:		Surveyor:	Jen Costello	Rim to Invert:	5.5
Customer:		Cert. #:	U-907-5518	Wall Material:	Concrete (reinforced)

Street:	10th St. and Union St. Hobart High S	Project:	Hobart, IN
City:	Hobart, IN	GPS Northing:	0.0
Location:		GPS Easting:	0.0
Drain Area:	Southeast	GPS Accuracy:	Nearest Meter
Cover Shape:	Circular	Evidence of Surcharge:	No
Cover Size:	22.5	Potential for Runoff:	None
Comments:

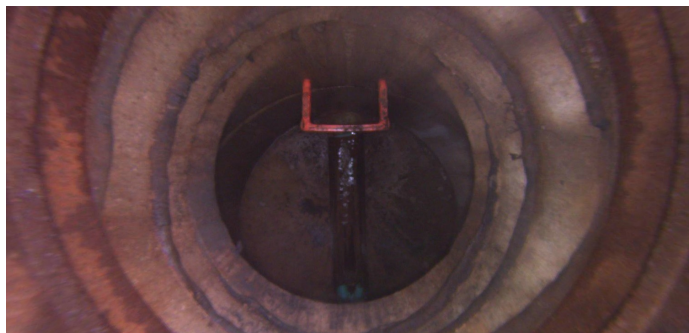
Code: **MGO**
Description: **General Observation**

Distance (ft): **.0**
Structural Grade: **0**
O&M Grade: **0**
Clock Start/From:
Clock To:
1st Value:
2nd Value:
Value Percent:
Step: **NO**
Remarks: **ACCESS MH**

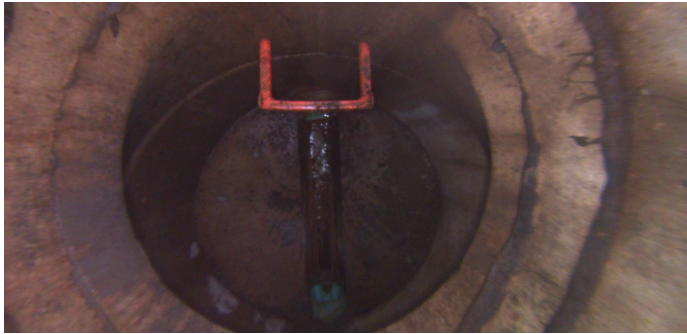
Code: **RFJ**
Description: **Roots Fine Joint**

Distance (ft): **.8**
Structural Grade: **0**
O&M Grade: **1**
Clock Start/From: **2**
Clock To: **3**
1st Value:
2nd Value:
Value Percent:
Step: **NO**
Remarks:

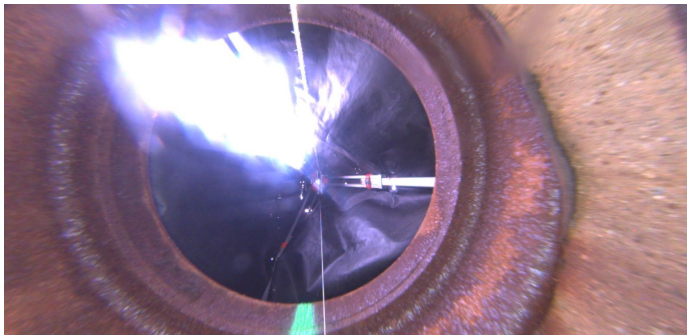
Code: **MGO**
Description: **General Observation**

Distance (ft): **1.9**
Structural Grade: **0**
O&M Grade: **0**
Clock Start/From:
Clock To:
1st Value:
2nd Value:
Value Percent:
Step: **NO**
Remarks: **UNDERSIDE OF FRAME**

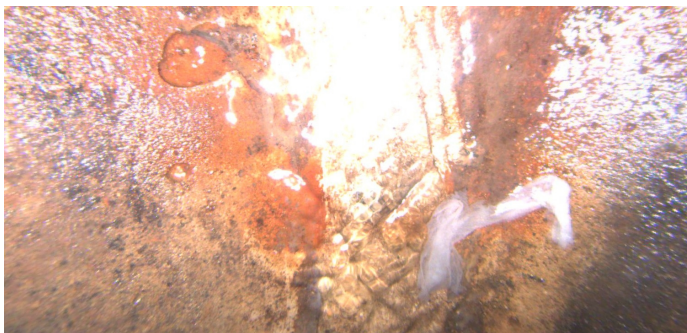
Code: **MGO**
Description: **General Observation**

Distance (ft): **5.9**
Structural Grade: **0**
O&M Grade: **0**
Clock Start/From:
Clock To:
1st Value:
2nd Value:
Value Percent:
Step: **NO**
Remarks: **END SURVEY**
