Manhole Inspection Report

Date:	04/22/2018	Weather:		Coding:	RZMACP
MH#:	M-907-012	Owner:	NA	Len. Surveyed:	8.4
P.O.#:		Surveyor:	Jen Costello	Rim to Invert:	8.3
Customer:	8.7	Cert. #:	U-907-5518	Wall Material:	Concrete (reinforced)

Street:	10th St. and Union St. Hobart High S	Project:	Hobart, IN
City:	Hobart, IN	GPS Northing:	0.0
Location:		GPS Easting:	0.0
Drain Area:	Southeast	GPS Accuracy:	Nearest Meter
Cover Shape:	Circular	Evidence of Surcharge:	No
Cover Size:	22.5	Potential for Runoff:	None
Comments:

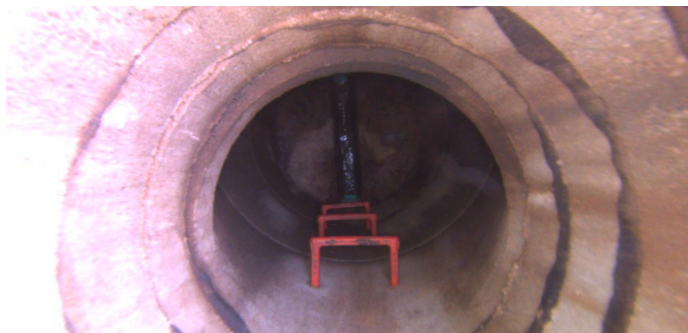
Code: **MGO**
 Description: **General Observation**

Distance (ft): **.0**
 Structural Grade: **0**
 O&M Grade: **0**
 Clock Start/From:
 Clock To:
 1st Value:
 2nd Value:
 Value Percent:
 Step: **NO**
 Remarks: **access MH**

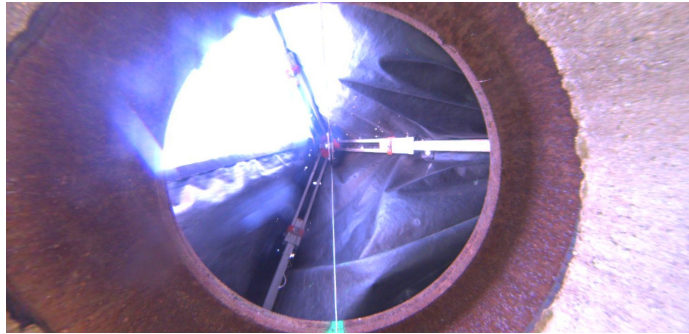
Code: **MGO**
Description: **General Observation**

Distance (ft): **1.6**
Structural Grade: **0**
O&M Grade: **0**
Clock Start/From:
Clock To:
1st Value:
2nd Value:
Value Percent:
Step: **NO**
Remarks: **UNDERSIDE OF FRAME**

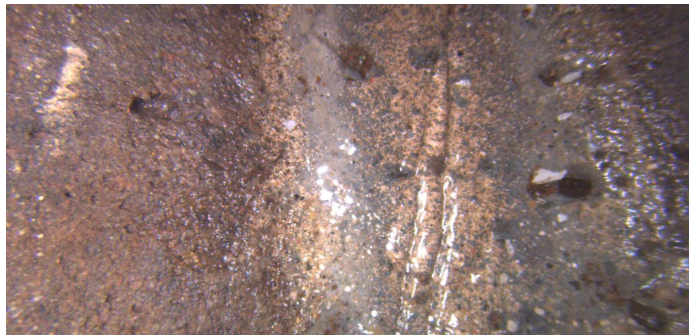
Code: **MGO**
Description: **General Observation**

Distance (ft): **8.4**
Structural Grade: **0**
O&M Grade: **0**
Clock Start/From:
Clock To:
1st Value:
2nd Value:
Value Percent:
Step: **NO**
Remarks: **END SURVEY**
