Manhole Inspection Report

Date:	04/21/2018	Weather:		Coding:	RZMACP
MH#:	M-907-015	Owner:	NA	Len. Surveyed:	6.2
P.O.#:		Surveyor:	Jen Costello	Rim to Invert:	6.4
Customer:		Cert. #:	U-907-5518	Wall Material:	Concrete (reinforced)

Street:	10th St. and Union St. Hobart High S	Project:	Hobart, IN
City:	Hobart, IN	GPS Northing:	0.0
Location:		GPS Easting:	0.0
Drain Area:	Southeast	GPS Accuracy:	Nearest Meter
Cover Shape:	Circular	Evidence of Surcharge:	No
Cover Size:	22.5	Potential for Runoff:	None
Comments:

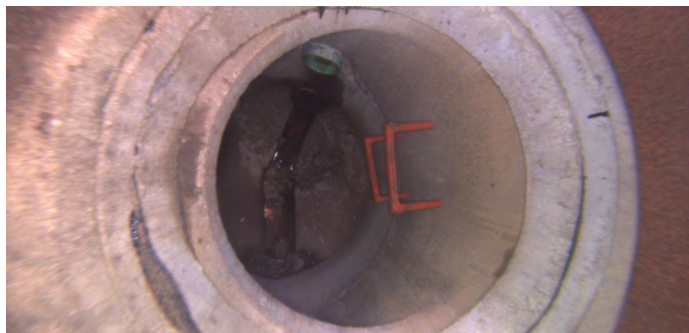
Code: **MGO**
Description: **General Observation**

Distance (ft): **.0**
Structural Grade: **0**
O&M Grade: **0**
Clock Start/From:
Clock To:
1st Value:
2nd Value:
Value Percent:
Step: **NO**
Remarks: **ACCESS MH**

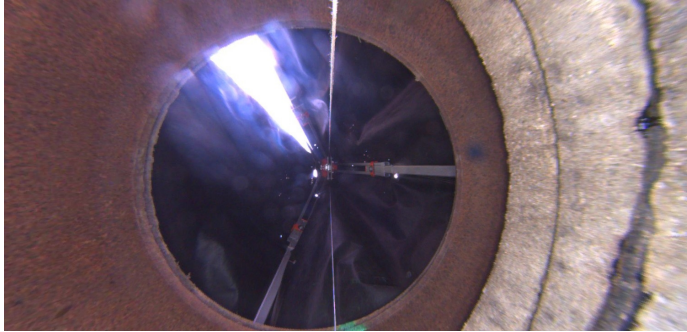
Code: **MGO**
Description: **General Observation**

Distance (ft): **1.9**
Structural Grade: **0**
O&M Grade: **0**
Clock Start/From:
Clock To:
1st Value:
2nd Value:
Value Percent:
Step: **NO**
Remarks: **UNDERSIDE OF FRAME**

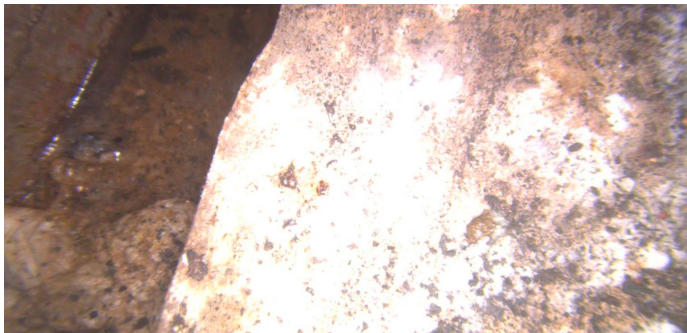
Code: **MGO**
Description: **General Observation**

Distance (ft): **6.2**
Structural Grade: **0**
O&M Grade: **0**
Clock Start/From:
Clock To:
1st Value:
2nd Value:
Value Percent:
Step: **NO**
Remarks: **END SURVEY**
