Manhole Inspection Report

Date:	04/22/2018	Weather:		Coding:	RZMACP
MH#:	M-907-019	Owner:	NA	Len. Surveyed:	11.5
P.O.#:		Surveyor:	Jen Costello	Rim to Invert:	12.2
Customer:	8.7	Cert. #:	U-907-5518	Wall Material:	Concrete (reinforced)

Street:	10th St. and Union St. Hobart High S	Project:	Hobart, IN
City:	Hobart, IN	GPS Northing:	0.0
Location:		GPS Easting:	0.0
Drain Area:	Southeast	GPS Accuracy:	Nearest Meter
Cover Shape:	Circular	Evidence of Surcharge:	No
Cover Size:	22.5	Potential for Runoff:	None
Comments:

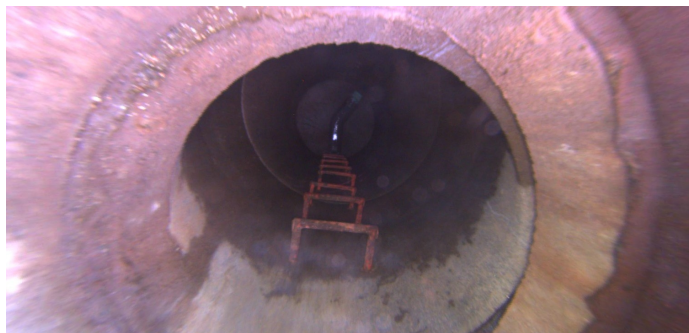
Code: **MGO**
Description: **General Observation**

Distance (ft): **.0**
Structural Grade: **0**
O&M Grade: **0**
Clock Start/From:
Clock To:
1st Value:
2nd Value:
Value Percent:
Step: **NO**
Remarks: **ACCESS MH**

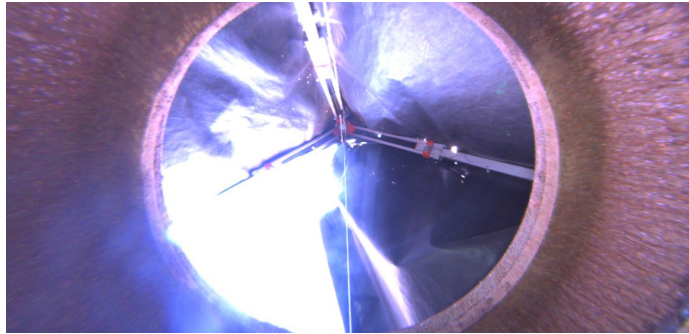
Code:	MGP
Description:	General Photo
Distance (ft):	1.3
Structural Grade:	0
O&M Grade:	0
Clock Start/From:	
Clock To:	
1st Value:	
2nd Value:	
Value Percent:	
Step:	NO
Remarks:	UNDERSIDE OF FRAME

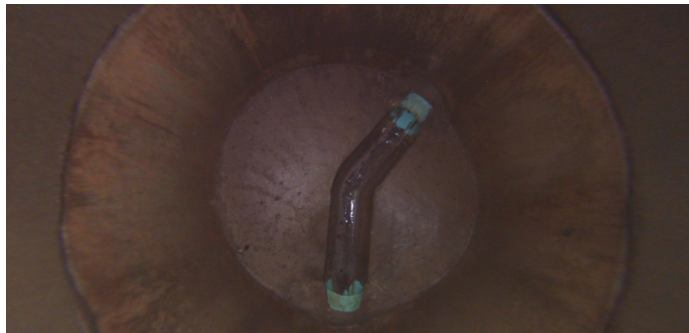
Code:	IS
Description:	Infil Stain
Distance (ft):	8.6
Structural Grade:	0
O&M Grade:	0
Clock Start/From:	12
Clock To:	12
1st Value:	
2nd Value:	
Value Percent:	
Step:	NO
Remarks:

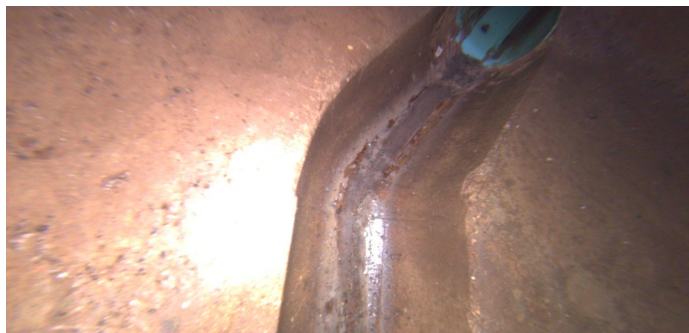
Code:	MGO
Description:	General Observation
Distance (ft):	11.5
Structural Grade:	0
O&M Grade:	0
Clock Start/From:	
Clock To:	
1st Value:	
2nd Value:	
Value Percent:	
Step:	NO
Remarks:	END SURVEY
