Manhole Inspection Report

Date:	04/22/2018	Weather:		Coding:	RZMACP
MH#:	M-907-021	Owner:	NA	Len. Surveyed:	18.2
P.O.#:		Surveyor:	Jen Costello	Rim to Invert:	18.1
Customer:	8.7	Cert. #:	U-907-5518	Wall Material:	Concrete (reinforced)

Street:	10th St. and Union St. Hobart High S	Project:	Hobart, IN
City:	Hobart, IN	GPS Northing:	0.0
Location:		GPS Easting:	0.0
Drain Area:	Southeast	GPS Accuracy:	Nearest Meter
Cover Shape:	Circular	Evidence of Surcharge:	No
Cover Size:	22.5	Potential for Runoff:	None
Comments:

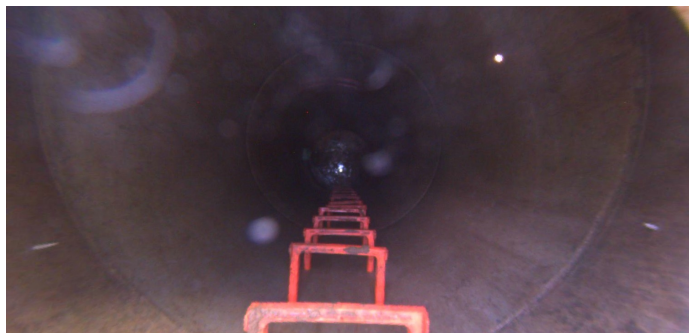
Code: **MGO**
Description: **General Observation**

Distance (ft): **.0**
Structural Grade: **0**
O&M Grade: **0**
Clock Start/From:
Clock To:
1st Value:
2nd Value:
Value Percent:
Step: **NO**
Remarks: **ACCESS MH**

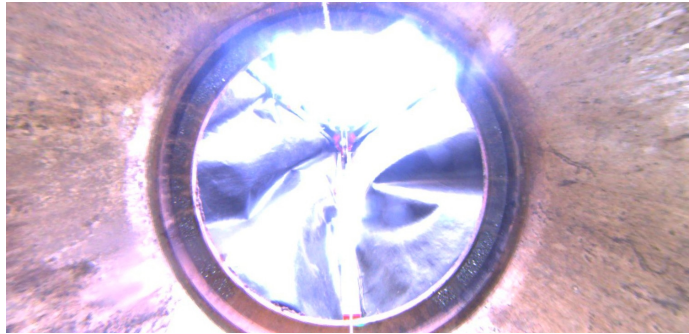
Code:	MGP
Description:	General Photo
Distance (ft):	2.2
Structural Grade:	0
O&M Grade:	0
Clock Start/From:	
Clock To:	
1st Value:	
2nd Value:	
Value Percent:	
Step:	NO
Remarks:	UNDERSIDE OF FRAME

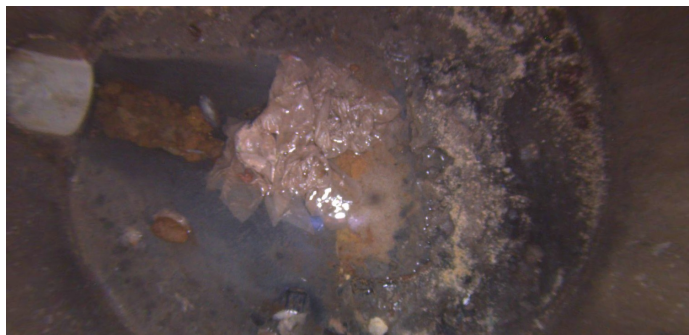
Code:	DSZ
Description:	Deposits Settled Other
Distance (ft):	17.2
Structural Grade:	0
O&M Grade:	2
Clock Start/From:	12
Clock To:	12
1st Value:	
2nd Value:	
Value Percent:	5.000
Step:	NO
Remarks:	MISC

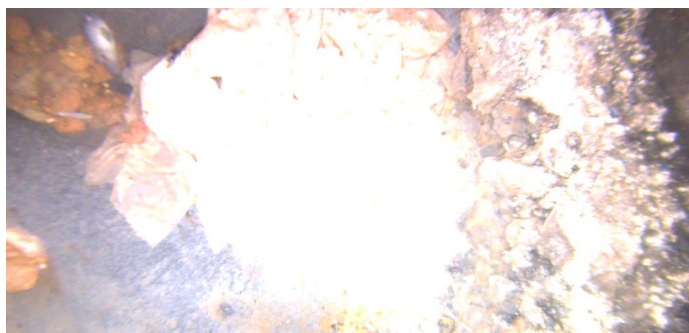
Code:	MGO
Description:	General Observation
Distance (ft):	18.2
Structural Grade:	0
O&M Grade:	0
Clock Start/From:	
Clock To:	
1st Value:	
2nd Value:	
Value Percent:	
Step:	NO
Remarks:	END SURVEY
