Manhole Inspection Report

Date:	04/16/2018	Weather:		Coding:	RZMACP
MH#:	M-910-004	Owner:	NA	Len. Surveyed:	11.1
P.O.#:		Surveyor:	Jen Costello	Rim to Invert:	11.6
Customer:		Cert. #:	U-907-5518	Wall Material:	Concrete (reinforced)

Street:	Norris Dr. 601' East of Randolph St.	Project:	Hobart, IN
City:	Hobart, IN	GPS Northing:	2910617.492
Location:		GPS Easting:	2910617.492
Drain Area:	Southeast	GPS Accuracy:	Sub-Meter
Cover Shape:	Circular	Evidence of Surcharge:	No
Cover Size:	29.0	Potential for Runoff:	None
Comments:

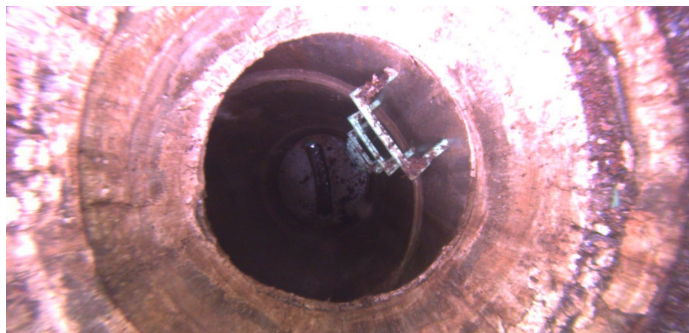
Code: **MGO**
Description: **General Observation**

Distance (ft): **.0**
Structural Grade: **0**
O&M Grade: **0**
Clock Start/From:
Clock To:
1st Value:
2nd Value:
Value Percent:
Step: **NO**
Remarks: **ACCESS MH**

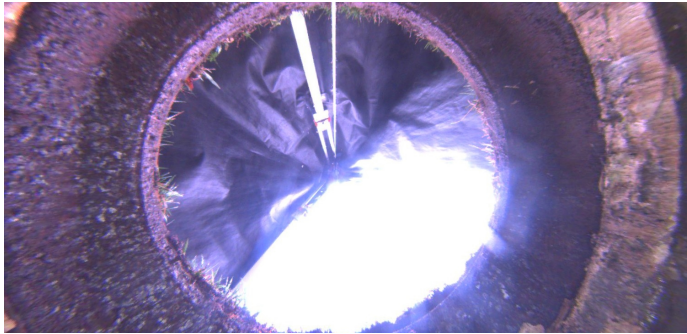
Code:	MGP
Description:	General Photo
Distance (ft):	1.4
Structural Grade:	0
O&M Grade:	0
Clock Start/From:	
Clock To:	
1st Value:	
2nd Value:	
Value Percent:	
Step:	NO
Remarks:	UNDERSIDE OF FRAME

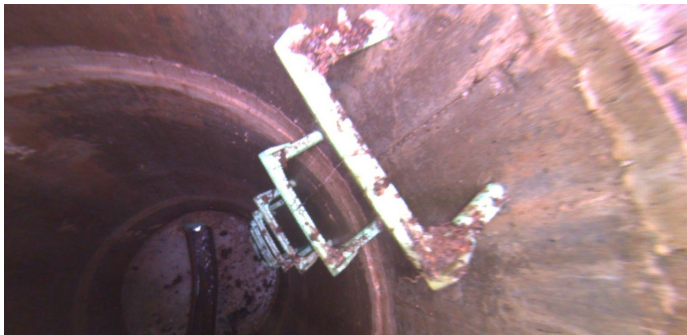
Code:	FL
Description:	Fracture Longitudinal
Distance (ft):	1.4
Structural Grade:	3
O&M Grade:	0
Clock Start/From:	2
Clock To:	
1st Value:	
2nd Value:	
Value Percent:	
Step:	NO
Remarks:

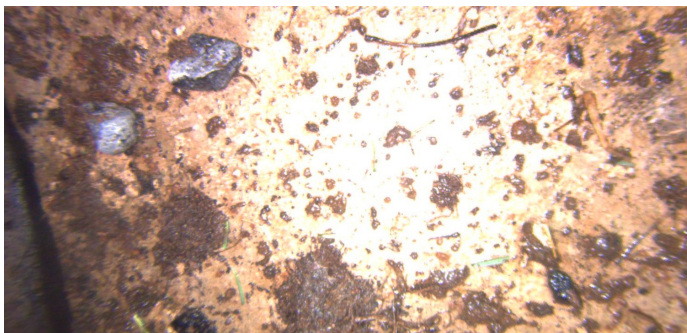
Code:	MGO
Description:	General Observation
Distance (ft):	11.1
Structural Grade:	0
O&M Grade:	0
Clock Start/From:	
Clock To:	
1st Value:	
2nd Value:	
Value Percent:	
Step:	NO
Remarks:	END SURVEY
