# Manhole Inspection Report

| MH#: | <b>M-910-007</b> | Owner: | <b>NA</b> | Len. Surveyed: | <b>12.7</b> |

| Street: | <b>Norris Dr. 938' East of Randolph St.</b> | Project: | <b>Hobart, IN</b> |

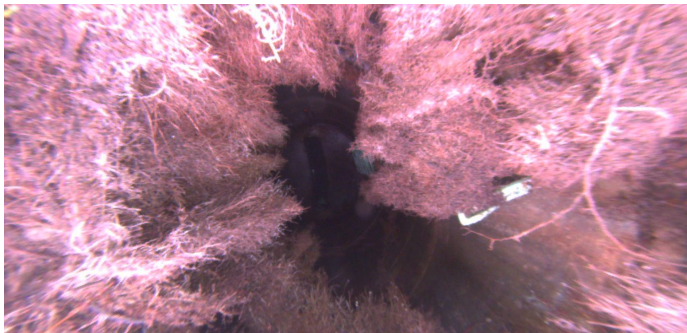
Code: **RMJ**  
Description: **Roots Medium Joint**

Distance (ft): **.0**  
Structural Grade: **0**  
O&M Grade: **3**  
Clock Start/From: **12**  
Clock To: **12**  
1st Value:  
2nd Value:  
Value Percent: **40.000**  
Step: **NO**  
Remarks:

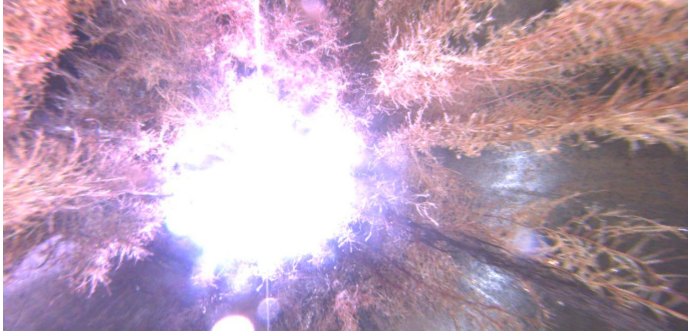
Code: **MGP**  
Description: **General Photo**

Distance (ft): **3.8**  
Structural Grade: **0**  
O&M Grade: **0**  
Clock Start/From:  
Clock To:  
1st Value:  
2nd Value:  
Value Percent:  
Step: **NO**  
Remarks: **underside of frame**

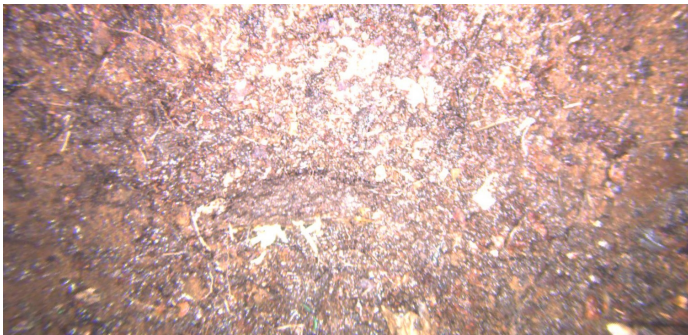
Code: **MGO**  
Description: **General Observation**

Distance (ft): **12.7**  
Structural Grade: **0**  
O&M Grade: **0**  
Clock Start/From:  
Clock To:  
1st Value:  
2nd Value:  
Value Percent:  
Step: **NO**  
Remarks: **end survey**
