Manhole Inspection Report

Date:	04/16/2018	Weather:		Coding:	RZMACP
MH#:	M-910-012	Owner:	NA	Len. Surveyed:	9.2
P.O.#:		Surveyor:	Jen Costello	Rim to Invert:	9.7
Customer:		Cert. #:	U-907-5518	Wall Material:	Concrete (reinforced)

Street:	Norris Dr. 1574' East of Randolph St.	Project:	Hobart, IN
City:	Hobart, IN	GPS Northing:	0.0
Location:		GPS Easting:	0.0
Drain Area:	Southeast	GPS Accuracy:	Nearest Meter
Cover Shape:	Circular	Evidence of Surcharge:	No
Cover Size:	29.0	Potential for Runoff:	None
Comments:

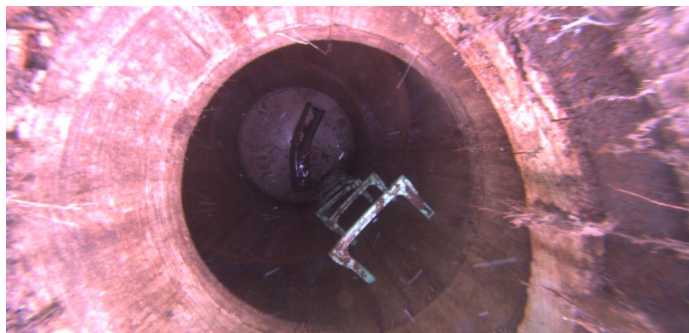
Code: **MGO**
Description: **General Observation**

Distance (ft): **.0**
Structural Grade: **0**
O&M Grade: **0**
Clock Start/From:
Clock To:
1st Value:
2nd Value:
Value Percent:
Step: **NO**
Remarks: **ACCESS MH**

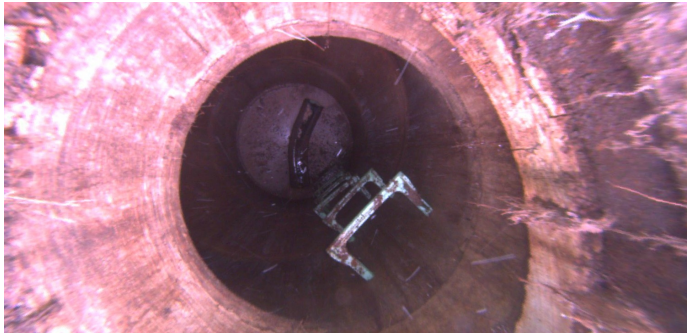
Code: **RFJ**
Description: **Roots Fine Joint**

Distance (ft): **.0**
Structural Grade: **0**
O&M Grade: **1**
Clock Start/From: **12**
Clock To: **12**
1st Value:
2nd Value:
Value Percent:
Step: **NO**
Remarks:

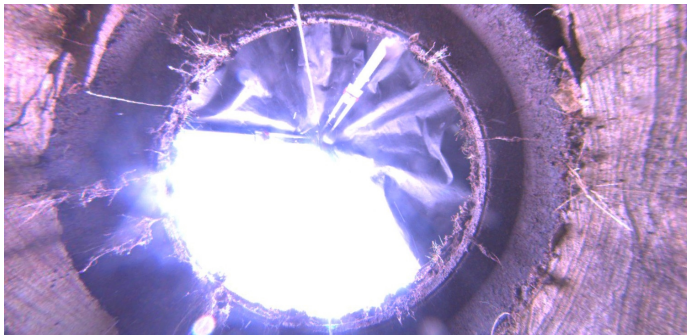
Code: **MGP**
Description: **General Photo**

Distance (ft): **1.5**
Structural Grade: **0**
O&M Grade: **0**
Clock Start/From:
Clock To:
1st Value:
2nd Value:
Value Percent:
Step: **NO**
Remarks: **UNDERSIDE OF FRAME**

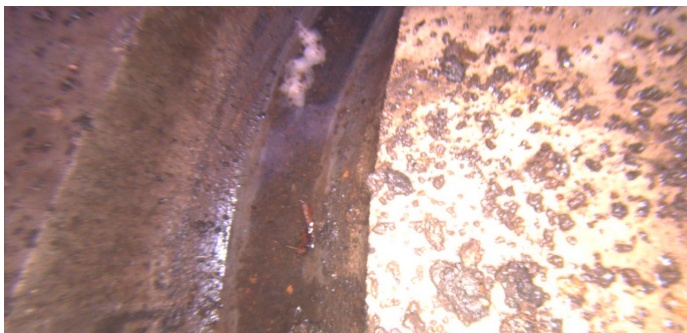
Code: **MGO**
Description: **General Observation**

Distance (ft): **9.0**
Structural Grade: **0**
O&M Grade: **0**
Clock Start/From:
Clock To:
1st Value:
2nd Value:
Value Percent:
Step: **NO**
Remarks: **END SURVEY**
