Manhole Inspection Report

Date:	04/16/2018	Weather:		Coding:	RZMACP
MH#:	M-910-013	Owner:	NA	Len. Surveyed:	8.0
P.O.#:		Surveyor:	Jen Costello	Rim to Invert:	8.4
Customer:		Cert. #:	U-907-5518	Wall Material:	Concrete (reinforced)

Street:	Norris Dr. 1651' East of Randolph St.	Project:	Hobart, IN
City:	Hobart, IN	GPS Northing:	2911666.27
Location:		GPS Easting:	2911666.27
Drain Area:	Southeast	GPS Accuracy:	Sub-Meter
Cover Shape:	Circular	Evidence of Surcharge:	No
Cover Size:	29.0	Potential for Runoff:	None
Comments:

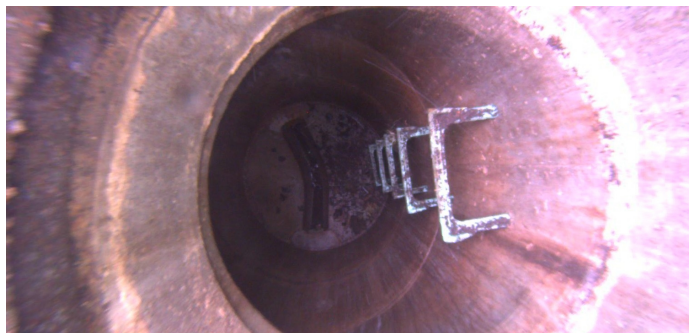
Code: **MGO**
Description: **General Observation**

Distance (ft): **.0**
Structural Grade: **0**
O&M Grade: **0**
Clock Start/From:
Clock To:
1st Value:
2nd Value:
Value Percent:
Step: **NO**
Remarks: **ACCESS MH**

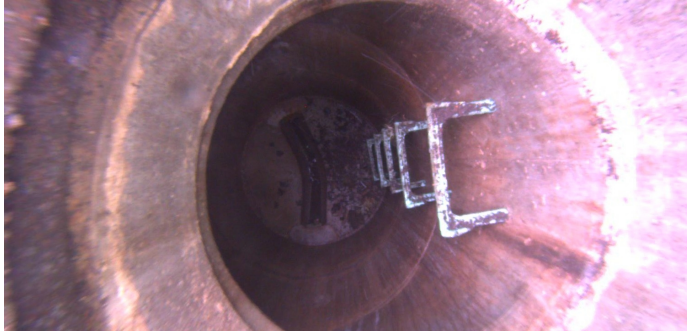
Code: **IS**
Description: **Infil Stain**

Distance (ft): **.0**
Structural Grade: **0**
O&M Grade: **0**
Clock Start/From: **4**
Clock To:
1st Value:
2nd Value:
Value Percent:
Step: **NO**
Remarks:

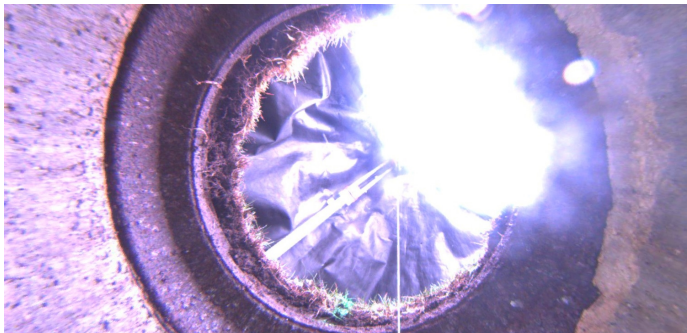
Code: **MGP**
Description: **General Photo**

Distance (ft): **1.8**
Structural Grade: **0**
O&M Grade: **0**
Clock Start/From:
Clock To:
1st Value:
2nd Value:
Value Percent:
Step: **NO**
Remarks: **UNDERSIDE OF FRAME**

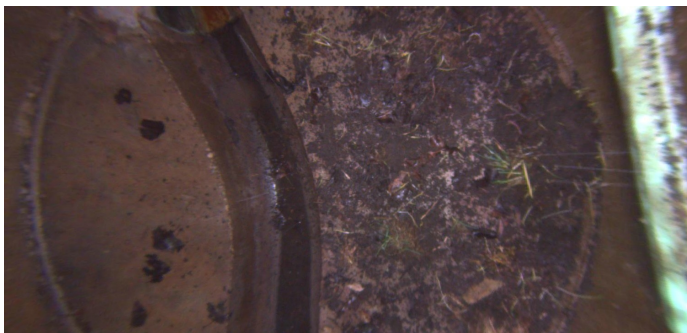
Code: **DSF**
Description: **Deposits Settled Fine**

Distance (ft): **6.2**
Structural Grade: **0**
O&M Grade: **2**
Clock Start/From: **12**
Clock To: **6**
1st Value:
2nd Value:
Value Percent: **5.000**
Step: **NO**
Remarks:

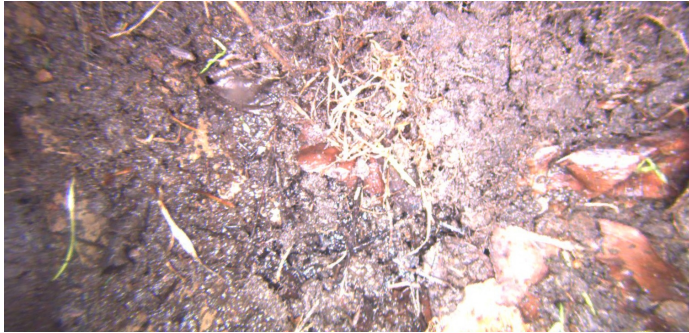
Code:	MGO
Description:	General Observation
Distance (ft):	8.0
Structural Grade:	0
O&M Grade:	0
Clock Start/From:	
Clock To:	
1st Value:	
2nd Value:	
Value Percent:	
Step:	NO
Remarks:	END SURVEY
