Manhole Inspection Report

Date:	04/16/2018	Weather:		Coding:	RZMACP
MH#:	M-910-015	Owner:	NA	Len. Surveyed:	8.1
P.O.#:		Surveyor:	Jen Costello	Rim to Invert:	8.6
Customer:		Cert. #:	U-907-5518	Wall Material:	Concrete (reinforced)

Street:	Norris Dr. 1714' East of Randolph St.	Project:	Hobart, IN
City:	Hobart, IN	GPS Northing:	2911732.573
Location:		GPS Easting:	2911732.573
Drain Area:	Southeast	GPS Accuracy:	Sub-Meter
Cover Shape:	Circular	Evidence of Surcharge:	No
Cover Size:	29.0	Potential for Runoff:	None
Comments:

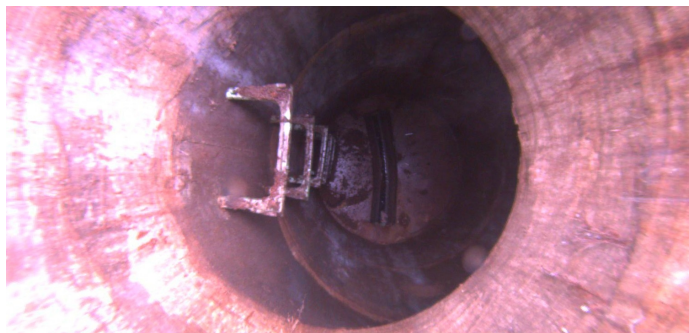
Code: **MGO**
Description: **General Observation**

Distance (ft): **.0**
Structural Grade: **0**
O&M Grade: **0**
Clock Start/From:
Clock To:
1st Value:
2nd Value:
Value Percent:
Step: **NO**
Remarks: **ACCESS MH**

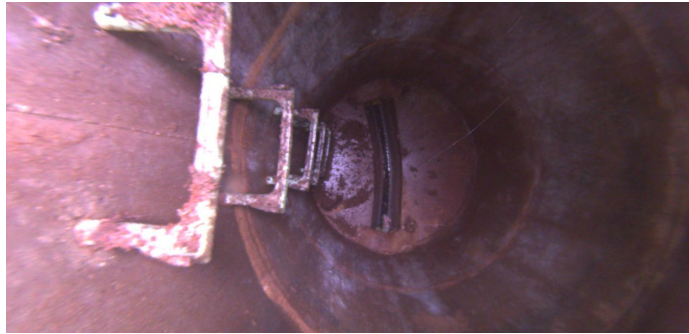
Code: **FL**
Description: **Fracture Longitudinal**

Distance (ft): **1.3**
Structural Grade: **3**
O&M Grade: **0**
Clock Start/From: **9**
Clock To:
1st Value:
2nd Value:
Value Percent:
Step: **NO**
Remarks:

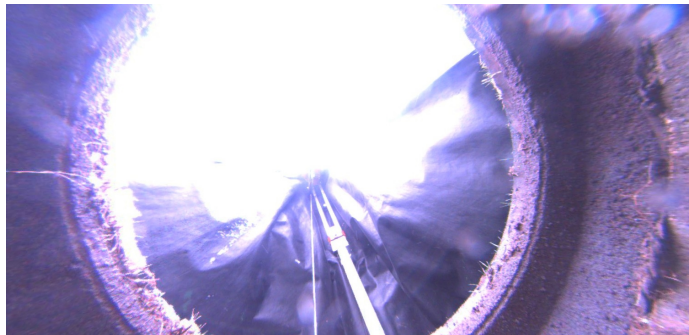
Code: **MGP**
Description: **General Photo**

Distance (ft): **1.3**
Structural Grade: **0**
O&M Grade: **0**
Clock Start/From:
Clock To:
1st Value:
2nd Value:
Value Percent:
Step: **NO**
Remarks: **UNDERSIDE OF FRAME**

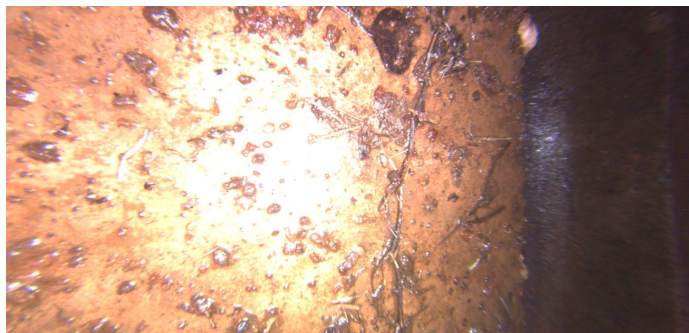
Code: **MGO**
Description: **General Observation**

Distance (ft): **8.1**
Structural Grade: **0**
O&M Grade: **0**
Clock Start/From:
Clock To:
1st Value:
2nd Value:
Value Percent:
Step: **NO**
Remarks: **END SURVEY**
