Manhole Inspection Report

Date:	04/16/2018	Weather:		Coding:	RZMACP
MH#:	M-910-017	Owner:	NA	Len. Surveyed:	7.5
P.O.#:		Surveyor:	Jen Costello	Rim to Invert:	7.7
Customer:		Cert. #:	U-907-5518	Wall Material:	Concrete (reinforced)

Street:	Norris Dr. 1669' East of Randolph St.	Project:	Hobart, IN
City:	Hobart, IN	GPS Northing:	2911684.956
Location:		GPS Easting:	2911684.956
Drain Area:	Southeast	GPS Accuracy:	Sub-Meter
Cover Shape:	Circular	Evidence of Surcharge:	No
Cover Size:	29.0	Potential for Runoff:	None
Comments:

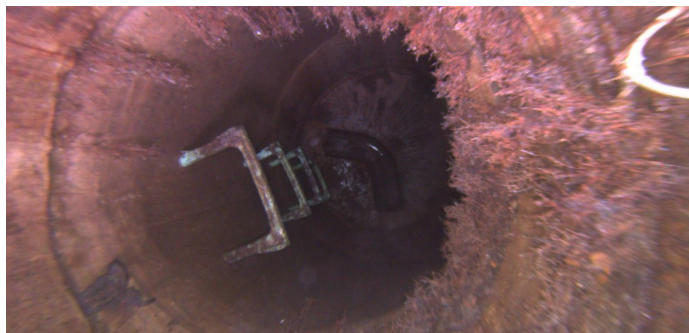
Code: **MGO**
Description: **General Observation**

Distance (ft): **.0**
Structural Grade: **0**
O&M Grade: **0**
Clock Start/From:
Clock To:
1st Value:
2nd Value:
Value Percent:
Step: **NO**
Remarks: **ACCESS MH**

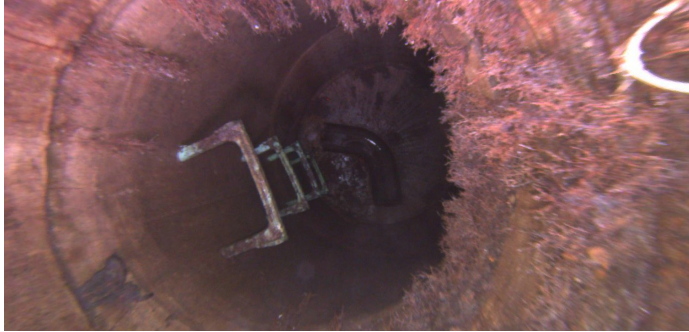
Code:	RFJ
Description:	Roots Fine Joint
Distance (ft):	.0
Structural Grade:	0
O&M Grade:	1
Clock Start/From:	12
Clock To:	12
1st Value:	
2nd Value:	
Value Percent:	
Step:	NO
Remarks:

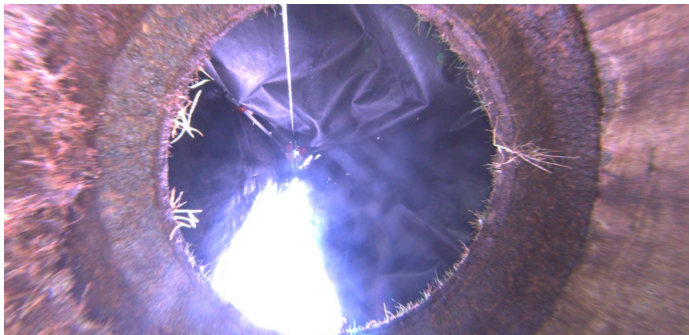
Code:	MGP
Description:	General Photo
Distance (ft):	1.5
Structural Grade:	0
O&M Grade:	0
Clock Start/From:	
Clock To:	
1st Value:	
2nd Value:	
Value Percent:	
Step:	NO
Remarks:	UNDERSIDE OF FRAME

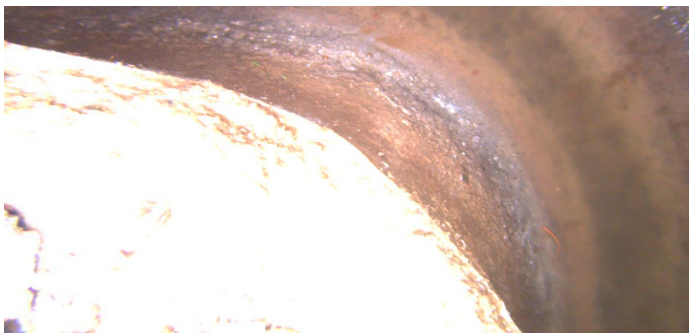
Code:	MGO
Description:	General Observation
Distance (ft):	7.5
Structural Grade:	0
O&M Grade:	0
Clock Start/From:	
Clock To:	
1st Value:	
2nd Value:	
Value Percent:	
Step:	NO
Remarks:	END SURVEY
