Manhole Inspection Report

Date:	04/13/2018	Weather:		Coding:	RZMACP
MH#:	M-910-018	Owner:	NA	Len. Surveyed:	3.7
P.O.#:		Surveyor:	John Kuglmaier	Rim to Invert:	4.4
Customer:		Cert. #:	U-1215-07002349	Wall Material:	Concrete (reinforced)

Street:	158' Southeast of Norris Dr.	Project:	Hobart, IN
City:	Hobart, IN	GPS Northing:	2911775.359
Location:		GPS Easting:	2911775.359
Drain Area:	Southeast	GPS Accuracy:	Sub-Meter
Cover Shape:	Circular	Evidence of Surcharge:	No
Cover Size:	22.5	Potential for Runoff:	None
Comments:

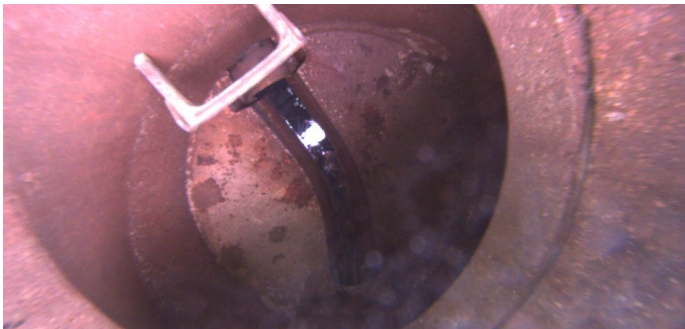
Code:	MGP
Description:	General Photo

Distance (ft):	.0
Structural Grade:	0
O&M Grade:	0
Clock Start/From:	
Clock To:	
1st Value:	
2nd Value:	
Value Percent:	
Step:	NO
Remarks:

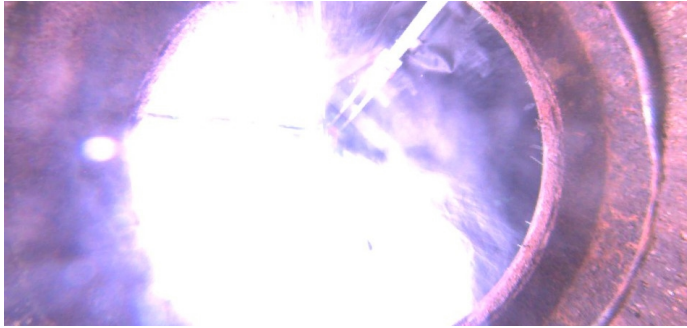
Code: **MGP**
Description: **General Photo**

Distance (ft): **1.5**
Structural Grade: **0**
O&M Grade: **0**
Clock Start/From:
Clock To:
1st Value:
2nd Value:
Value Percent:
Step: **NO**
Remarks:

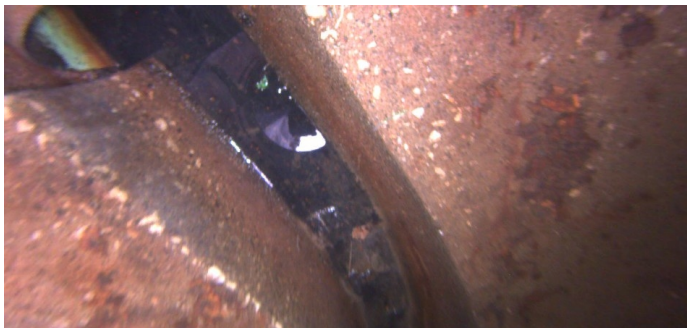
Code: **MGO**
Description: **General Observation**

Distance (ft): **3.2**
Structural Grade: **0**
O&M Grade: **0**
Clock Start/From:
Clock To:
1st Value:
2nd Value:
Value Percent:
Step: **NO**
Remarks: **Ins. Comp.**
