Manhole Inspection Report

Date:	04/13/2018	Weather:		Coding:	RZMACP
MH#:	M-910-025	Owner:	NA	Len. Surveyed:	6.3
P.O.#:		Surveyor:	John Kuglmaier	Rim to Invert:	6.5
Customer:		Cert. #:	U-1215-07002349	Wall Material:	Concrete (reinforced)

Street:	155' South of Norris Dr. East of Rand	Project:	Hobart, IN
City:	Hobart, IN	GPS Northing:	2911572.837
Location:		GPS Easting:	2911572.837
Drain Area:	Southeast	GPS Accuracy:	Sub-Meter
Cover Shape:	Circular	Evidence of Surcharge:	No
Cover Size:	22.5	Potential for Runoff:	None
Comments:

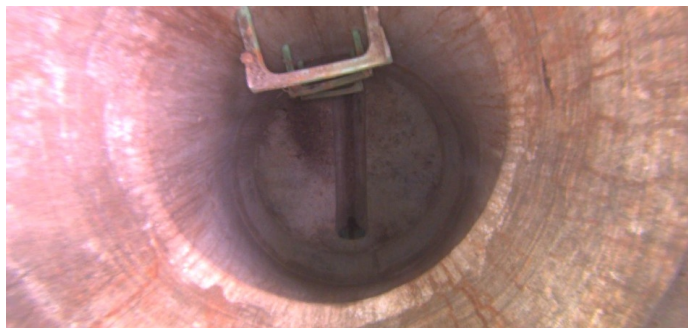
Code: **MGP**
Description: **General Photo**

Distance (ft): **.0**
Structural Grade: **0**
O&M Grade: **0**
Clock Start/From:
Clock To:
1st Value:
2nd Value:
Value Percent:
Step: **NO**
Remarks:

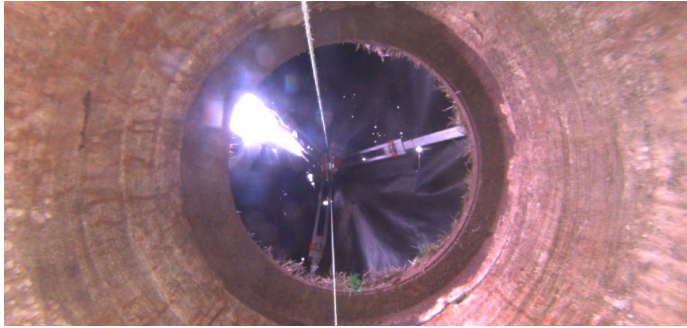
Code: **MGP**
Description: **General Photo**

Distance (ft): **2.4**
Structural Grade: **0**
O&M Grade: **0**
Clock Start/From:
Clock To:
1st Value:
2nd Value:
Value Percent:
Step: **NO**
Remarks:

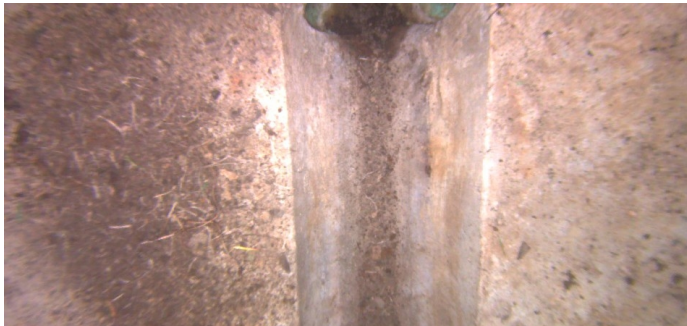
Code: **MGO**
Description: **General Observation**

Distance (ft): **5.2**
Structural Grade: **0**
O&M Grade: **0**
Clock Start/From:
Clock To:
1st Value:
2nd Value:
Value Percent:
Step: **NO**
Remarks: **Ins. Comp.**
