# Manhole Inspection Report

Date:	<b>04/13/2018</b>	Weather:		Coding:	<b>RZMACP</b>
MH#:	<b>M-910-027</b>	Owner:	<b>NA</b>	Len. Surveyed:	<b>2.3</b>
P.O.#:		Surveyor:	<b>John Kuglmaier</b>	Rim to Invert:	<b>2.9</b>
Customer:		Cert. #:	<b>U-1215-07002349</b>	Wall Material:	<b>Concrete (reinforced)</b>

Street:	<b>370' South of Norris Dr. East of Rand</b>	Project:	<b>Hobart, IN</b>
City:	<b>Hobart, IN</b>	GPS Northing:	<b>2911556.251</b>
Location:		GPS Easting:	<b>2911556.251</b>
Drain Area:	<b>Southeast</b>	GPS Accuracy:	<b>Sub-Meter</b>
Cover Shape:	<b>Circular</b>	Evidence of Surcharge:	<b>No</b>
Cover Size:	<b>22.5</b>	Potential for Runoff:	<b>None</b>
Comments:

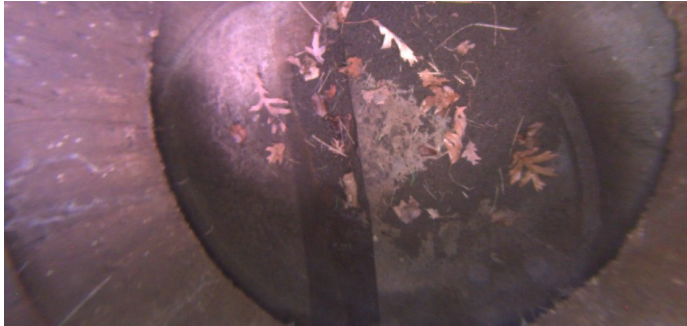
Code:	<b>DAZ</b>
Description:	<b>Deposits Attached Other</b>
Distance (ft):	<b>.0</b>
Structural Grade:	<b>0</b>
O&M Grade:	<b>2</b>
Clock Start/From:	<b>12</b>
Clock To:	<b>12</b>
1st Value:	
2nd Value:	
Value Percent:	<b>5.000</b>
Step:	<b>NO</b>
Remarks:	<b>Mixed materials</b>

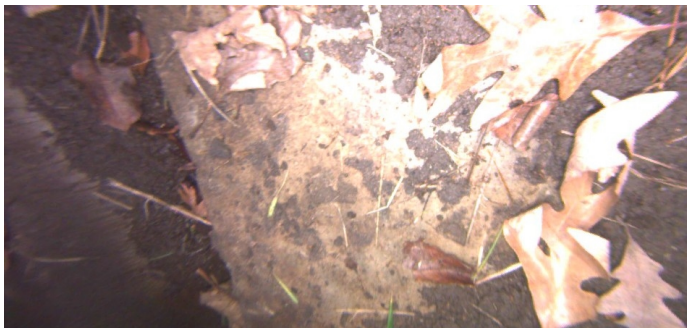
Code:	<b>MGO</b>
Description:	<b>General Observation</b>
Distance (ft):	<b>1.9</b>
Structural Grade:	<b>0</b>
O&M Grade:	<b>0</b>
Clock Start/From:	
Clock To:	
1st Value:	
2nd Value:	
Value Percent:	
Step:	<b>NO</b>
Remarks:	<b>Ins. Comp.</b>
