Manhole Inspection Report

Date:	04/13/2018	Weather:		Coding:	RZMACP
MH#:	M-910-028	Owner:	NA	Len. Surveyed:	5.7
P.O.#:		Surveyor:	John Kuglmaier	Rim to Invert:	6.3
Customer:		Cert. #:	U-1215-07002349	Wall Material:	Concrete (reinforced)

Street:	331' Southeast of Norris Dr.	Project:	Hobart, IN
City:	Hobart, IN	GPS Northing:	2911933.812
Location:		GPS Easting:	2911933.812
Drain Area:	Southeast	GPS Accuracy:	Sub-Meter
Cover Shape:	Circular	Evidence of Surcharge:	Yes
Cover Size:	22.5	Potential for Runoff:	None
Comments:

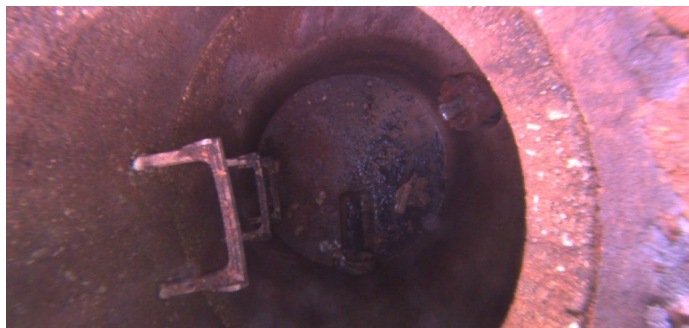
Code: **MGP**
 Description: **General Photo**

Distance (ft): **.0**
 Structural Grade: **0**
 O&M Grade: **0**
 Clock Start/From:
 Clock To:
 1st Value:
 2nd Value:
 Value Percent:
 Step: **NO**
 Remarks:

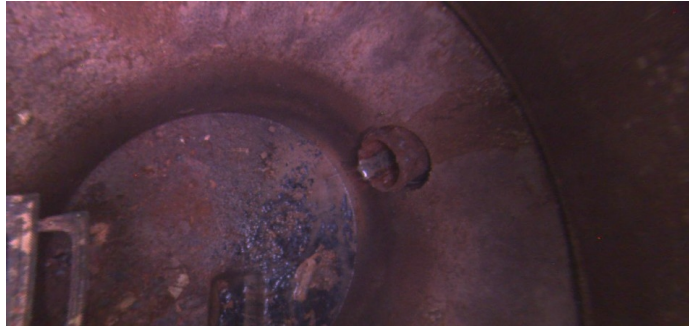
Code: **IS**
Description: **Infil Stain**

Distance (ft): **1.4**
Structural Grade: **0**
O&M Grade: **0**
Clock Start/From: **2**
Clock To:
1st Value:
2nd Value:
Value Percent:
Step: **NO**
Remarks:

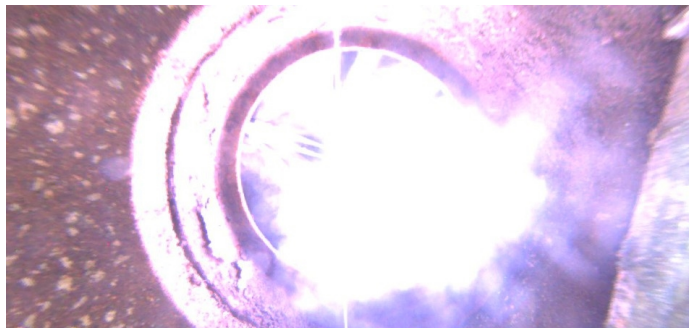
Code: **MGP**
Description: **General Photo**

Distance (ft): **2.5**
Structural Grade: **0**
O&M Grade: **0**
Clock Start/From:
Clock To:
1st Value:
2nd Value:
Value Percent:
Step: **NO**
Remarks:

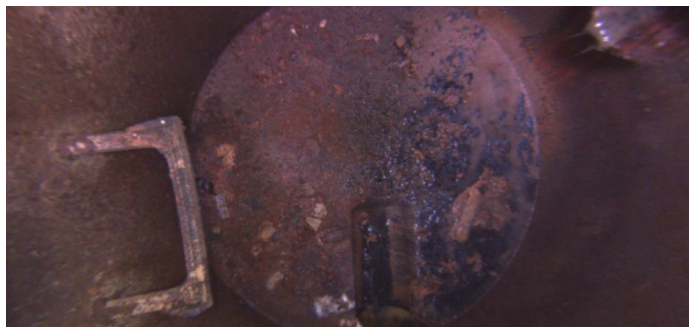
Code: **DAZ**
Description: **Deposits Attached Other**

Distance (ft): **2.9**
Structural Grade: **0**
O&M Grade: **2**
Clock Start/From: **12**
Clock To: **12**
1st Value:
2nd Value:
Value Percent: **5.000**
Step: **NO**
Remarks: **Mixed materials**

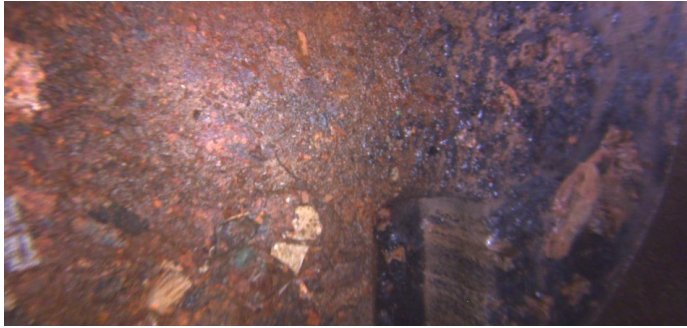
Code:	MGO
Description:	General Observation
Distance (ft):	4.7
Structural Grade:	0
O&M Grade:	0
Clock Start/From:	
Clock To:	
1st Value:	
2nd Value:	
Value Percent:	
Step:	NO
Remarks:	Ins. Comp.
