Manhole Inspection Report

Date:	04/13/2018	Weather:		Coding:	RZMACP
MH#:	M-910-029	Owner:	NA	Len. Surveyed:	4.7
P.O.#:		Surveyor:	John Kuglmaier	Rim to Invert:	5.2
Customer:		Cert. #:	U-1215-07002349	Wall Material:	Concrete (reinforced)

Street:	434' Southeast of Norris Dr.	Project:	Hobart, IN
City:	Hobart, IN	GPS Northing:	2911941.081
Location:		GPS Easting:	2911941.081
Drain Area:	Southeast	GPS Accuracy:	Sub-Meter
Cover Shape:	Circular	Evidence of Surcharge:	Yes
Cover Size:	29.0	Potential for Runoff:	None
Comments:	29 inch lid too large for 22.5 hole

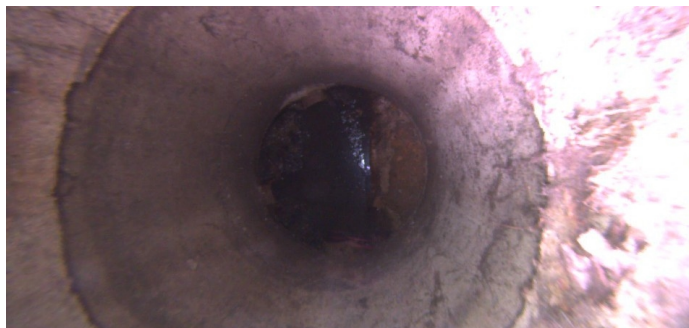
Code: **MGP**
Description: **General Photo**

Distance (ft): **.0**
Structural Grade: **0**
O&M Grade: **0**
Clock Start/From:
Clock To:
1st Value:
2nd Value:
Value Percent:
Step: **NO**
Remarks:

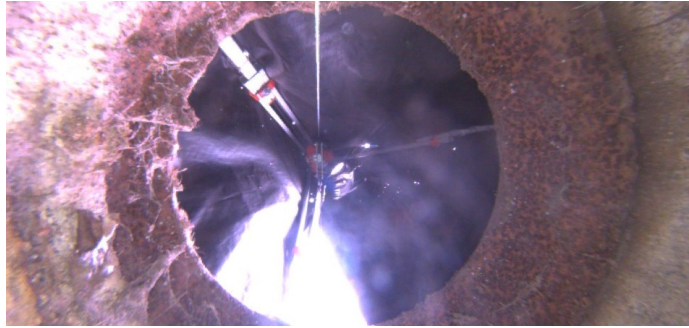
Code: **MGP**
Description: **General Photo**

Distance (ft): **1.7**
Structural Grade: **0**
O&M Grade: **0**
Clock Start/From:
Clock To:
1st Value:
2nd Value:
Value Percent:
Step: **NO**
Remarks:

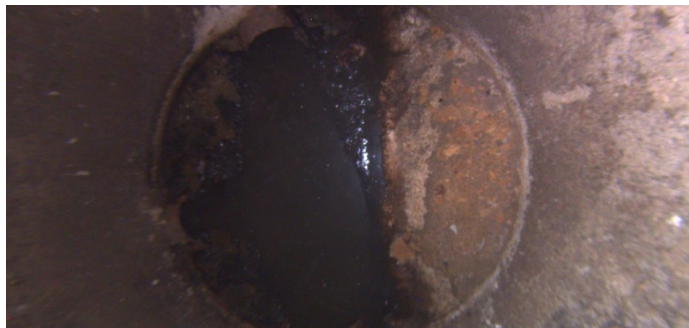
Code: **DAZ**
Description: **Deposits Attached Other**

Distance (ft): **2.8**
Structural Grade: **0**
O&M Grade: **2**
Clock Start/From: **12**
Clock To: **12**
1st Value:
2nd Value:
Value Percent: **5.000**
Step: **NO**
Remarks: **Mixed materials**

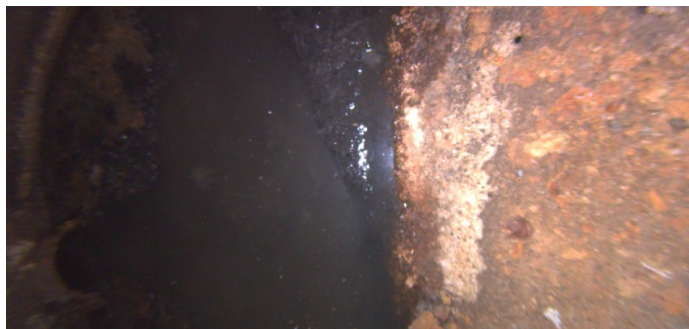
Code: **MGO**
Description: **General Observation**

Distance (ft): **3.9**
Structural Grade: **0**
O&M Grade: **0**
Clock Start/From:
Clock To:
1st Value:
2nd Value:
Value Percent:
Step: **NO**
Remarks: **Ins. Comp.**
