## Profile/Photo Observation Report

Date:	<b>04/25/2018</b>	Weather:		Coding:	<b>PACP 4.2</b>
Pipe Length (ft):	<b>10.9</b>	Owner:	<b>City of Hobart</b>	Pre Clean:	<b>No Pre-Cleaning</b>
P.O.#:	<b>2004</b>	Surveyor:	<b>SAN</b>	PSR:	<b>P-1003-001-002</b>
Customer:	<b>Red Zone</b>	Clean Date:		Shape:	<b>C</b>

Street:	<b>446 Deerpath Ct</b>	Flow Control:	<b>Not Controlled</b>
City:	<b>Hobart In</b>	Year Renewed:	
Location:	<b>Yard</b>	Tape/Media #:	<b>Deliverable 1</b>
Purpose:	<b>Routine Assessment</b>	Dia/Height:	<b>6"</b>
Use:	<b>Sanitary</b>	Material:	<b>PVC</b>
Drain Area:	<b>Northeast</b>	Lining:	
Category:	<b>NA</b>		
Comment:	<b>435-1</b>		
Location Details:	<b>Edge of street</b>	Direction of Survey:	<b>Upstream</b>
US MH:	<b>M-1003-001</b>	DS MH:	<b>M-1003-002</b>
		Total Length Surveyed (ft):	<b>10.9</b>

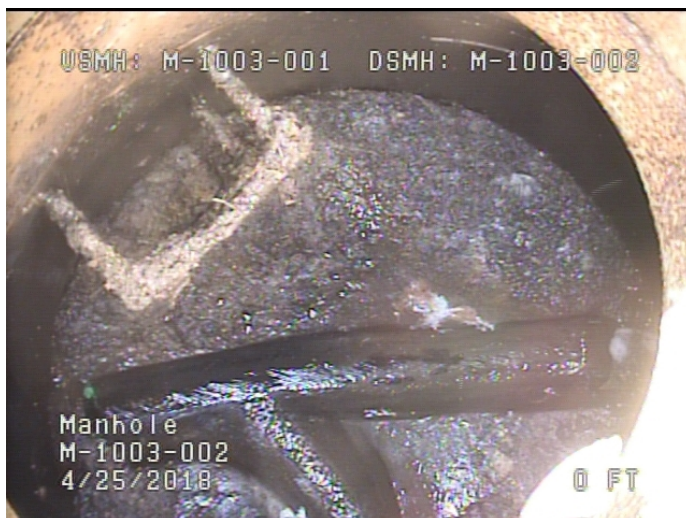
Code: **AMH**  
Description: **Manhole**

Distance (ft): **.0**  
Structural Grade: **0**  
O&M Grade: **0**  
Clock Start/From:  
Clock To:  
1st Value:  
2nd Value:  
Value Percent:  
Continuous Index:  
Within 8" of Joint: **NO**  
Remarks: **M-1003-002**

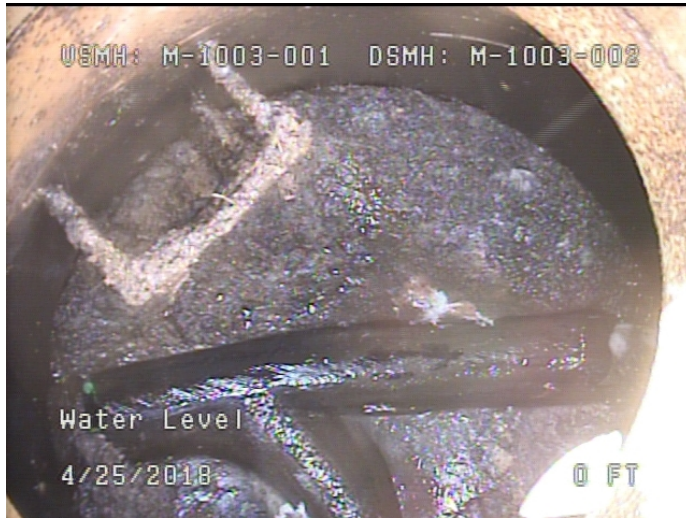
Code:	<b>MWL</b>
Description:	<b>Water Level</b>
Distance (ft):	<b>.0</b>
Structural Grade:	<b>0</b>
O&M Grade:	<b>0</b>
Clock Start/From:	
Clock To:	
1st Value:	
2nd Value:	
Value Percent:	<b>5.000</b>
Continuous Index:	
Within 8" of Joint:	<b>NO</b>
Remarks:

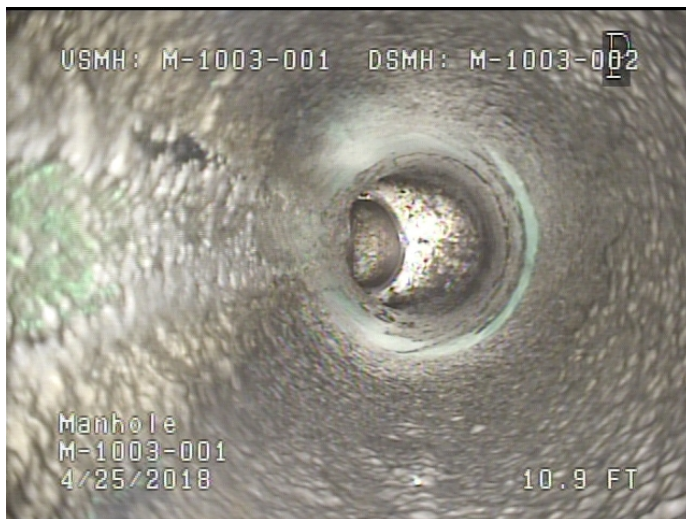
Code:	<b>AMH</b>
Description:	<b>Manhole</b>
Distance (ft):	<b>10.9</b>
Structural Grade:	<b>0</b>
O&M Grade:	<b>0</b>
Clock Start/From:	
Clock To:	
1st Value:	
2nd Value:	
Value Percent:	
Continuous Index:	
Within 8" of Joint:	<b>NO</b>
Remarks:	<b>M-1003-001</b>
