Profile/Photo Observation Report

Street:	East State Rt 130	Flow Control:	Not Controlled
City:	Hobart, IN	Year Renewed:	
Location:	Light Highway	Tape/Media #:	DEP263
Purpose:	Routine Assessment	Dia/Height:	15"
Use:	Sanitary	Material:	PVC
Drain Area:		Lining:	
Category:	NA		
Comment:	5-21-2018

Location Details:		Direction of Survey:	Upstream
US MH:	M-1006-008A	DS MH:	M-1006-001
		Total Length Surveyed (ft):	376.4

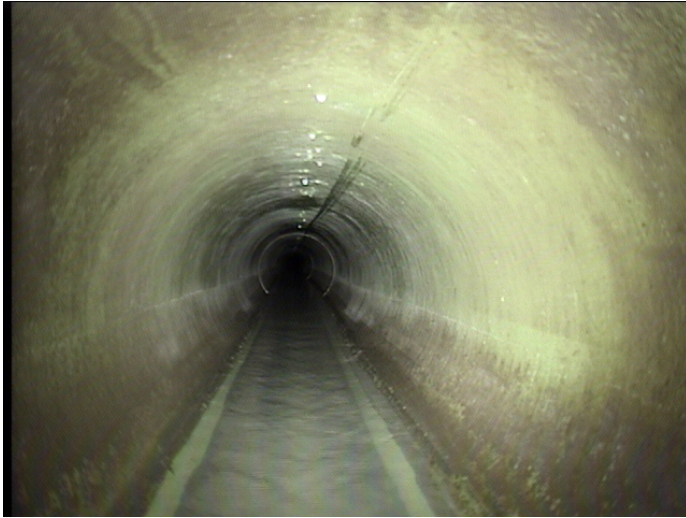
Code: **AMH**
Description: **Manhole**

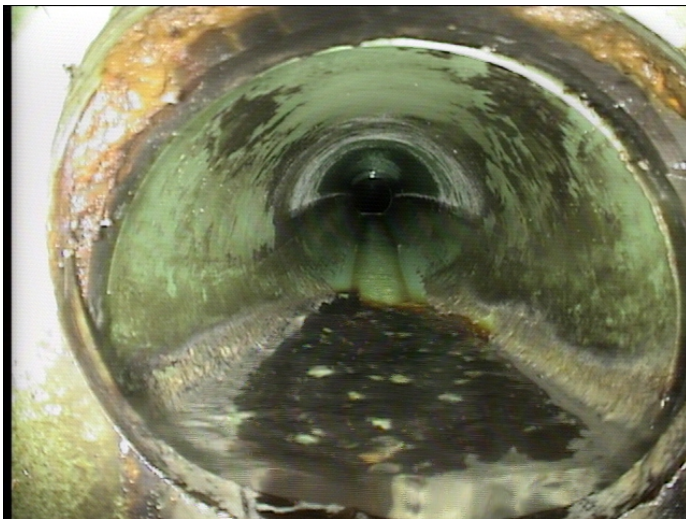
Code: **MWL**
Description: **Water Level**

Distance (ft): **.0**
Structural Grade: **0**
O&M Grade: **0**
Clock Start/From:
Clock To:
1st Value:
2nd Value:
Value Percent: **5.000**
Continuous Index:
Within 8" of Joint: **NO**
Remarks:

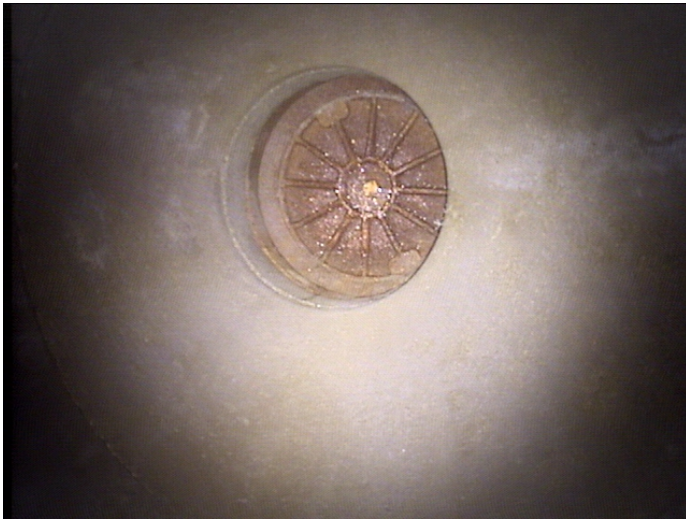
Code: **TBA**
Description: **Tap Break-in Active**

Distance (ft): **300.5**
Structural Grade: **0**
O&M Grade: **0**
Clock Start/From: **9**
Clock To:
1st Value: **6.000**
2nd Value:
Value Percent:
Continuous Index:
Within 8" of Joint: **NO**
Remarks:
