Profile/Photo Observation Report

Date:	05/07/2018	Weather:		Coding:	PACP 6.0	
Pipe Length (ft		Owner:	City of Hobart	Pre Clean:	No Pre-Cleaning	
P.O.#:	614	Surveyor:	M. Pielacha	PSR:		
Customer:	City of Hobart	Clean Date:		Shape:	С	
Street:	Off State Road 130		Flow Control:	Not Controlled	Not Controlled	
City:	Hobart, IN		Year Renewed:			
Location:	Easement/Right of Way		Tape/Media #:	DEP 614		
Purpose:	Routine Assessment		Dia/Height:	6"		
Use:	Sanitary		Material:	PVC		
Drain Area:			Lining:			
Category:	NA					
Comment:	5-21-2018					
Location Details:		Direction of Survey:	Downstream			
US MH:	M-1006-008	DS MH:	M-1006-008T	Total Length Surveyed (ft): 35.7	
0&M Index:	0.00	O&M Quick:	0000	O&M Rating:	0.00	
tructural Index:	0.00	Structural Qui	ick: 0000	Structural Rating:	0.00

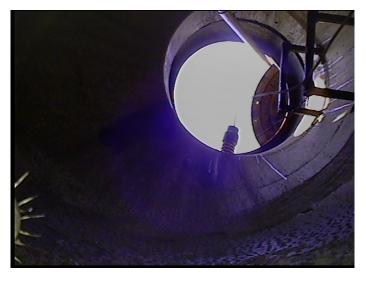
Description:	Manhole	
5: (6)		
Distance (ft):	.0	
Structural Grade:	0	
O&M Grade:	0	
Clock Start/From:		
Clock To:		
1st Value:		
2nd Value:		
Value Percent:		
Continuous Index:		
Within 8" of Joint:	NO	
Remarks:	M-1006-008

AMH

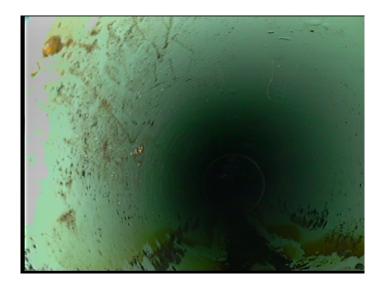
Code: MWL
Description: Water Level

Distance (ft): .0
Structural Grade: 0
O&M Grade: 0
Clock Start/From:
Clock To:
1st Value:

t: **5.000**

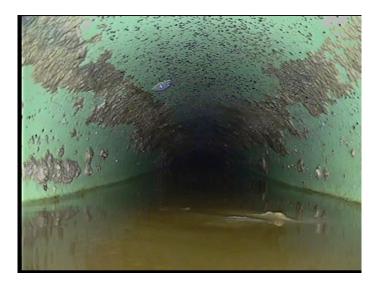
Code: MWL
Description: Water Level

Distance (ft): 28.9
Structural Grade: 0
O&M Grade: 0
Clock Start/From:

Value Percent: 50.000
