Profile/Photo Observation Report

Date:	04/10/2018	Weather:		Coding:	PACP 6.0
Pipe Length (ft):		Owner:	City of Hobart	Pre Clean:	Not Known
P.O.#:	227	Surveyor:	B. Helbling	PSR:	
Customer:	City of Hobart	Clean Date:		Shape:	C

Street:	South Liverpool Road	Flow Control:	Not Controlled		
City:	Hobart, IN	Year Renewed:			
Location:	Light Highway	Tape/Media #:	DEP227		
Purpose:	Routine Assessment	Dia/Height:	15"		
Use:	Sanitary	Material:	VCP		
Drain Area:		Lining:			
Category:	NA				
Comment:	YES501824 Submittal 2				
Location Details:		Direction of Survey:	Upstream		
US MH:	M-208-023A	DS MH:	M-208-023	Total Length Surveyed (ft):	23.0

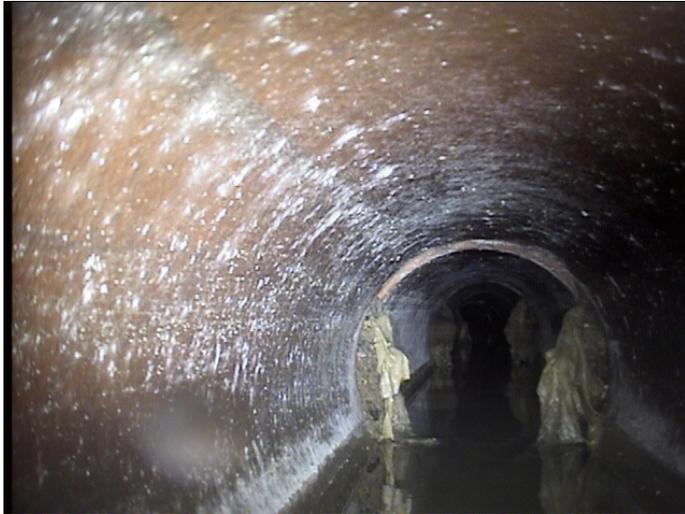
Code: **MWL**
Description: **Water Level**

Distance (ft): **.0**
Structural Grade: **0**
O&M Grade: **0**
Clock Start/From:
Clock To:
1st Value:
2nd Value:
Value Percent: **10.000**
Continuous Index:
Within 8" of Joint: **NO**
Remarks:

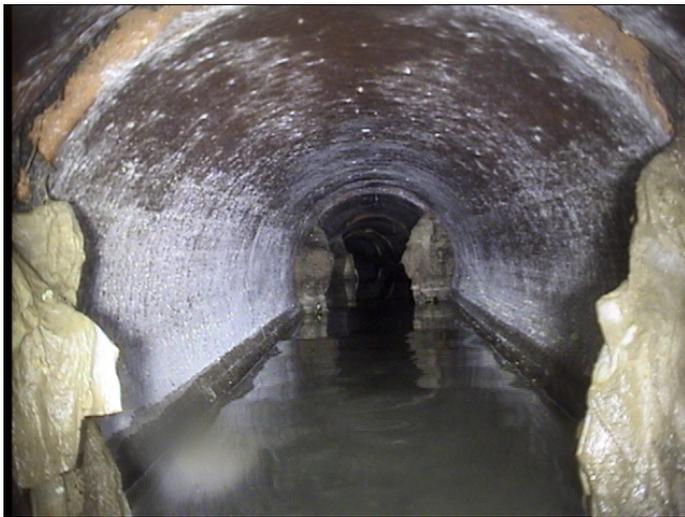
Code: **DSF**
Description: **Deposits Settled Fine**

Distance (ft): **3.1**
Structural Grade: **0**
O&M Grade: **2**
Clock Start/From: **5**
Clock To: **7**
1st Value:
2nd Value:
Value Percent: **5.000**
Continuous Index:
Within 8" of Joint: **NO**
Remarks:

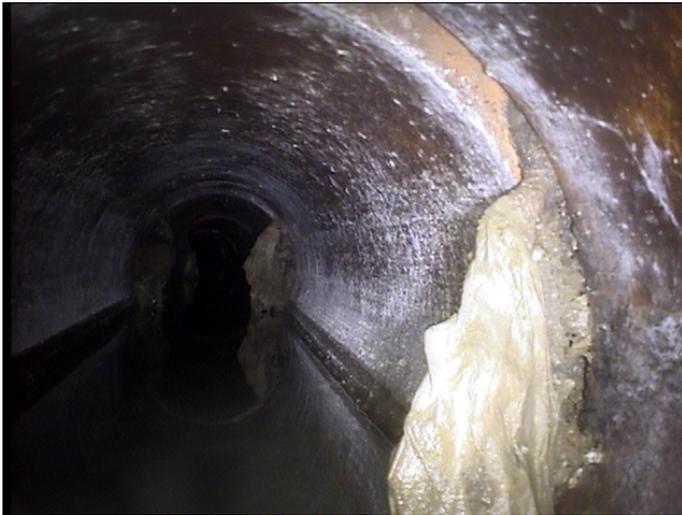
Code: **DAR**
Description: **Deposits Attached Ragging**

Distance (ft): **3.1**
Structural Grade: **0**
O&M Grade: **3**
Clock Start/From: **8**
Clock To: **4**
1st Value:
2nd Value:
Value Percent: **15.000**
Continuous Index:
Within 8" of Joint: **YES**
Remarks:

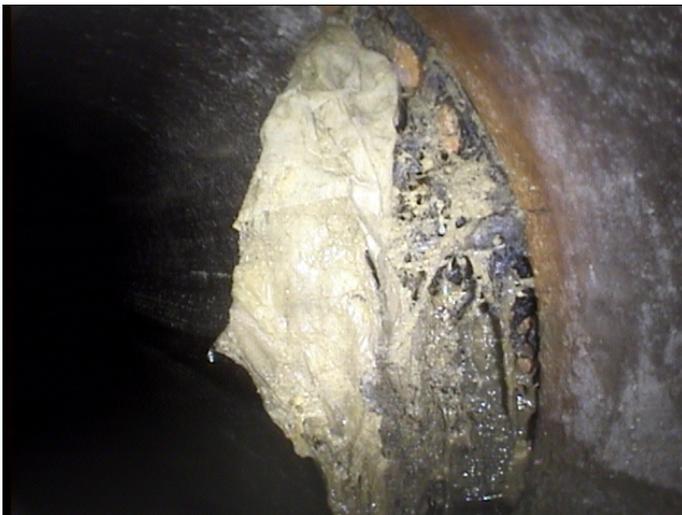
Code: **RFJ**
Description: **Roots Fine Joint**

Distance (ft): **8.6**
Structural Grade: **0**
O&M Grade: **1**
Clock Start/From: **8**
Clock To: **4**
1st Value:
2nd Value:
Value Percent:
Continuous Index:
Within 8" of Joint: **YES**
Remarks:

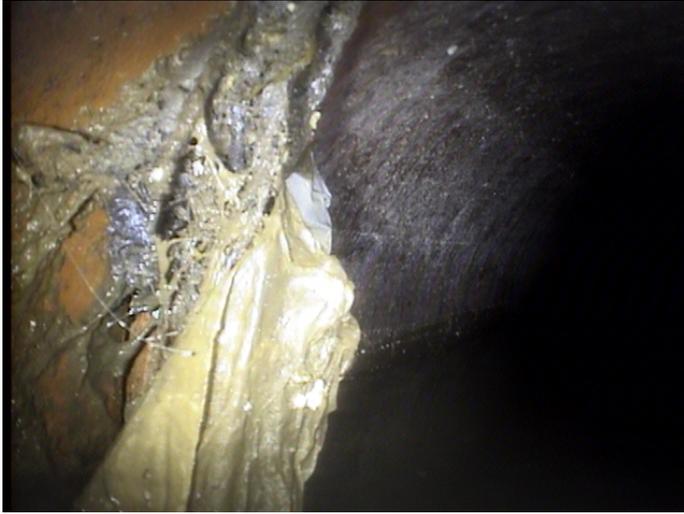
Code: **RFJ**
Description: **Roots Fine Joint**

Distance (ft): **13.8**
Structural Grade: **0**
O&M Grade: **1**
Clock Start/From: **8**
Clock To: **10**
1st Value:
2nd Value:
Value Percent:
Continuous Index:
Within 8" of Joint: **YES**
Remarks:

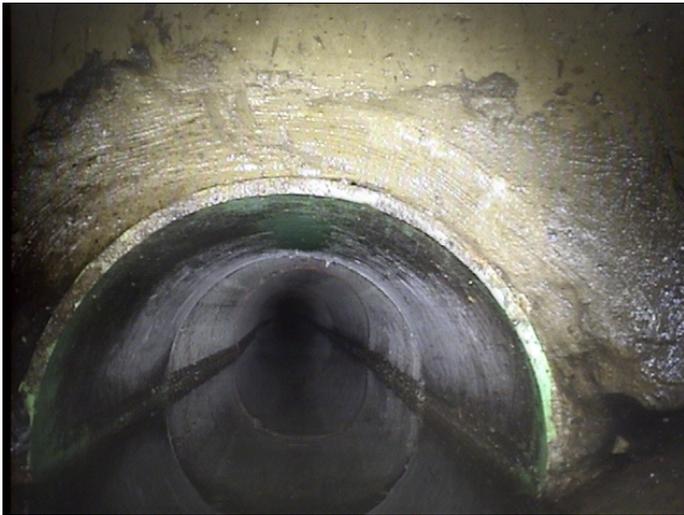
Code: **AMH**
Description: **Manhole**

Distance (ft): **23.0**
Structural Grade: **0**
O&M Grade: **0**
Clock Start/From:
Clock To:
1st Value:
2nd Value:
Value Percent:
Continuous Index:
Within 8" of Joint: **NO**
Remarks: **M-208-023A. New MH found**

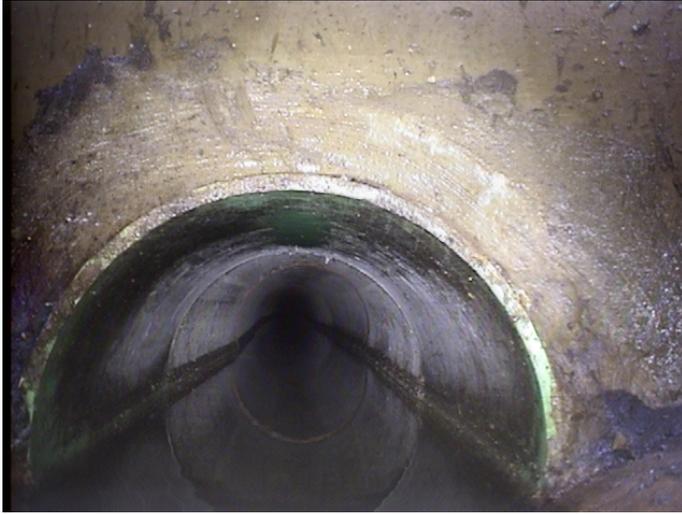
Code:	DSF
Description:	Deposits Settled Fine
Distance (ft):	23.0
Structural Grade:	0
O&M Grade:	2
Clock Start/From:	5
Clock To:	7
1st Value:	
2nd Value:	
Value Percent:	5.000
Continuous Index:	
Within 8" of Joint:	NO
Remarks:
