Profile/Photo Observation Report

Date:	04/14/2018	Weather:		Coding:	PACP 6.0
Pipe Length (ft):	287.2	Owner:	NA	Pre Clean:	Not Known
P.O.#:		Surveyor:	Jen Costello	PSR:	P-1004-001-002
Customer:		Clean Date:	01/01/1900	Shape:	C

Street:	E Cleveland Ave.	Flow Control:	Not Controlled
City:	Hobart, IN	Year Renewed:	
Location:	Other	Tape/Media #:	
Purpose:	Not Known	Dia/Height:	8"
Use:	Sanitary	Material:	PVC
Drain Area:	NA	Lining:	
Category:	NA		
Comment:

Location Details:		Direction of Survey:	Upstream
US MH:	M-1004-002	DS MH:	M-1004-001
		Total Length Surveyed (ft):	282.2

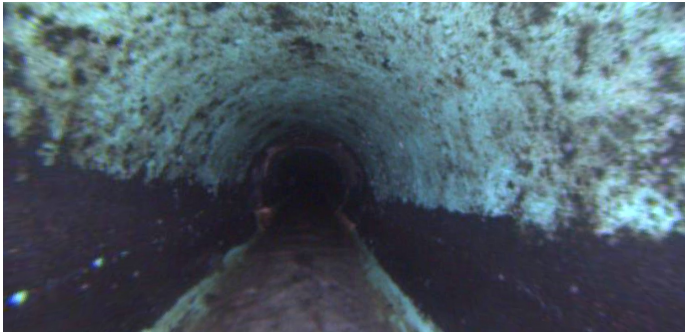
Code:	MWL
Description:	Water Level

Distance (ft):	.0
Structural Grade:	0
O&M Grade:	0
Clock Start/From:	
Clock To:	
1st Value:	
2nd Value:	
Value Percent:	5.000
Continuous Index:	
Within 8" of Joint:	NO
Remarks:

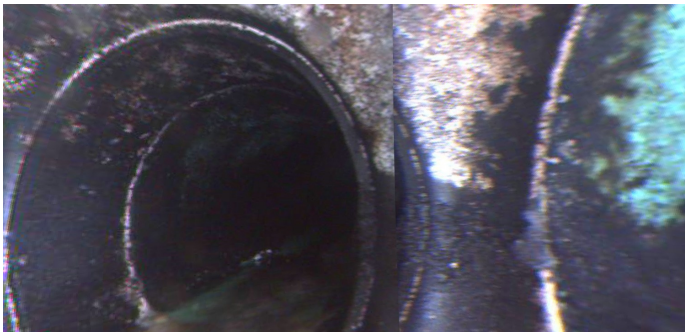
Code:	TFA
Description:	Tap Factory Active

Distance (ft):	3.3
Structural Grade:	0
O&M Grade:	0
Clock Start/From:	9
Clock To:	
1st Value:	4.000
2nd Value:	
Value Percent:	
Continuous Index:	
Within 8" of Joint:	
Remarks:

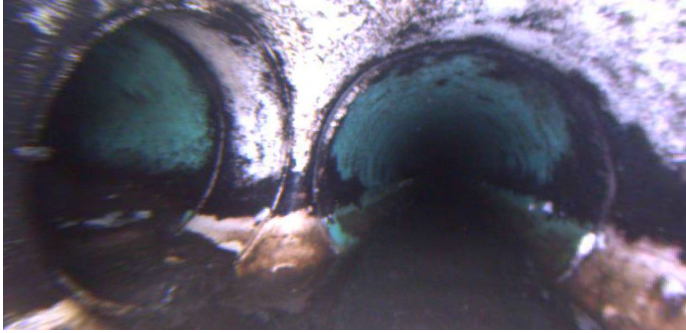
Code: **TFA**
Description: **Tap Factory Active**

Distance (ft): **70.6**
Structural Grade: **0**
O&M Grade: **0**
Clock Start/From: **9**
Clock To:
1st Value: **4.000**
2nd Value:
Value Percent:
Continuous Index:
Within 8" of Joint:
Remarks:

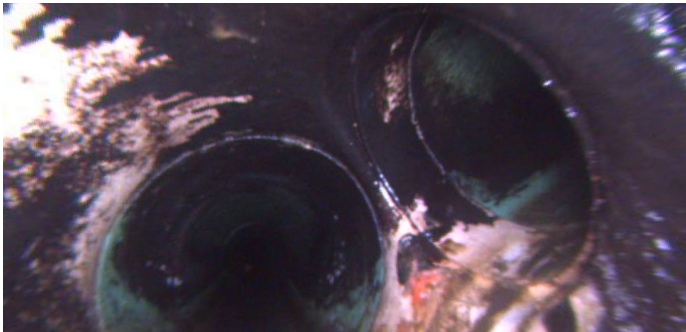
Code: **TFA**
Description: **Tap Factory Active**

Distance (ft): **94.5**
Structural Grade: **0**
O&M Grade: **0**
Clock Start/From: **2**
Clock To:
1st Value: **4.000**
2nd Value:
Value Percent:
Continuous Index:
Within 8" of Joint:
Remarks:

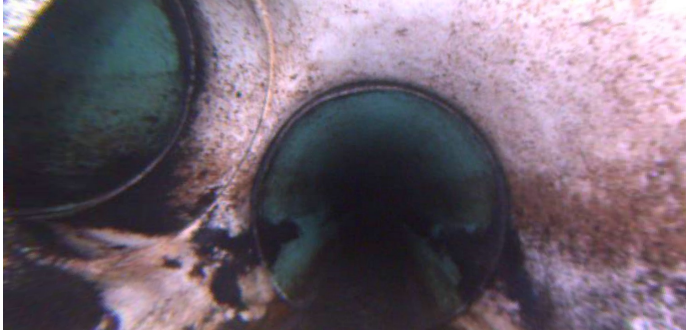
Code: **TF**
Description: **Tap Factory**

Distance (ft): **136.0**
Structural Grade: **0**
O&M Grade: **0**
Clock Start/From: **10**
Clock To:
1st Value: **4.000**
2nd Value:
Value Percent:
Continuous Index:
Within 8" of Joint:
Remarks:

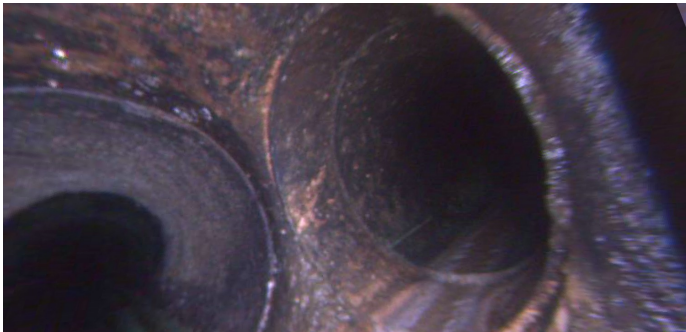
Code: **TF**
Description: **Tap Factory**

Distance (ft): **167.7**
Structural Grade: **0**
O&M Grade: **0**
Clock Start/From: **3**
Clock To:
1st Value: **4.000**
2nd Value:
Value Percent:
Continuous Index:
Within 8" of Joint:
Remarks:

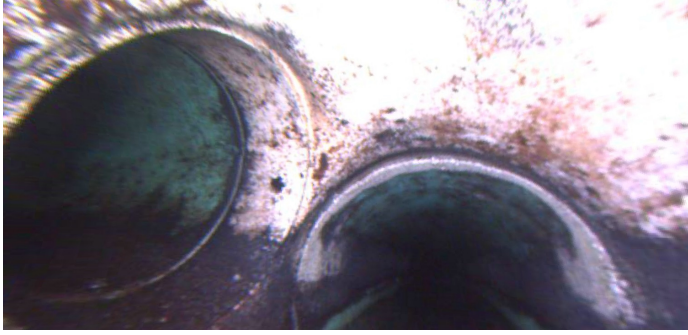
Code: **TF**
Description: **Tap Factory**

Distance (ft): **209.7**
Structural Grade: **0**
O&M Grade: **0**
Clock Start/From: **10**
Clock To:
1st Value: **4.000**
2nd Value:
Value Percent:
Continuous Index:
Within 8" of Joint:
Remarks:

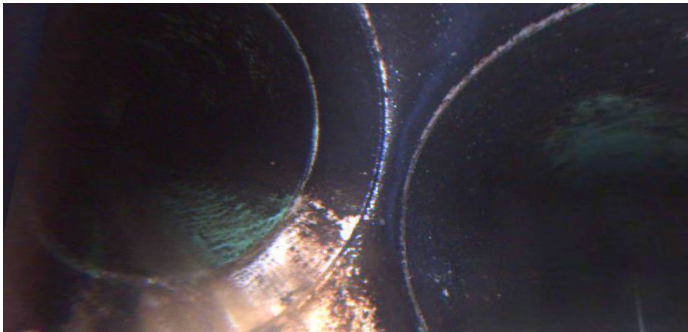
Code: **TFA**
Description: **Tap Factory Active**

Distance (ft): **244.6**
Structural Grade: **0**
O&M Grade: **0**
Clock Start/From: **3**
Clock To:
1st Value: **4.000**
2nd Value:
Value Percent:
Continuous Index:
Within 8" of Joint:
Remarks:

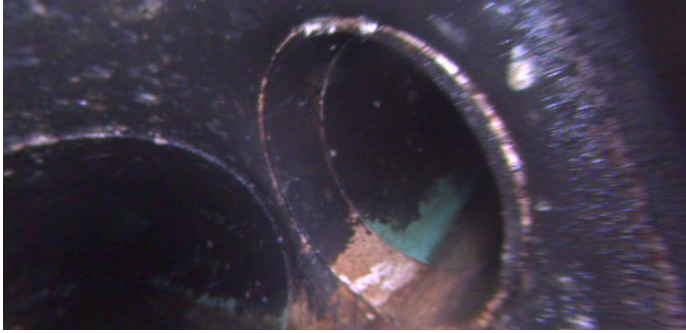
Code: **TF**
Description: **Tap Factory**

Distance (ft): **267.0**
Structural Grade: **0**
O&M Grade: **0**
Clock Start/From: **2**
Clock To:
1st Value: **4.000**
2nd Value:
Value Percent:
Continuous Index:
Within 8" of Joint:
Remarks:

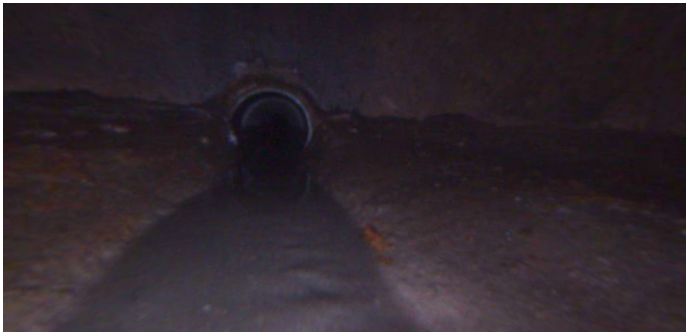
Code: **AMH**
Description: **Manhole**

Distance (ft): **282.2**
Structural Grade: **0**
O&M Grade: **0**
Clock Start/From:
Clock To:
1st Value:
2nd Value:
Value Percent:
Continuous Index:
Within 8" of Joint: **NO**
Remarks: **M-1004-002**
