Profile/Photo Observation Report

Street:	Coral Dr.	Flow Control:	Not Controlled
City:	Hobart, IN	Year Renewed:	
Location:	Other	Tape/Media #:	
Purpose:	Not Known	Dia/Height:	10"
Use:	Sanitary	Material:	PVC
Drain Area:	NA	Lining:	
Category:	NA		
Comment:

Location Details:		Direction of Survey:	Downstream
US MH:	M-1004-008	DS MH:	M-1004-009
		Total Length Surveyed (ft):	283.4

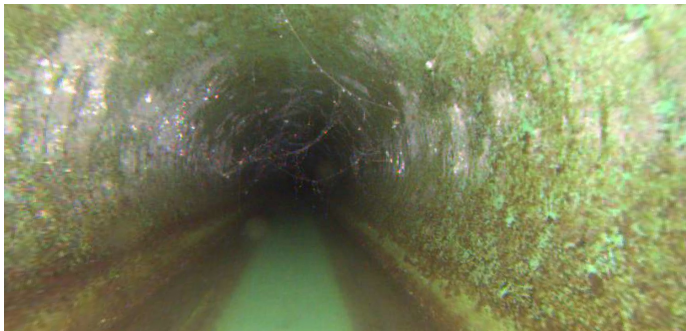
Code: **AMH**
Description: **Manhole**

Distance (ft): **.0**
Structural Grade: **0**
O&M Grade: **0**
Clock Start/From:
Clock To:
1st Value:
2nd Value:
Value Percent:
Continuous Index:
Within 8" of Joint: **NO**
Remarks: **M-1004-008**

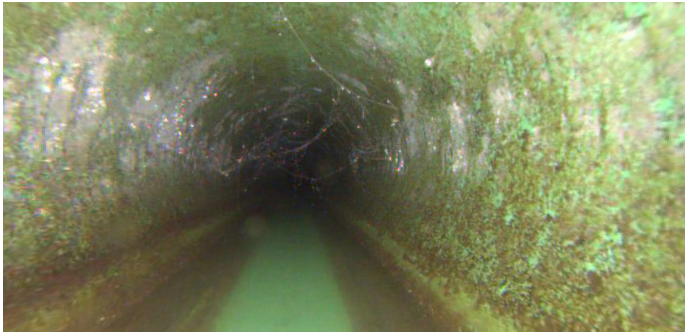
Code:	MWL
Description:	Water Level

Distance (ft):	.0
Structural Grade:	0
O&M Grade:	0
Clock Start/From:	
Clock To:	
1st Value:	
2nd Value:	
Value Percent:	5.000
Continuous Index:	
Within 8" of Joint:	NO
Remarks:

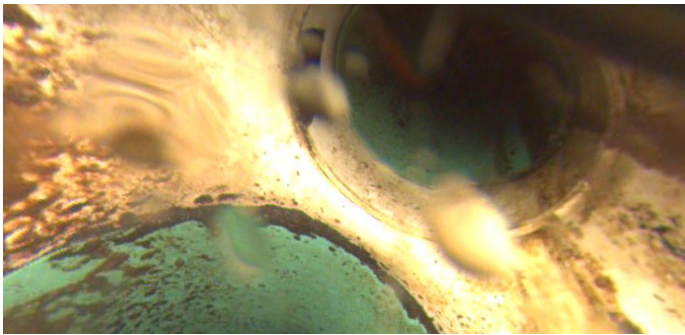
Code:	TF
Description:	Tap Factory

Distance (ft):	78.9
Structural Grade:	0
O&M Grade:	0
Clock Start/From:	1
Clock To:	
1st Value:	4.000
2nd Value:	
Value Percent:	
Continuous Index:	
Within 8" of Joint:	
Remarks:

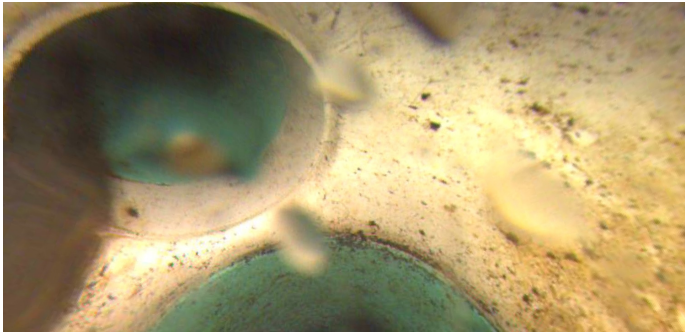
Code: **TF**
Description: **Tap Factory**

Distance (ft): **92.3**
Structural Grade: **0**
O&M Grade: **0**
Clock Start/From: **11**
Clock To:
1st Value: **4.000**
2nd Value:
Value Percent:
Continuous Index:
Within 8" of Joint:
Remarks:

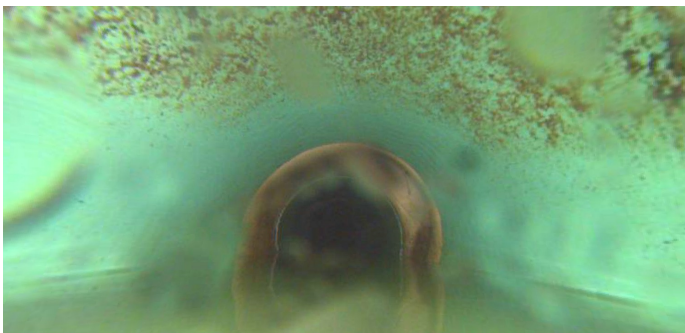
Code: **MWL**
Description: **Water Level**

Distance (ft): **187.1**
Structural Grade: **0**
O&M Grade: **0**
Clock Start/From:
Clock To:
1st Value:
2nd Value:
Value Percent: **40.000**
Continuous Index:
Within 8" of Joint: **NO**
Remarks:

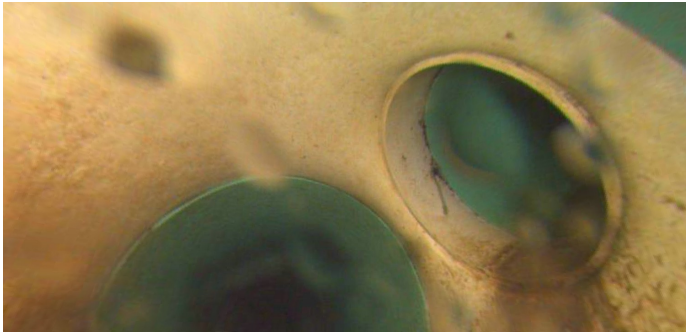
Code: **TF**
Description: **Tap Factory**

Distance (ft): **188.3**
Structural Grade: **0**
O&M Grade: **0**
Clock Start/From: **2**
Clock To:
1st Value: **4.000**
2nd Value:
Value Percent:
Continuous Index:
Within 8" of Joint:
Remarks:

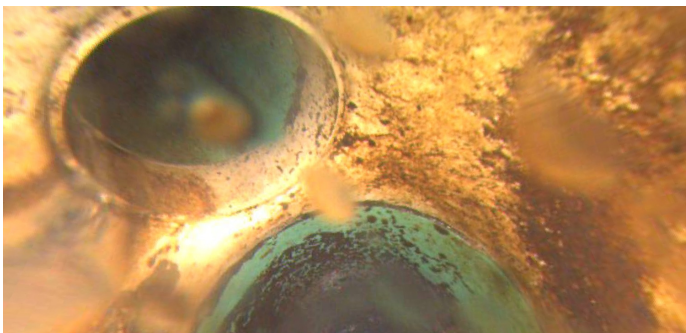
Code: **TF**
Description: **Tap Factory**

Distance (ft): **202.6**
Structural Grade: **0**
O&M Grade: **0**
Clock Start/From: **11**
Clock To:
1st Value: **4.000**
2nd Value:
Value Percent:
Continuous Index:
Within 8" of Joint:
Remarks:

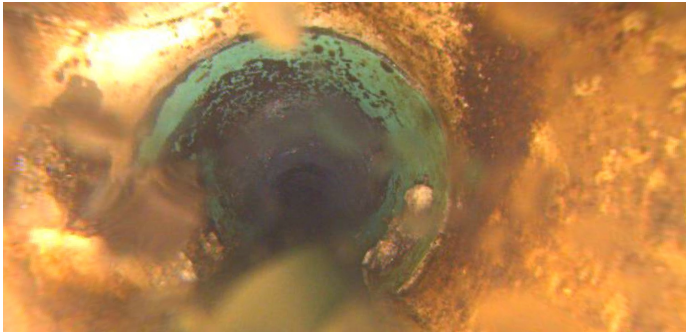
Code: **DAGS**
Description: **Deposits Attached Grease**

Distance (ft): **202.6**
Structural Grade: **0**
O&M Grade: **2**
Clock Start/From: **8**
Clock To: **4**
1st Value:
2nd Value:
Value Percent: **5.000**
Continuous Index:
Within 8" of Joint: **YES**
Remarks:

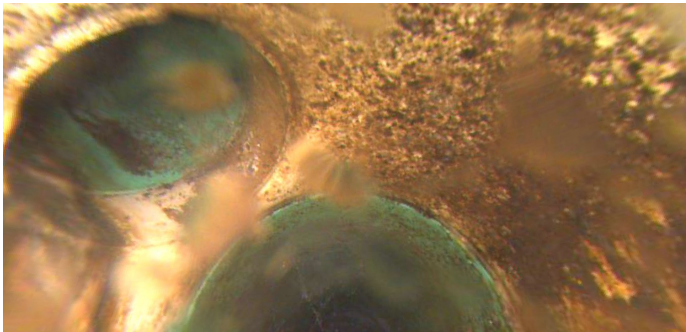
Code: **TF**
Description: **Tap Factory**

Distance (ft): **252.8**
Structural Grade: **0**
O&M Grade: **0**
Clock Start/From: **10**
Clock To:
1st Value: **4.000**
2nd Value:
Value Percent:
Continuous Index:
Within 8" of Joint:
Remarks:

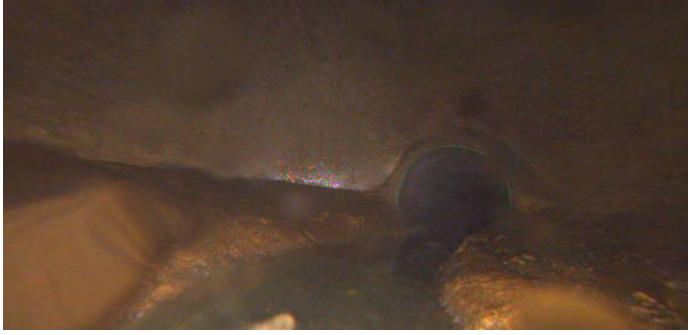
Code:	AMH
Description:	Manhole
Distance (ft):	283.4
Structural Grade:	0
O&M Grade:	0
Clock Start/From:	
Clock To:	
1st Value:	
2nd Value:	
Value Percent:	
Continuous Index:	
Within 8" of Joint:	NO
Remarks:	M-1004-009
