Profile/Photo Observation Report

| P.O.#: | | Surveyor: | Selasie Honu | PSR: | P-1004-010-009 |

| Street: | MCAFEE DR | Flow Control: | Not Controlled |
| City: | Hobart, IN | Year Renewed: | |

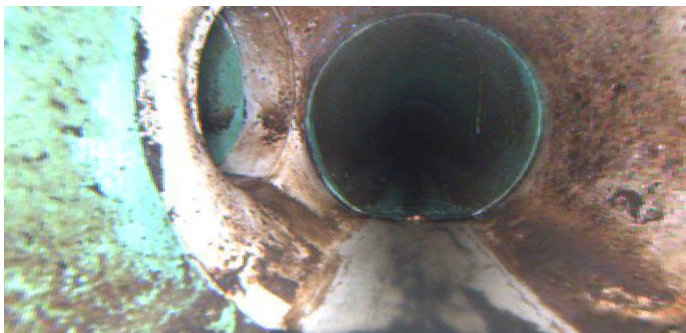
Code: **AMH**
Description: **Manhole**

Distance (ft): **.0**
Structural Grade: **0**
O&M Grade: **0**
Clock Start/From:
Clock To:
1st Value:
2nd Value:
Value Percent:
Continuous Index:
Within 8" of Joint: **NO**
Remarks: **M-1004-010**

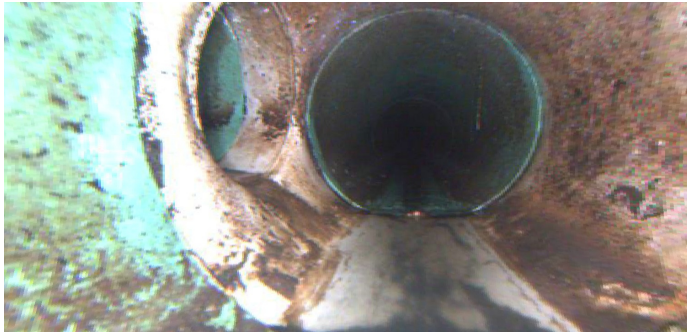
Code: **MWL**
Description: **Water Level**

Distance (ft): **.0**
Structural Grade: **0**
O&M Grade: **0**
Clock Start/From:
Clock To:
1st Value:
2nd Value:
Value Percent: **5.000**
Continuous Index:
Within 8" of Joint: **NO**
Remarks:

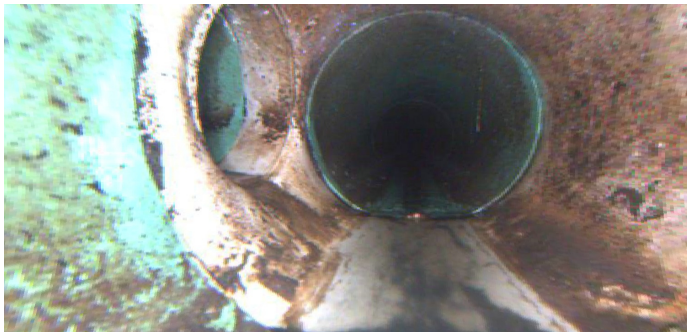
Code: **TF**
Description: **Tap Factory**

Distance (ft): **.0**
Structural Grade: **0**
O&M Grade: **0**
Clock Start/From: **9**
Clock To:
1st Value: **4.000**
2nd Value:
Value Percent:
Continuous Index:
Within 8" of Joint:
Remarks:

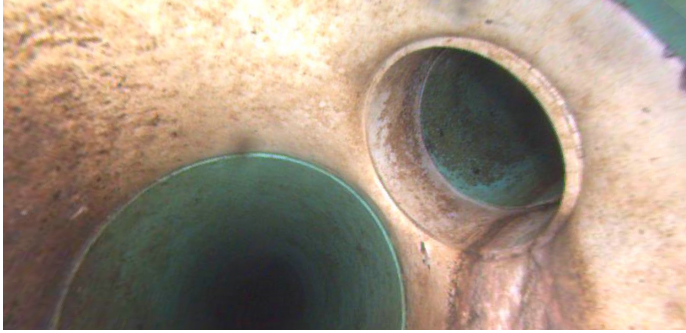
Code: **TF**
Description: **Tap Factory**

Distance (ft): **61.3**
Structural Grade: **0**
O&M Grade: **0**
Clock Start/From: **2**
Clock To:
1st Value: **4.000**
2nd Value:
Value Percent:
Continuous Index:
Within 8" of Joint:
Remarks:

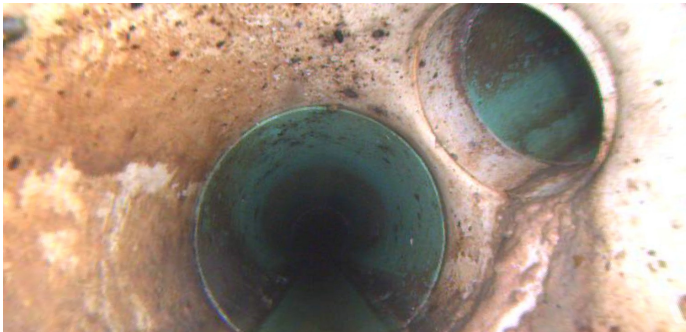
Code: **TF**
Description: **Tap Factory**

Distance (ft): **87.6**
Structural Grade: **0**
O&M Grade: **0**
Clock Start/From: **2**
Clock To:
1st Value: **4.000**
2nd Value:
Value Percent:
Continuous Index:
Within 8" of Joint:
Remarks:

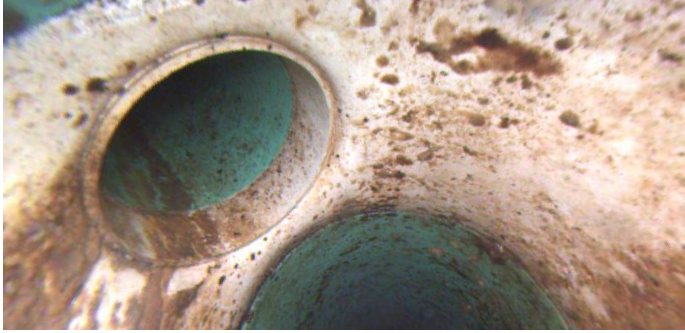
Code: **TF**
Description: **Tap Factory**

Distance (ft): **129.0**
Structural Grade: **0**
O&M Grade: **0**
Clock Start/From: **10**
Clock To:
1st Value: **4.000**
2nd Value:
Value Percent:
Continuous Index:
Within 8" of Joint:
Remarks:

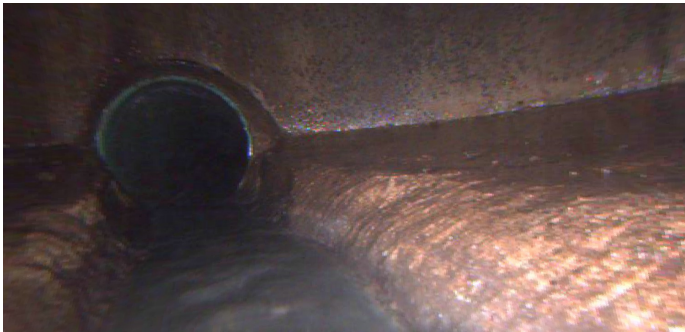
Code: **AMH**
Description: **Manhole**

Distance (ft): **160.0**
Structural Grade: **0**
O&M Grade: **0**
Clock Start/From:
Clock To:
1st Value:
2nd Value:
Value Percent:
Continuous Index:
Within 8" of Joint: **NO**
Remarks: **M-1004-009**
