Profile/Photo Observation Report

Date:	04/15/2018	Weather:		Coding:	PACP 6.0
Pipe Length (ft):	173.1	Owner:	NA	Pre Clean:	Not Known
P.O.#:		Surveyor:	Selasie Honu	PSR:	P-1004-011-010
Customer:		Clean Date:	01/01/1900	Shape:	C

Street:	MCAFEE DR	Flow Control:	Not Controlled
City:	Hobart, IN	Year Renewed:	
Location:	Other	Tape/Media #:	
Purpose:	Not Known	Dia/Height:	10"
Use:	Sanitary	Material:	PVC
Drain Area:	NA	Lining:	
Category:	NA		
Comment:

Location Details:		Direction of Survey:	Upstream
US MH:	M-1004-010	DS MH:	M-1004-011
		Total Length Surveyed (ft):	170.4

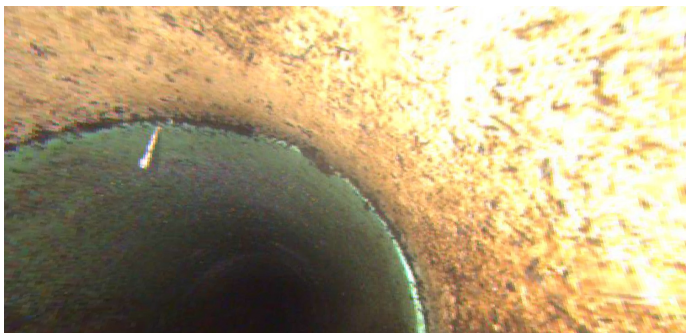
Code: **AMH**
Description: **Manhole**

Distance (ft): **.0**
Structural Grade: **0**
O&M Grade: **0**
Clock Start/From:
Clock To:
1st Value:
2nd Value:
Value Percent:
Continuous Index:
Within 8" of Joint: **NO**
Remarks: **M-1004-011**

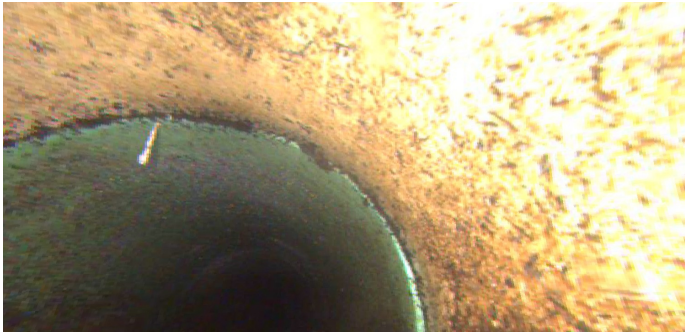
Code:	MWL
Description:	Water Level

Distance (ft):	.0
Structural Grade:	0
O&M Grade:	0
Clock Start/From:	
Clock To:	
1st Value:	
2nd Value:	
Value Percent:	5.000
Continuous Index:	
Within 8" of Joint:	NO
Remarks:

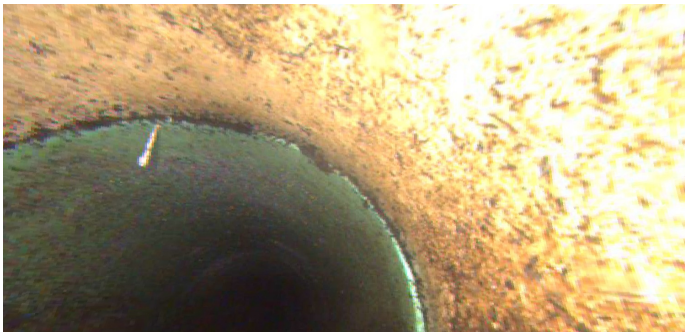
Code:	RFJ
Description:	Roots Fine Joint

Distance (ft):	.0
Structural Grade:	0
O&M Grade:	1
Clock Start/From:	12
Clock To:	
1st Value:	
2nd Value:	
Value Percent:	
Continuous Index:	
Within 8" of Joint:	YES
Remarks:

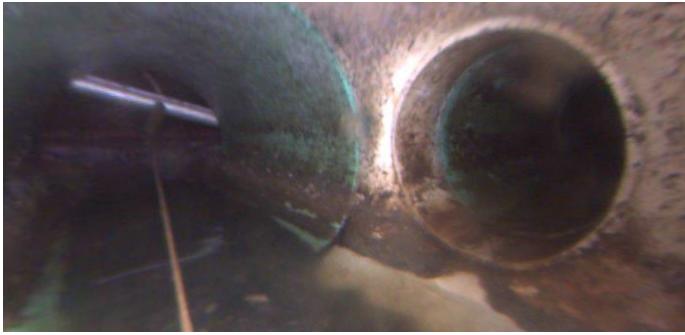
Code: **TFA**
Description: **Tap Factory Active**

Distance (ft): **1.8**
Structural Grade: **0**
O&M Grade: **0**
Clock Start/From: **9**
Clock To:
1st Value: **4.000**
2nd Value:
Value Percent:
Continuous Index:
Within 8" of Joint:
Remarks:

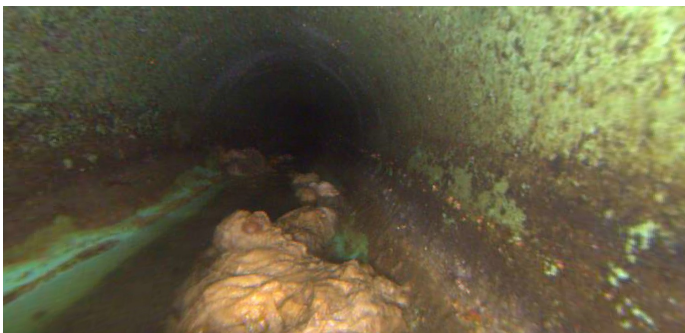
Code: **OBZ**
Description: **Obstacle Other**

Distance (ft): **1.8**
Structural Grade: **0**
O&M Grade: **2**
Clock Start/From: **5**
Clock To: **7**
1st Value:
2nd Value:
Value Percent: **10.000**
Continuous Index:
Within 8" of Joint: **NO**
Remarks: **paper products**

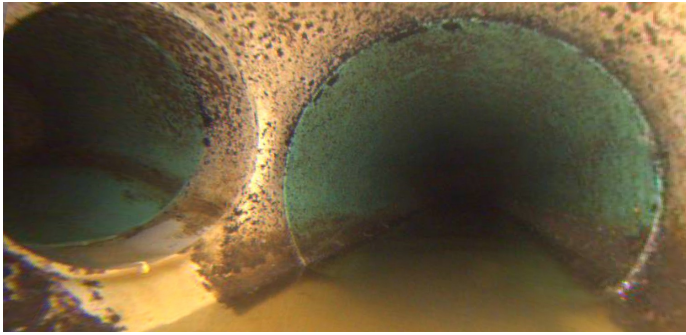
Code: **TF**
Description: **Tap Factory**

Distance (ft): **27.6**
Structural Grade: **0**
O&M Grade: **0**
Clock Start/From: **9**
Clock To:
1st Value: **4.000**
2nd Value:
Value Percent:
Continuous Index:
Within 8" of Joint:
Remarks:

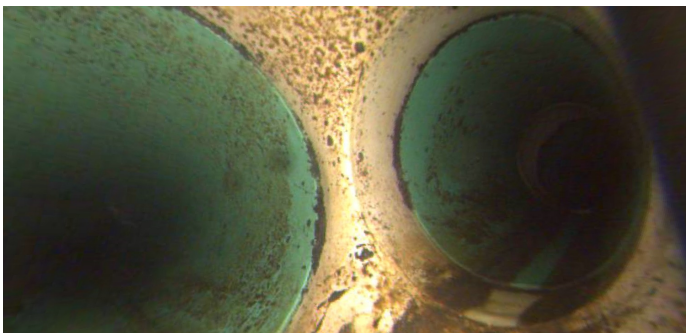
Code: **TF**
Description: **Tap Factory**

Distance (ft): **78.3**
Structural Grade: **0**
O&M Grade: **0**
Clock Start/From: **3**
Clock To:
1st Value: **4.000**
2nd Value:
Value Percent:
Continuous Index:
Within 8" of Joint:
Remarks:

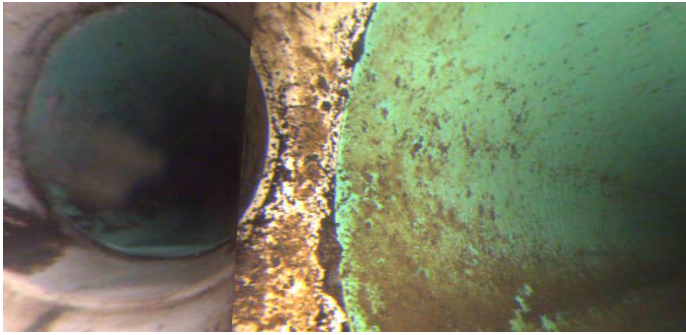
Code: **TF**
Description: **Tap Factory**

Distance (ft): **86.8**
Structural Grade: **0**
O&M Grade: **0**
Clock Start/From: **9**
Clock To:
1st Value: **4.000**
2nd Value:
Value Percent:
Continuous Index:
Within 8" of Joint:
Remarks:

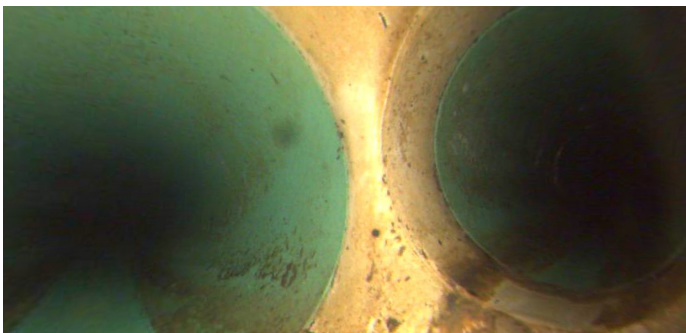
Code: **TF**
Description: **Tap Factory**

Distance (ft): **152.1**
Structural Grade: **0**
O&M Grade: **0**
Clock Start/From: **3**
Clock To:
1st Value: **4.000**
2nd Value:
Value Percent:
Continuous Index:
Within 8" of Joint:
Remarks:

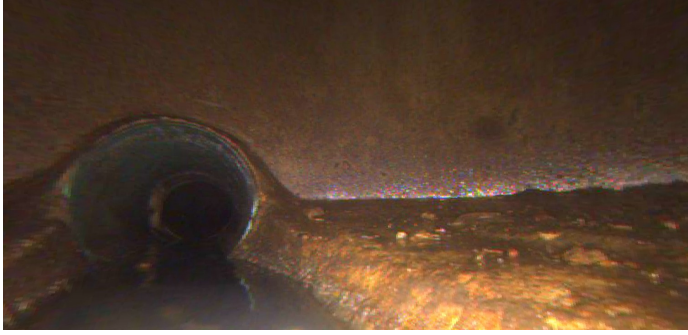
Code:	AMH
Description:	Manhole
Distance (ft):	170.4
Structural Grade:	0
O&M Grade:	0
Clock Start/From:	
Clock To:	
1st Value:	
2nd Value:	
Value Percent:	
Continuous Index:	
Within 8" of Joint:	NO
Remarks:	M-1004-010
