Profile/Photo Observation Report

Date:	10/22/2021	Weather:		Coding:	PACP 6.0
Pipe Length (ft):		Owner:	Hobart, IN	Pre Clean:	Not Known
P.O.#:	962_1	Surveyor:	M. Pielacha	PSR:	M-507-041_M-507-089
Customer:	Hobart, IN	Clean Date:		Shape:	C

Street:	Virginia Street	Flow Control:	
City:	Hobart, IN	Year Renewed:	
Location:	Light Highway	Tape/Media #:	962
Purpose:	Routine Assessment	Dia/Height:	15"
Use:	Sanitary	Material:	PVC
Drain Area:		Lining:

US MH: **M-507-041** DS MH: **M-507-089** Total Length Surveyed (ft): **325.6**

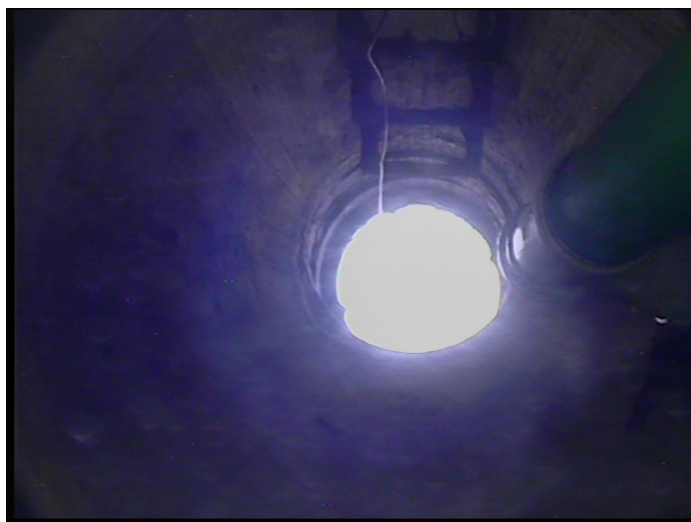
Code: **AMH**
 Description: **Manhole**

Distance (ft): **.0**
 Structural Grade: **0**
 O&M Grade: **0**
 Clock Start/From:
 Clock To:
 1st Value:
 2nd Value:
 Value Percent:
 Continuous Index:
 Within 8" of Joint: **NO**
 Remarks: **M-507-041**

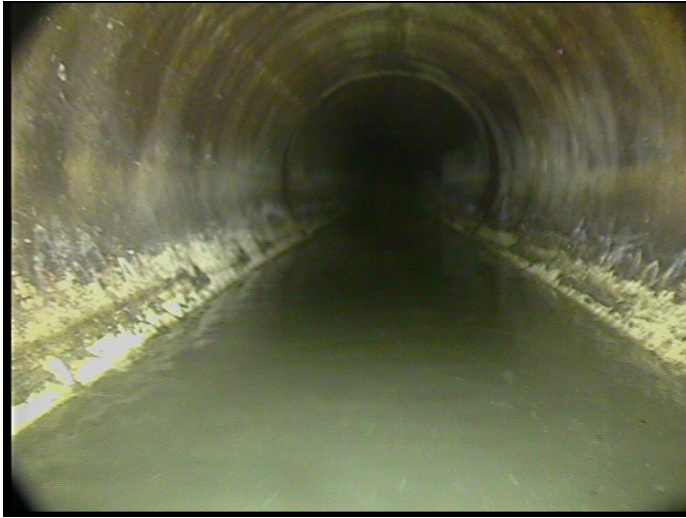
Code: **MWL**
Description: **Water Level**

Distance (ft): **.0**
Structural Grade: **0**
O&M Grade: **0**
Clock Start/From:
Clock To:
1st Value:
2nd Value:
Value Percent: **10.000**
Continuous Index:
Within 8" of Joint: **NO**
Remarks:

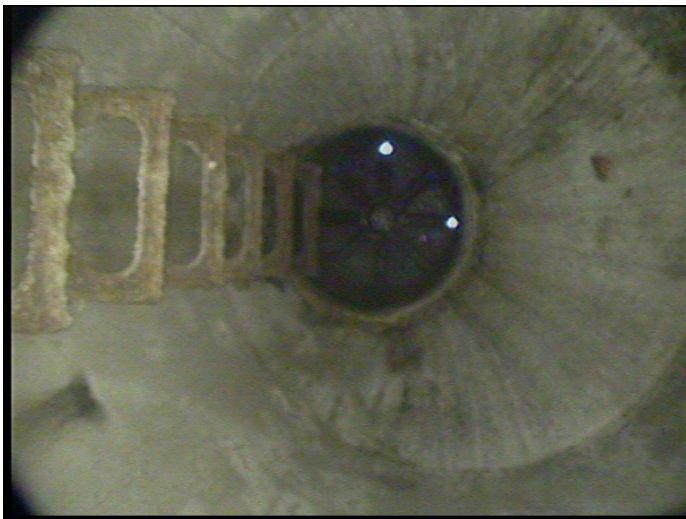
Code: **AMH**
Description: **Manhole**

Distance (ft): **325.6**
Structural Grade: **0**
O&M Grade: **0**
Clock Start/From:
Clock To:
1st Value:
2nd Value:
Value Percent:
Continuous Index:
Within 8" of Joint: **NO**
Remarks: **M-507-089**
