Profile/Photo Observation Report

Profile/Photo Observation Report										
Date:	10/21/2021	Weather:			Coding:	PACP 6.0				
Pipe Length (ft):		Owner:	Hobart, IN		Pre Clean:	Not Known				
P.O.#:	P.O.#: 924_1		M. Pielacha		PSR:	M-705-021_M-706-040				
Customer:	Hobart, IN	Clean Date:			Shape:	С				
Street:	Water Street		Flow Control:							
City:	Hobart, IN		Year Renewed:	;						
Location:	Light Highway		Tape/Media #:		924					
Purpose:	Routine Assessment		Dia/Height:		10"					
Use:	Sanitary		Material:		PVC					
Drain Area:			Lining:							
Category:	NA									
Comment:										
Location Detai	ls:		Direction of Su	rvey:	Upstream					
US MH:	M-705-021	DS MH:	M-706-040		Total Length Surveyed (ft)	: 280.9				
O&M Index:	0.00	O&M Quick:	00	000	O&M Rating:	0.00				
Structural Index:	0.00	Structural Qu	ick: 00	000	Structural Rating:	0.00				
Overall Index:	0.00	Overall Quick		000	Overall Rating:	0.00

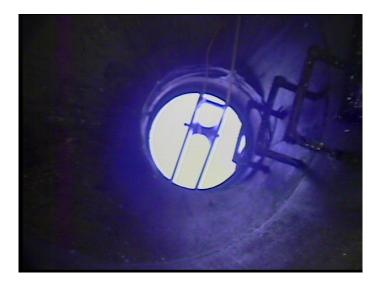
Description: Manhole Distance (ft): .0 Structural Grade: 0 O&M Grade: 0 Clock Start/From: Clock To: 1st Value: 2nd Value: Value Percent: Continuous Index: Within 8" of Joint: NO Remarks: M-706-040

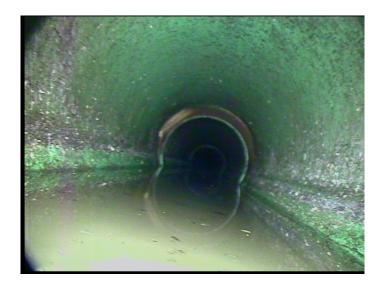
MWL Code: Description: **Water Level**

Distance (ft): .0 Structural Grade: 0 0 O&M Grade:

Value Percent: 10.000

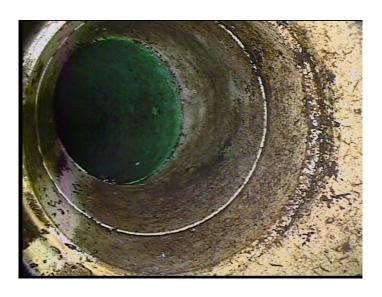
Code: TF Description: **Tap Factory**

Distance (ft): 2.9 Structural Grade: 0 O&M Grade: Clock Start/From: 10 Clock To:

1st Value: 4.000

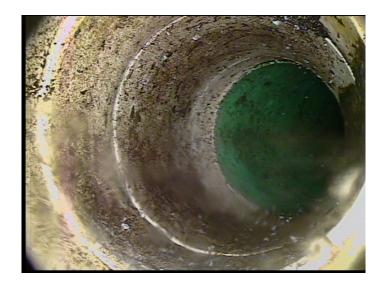
Description: Tap Factory

Distance (ft): 9.6
Structural Grade: 0

Clock Start/From: 2

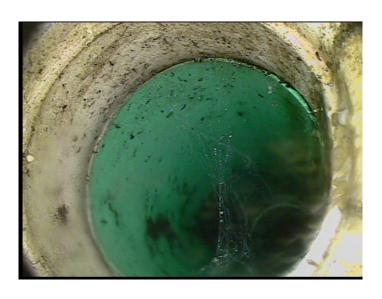
Code: TFA

Description: Tap Factory Active

Distance (ft): 52.9
Structural Grade: 0

Clock Start/From: 3

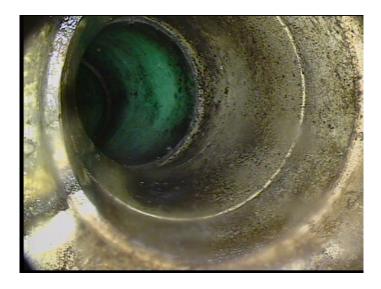
Description: Tap Factory

Distance (ft): 66.4
Structural Grade: 0

Clock Start/From: 10

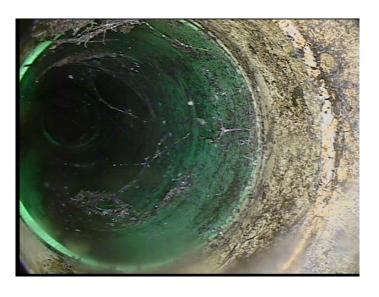
Code: **TF**

Description: Tap Factory

Distance (ft): 116.7
Structural Grade: 0
O&M Grade: 0
Clock Start/From: 9

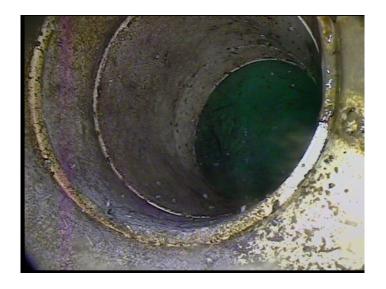
Description: Tap Factory

Distance (ft): 139.6
Structural Grade: 0
O&M Grade: 0
Clock Start/From: 3

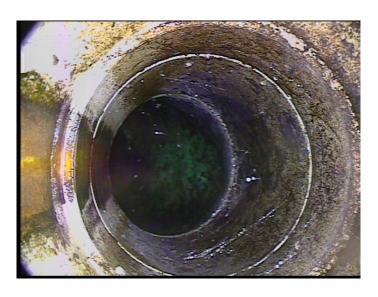
Code: **TF**

Description: Tap Factory

Distance (ft): 162.0
Structural Grade: 0
O&M Grade: 0
Clock Start/From: 10

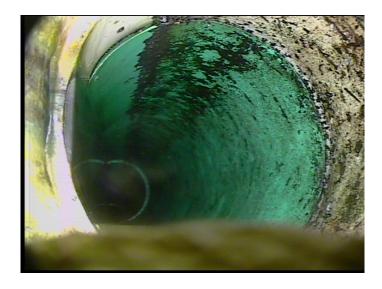
Description: Tap Factory

Distance (ft): 205.9
Structural Grade: 0
O&M Grade: 0
Clock Start/From: 9

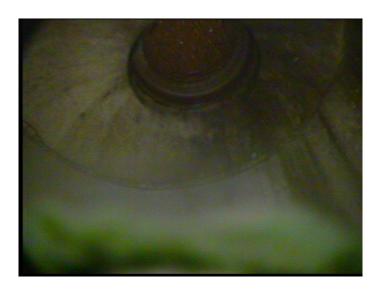
Code: AMH
Description: Manhole

Distance (ft): 280.9
Structural Grade: 0

Remarks: M-705-021
