## Profile/Photo Observation Report

Street:	<b>Center Street</b>	Flow Control:	
City:	<b>Hobart, IN</b>	Year Renewed:	
Location:	<b>Light Highway</b>	Tape/Media #:	<b>911</b>
Purpose:	<b>Routine Assessment</b>	Dia/Height:	<b>8"</b>
Use:	<b>Sanitary</b>	Material:	<b>PVC</b>
Drain Area:		Lining:	
Category:	<b>NA</b>		
Comment:

Location Details:		Direction of Survey:	<b>Upstream</b>
US MH:	<b>M-705-030</b>	DS MH:	<b>M-705-032A</b>
		Total Length Surveyed (ft):	<b>138.7</b>

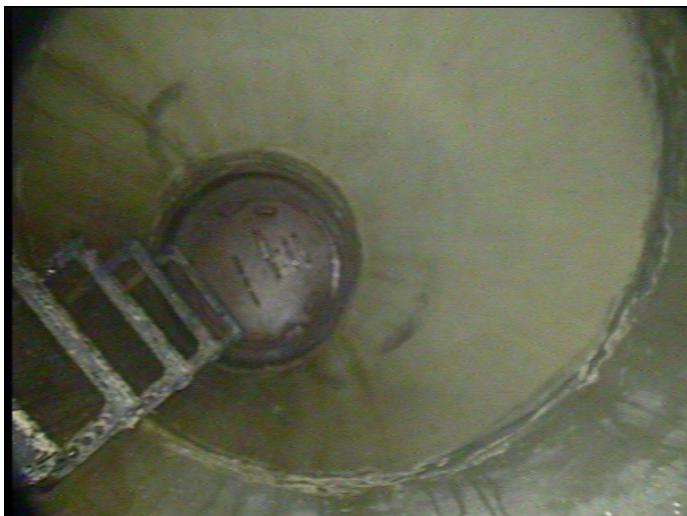
Code: **AMH**  
Description: **Manhole**

Distance (ft): **.0**  
Structural Grade: **0**  
O&M Grade: **0**  
Clock Start/From:  
Clock To:  
1st Value:  
2nd Value:  
Value Percent:  
Continuous Index:  
Within 8" of Joint: **NO**  
Remarks: **M-705-032A**

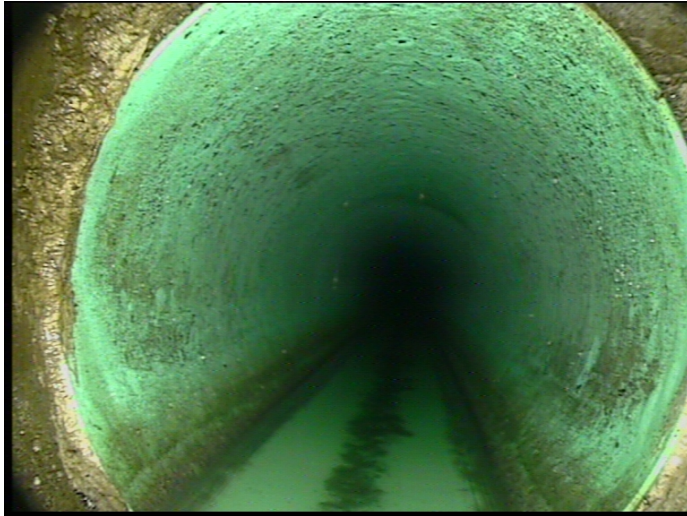
Code:	<b>MWL</b>
Description:	<b>Water Level</b>
Distance (ft):	<b>.0</b>
Structural Grade:	<b>0</b>
O&M Grade:	<b>0</b>
Clock Start/From:	
Clock To:	
1st Value:	
2nd Value:	
Value Percent:	<b>5.000</b>
Continuous Index:	
Within 8" of Joint:	<b>NO</b>
Remarks:

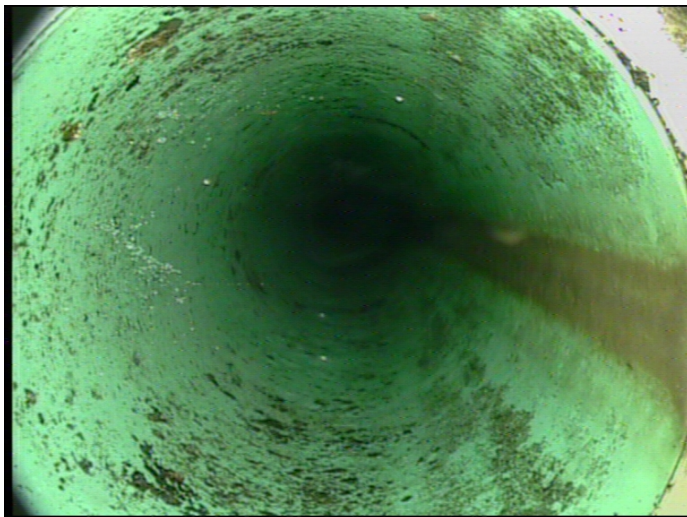
Code:	<b>TF</b>
Description:	<b>Tap Factory</b>
Distance (ft):	<b>16.8</b>
Structural Grade:	<b>0</b>
O&M Grade:	<b>0</b>
Clock Start/From:	<b>3</b>
Clock To:	
1st Value:	<b>4.000</b>
2nd Value:	
Value Percent:	
Continuous Index:	
Within 8" of Joint:	<b>NO</b>
Remarks:

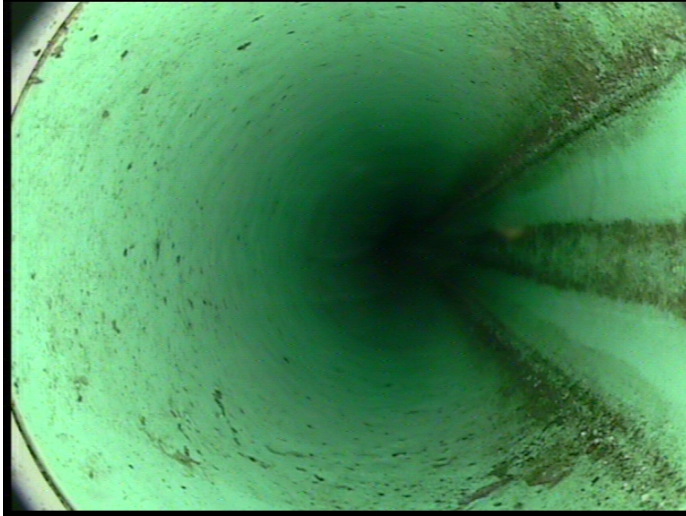
Code: **TF**  
Description: **Tap Factory**

Distance (ft): **96.4**  
Structural Grade: **0**  
O&M Grade: **0**  
Clock Start/From: **3**  
Clock To:  
1st Value: **4.000**  
2nd Value:  
Value Percent:  
Continuous Index:  
Within 8" of Joint: **NO**  
Remarks:

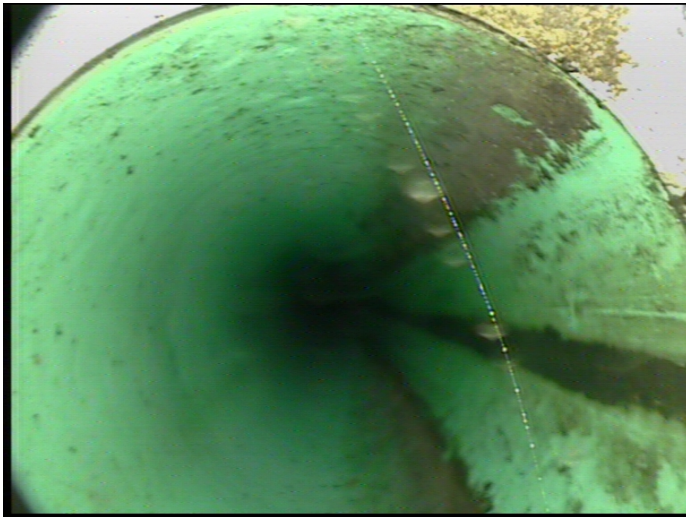
Code: **TF**  
Description: **Tap Factory**

Distance (ft): **137.9**  
Structural Grade: **0**  
O&M Grade: **0**  
Clock Start/From: **3**  
Clock To:  
1st Value: **4.000**  
2nd Value:  
Value Percent:  
Continuous Index:  
Within 8" of Joint: **NO**  
Remarks:

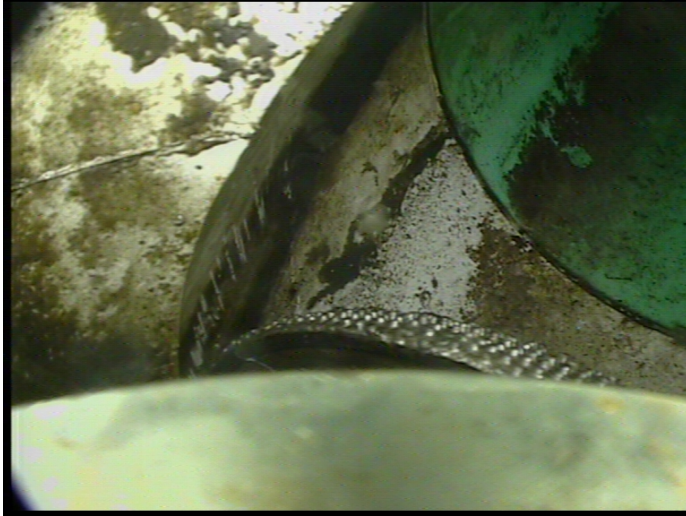
Code:	<b>MSA</b>
Description:	<b>Abandoned Survey</b>
Distance (ft):	<b>138.1</b>
Structural Grade:	<b>0</b>
O&M Grade:	<b>0</b>
Clock Start/From:	
Clock To:	
1st Value:	
2nd Value:	
Value Percent:	
Continuous Index:	
Within 8" of Joint:	<b>NO</b>
Remarks:	<b>Can not pass lateral</b>
