Profile/Photo Observation Report

Date:	10/20/2021	Weather:		Coding:	PACP 6.0
Pipe Length (ft):		Owner:	Hobart, IN	Pre Clean:	Not Known
P.O.#:	913_1	Surveyor:	M. Pielacha	PSR:	M-705-030_M-705-032A
Customer:	Hobart, IN	Clean Date:		Shape:	C

Street:	Center Street	Flow Control:	
City:	Hobart, IN	Year Renewed:	
Location:	Light Highway	Tape/Media #:	913
Purpose:	Reversal	Dia/Height:	8"
Use:	Sanitary	Material:	PVC
Drain Area:		Lining:	
Category:	NA		
Comment:

Location Details:		Direction of Survey:	Downstream
US MH:	M-705-030	DS MH:	M-705-032A
		Total Length Surveyed (ft):	56.0

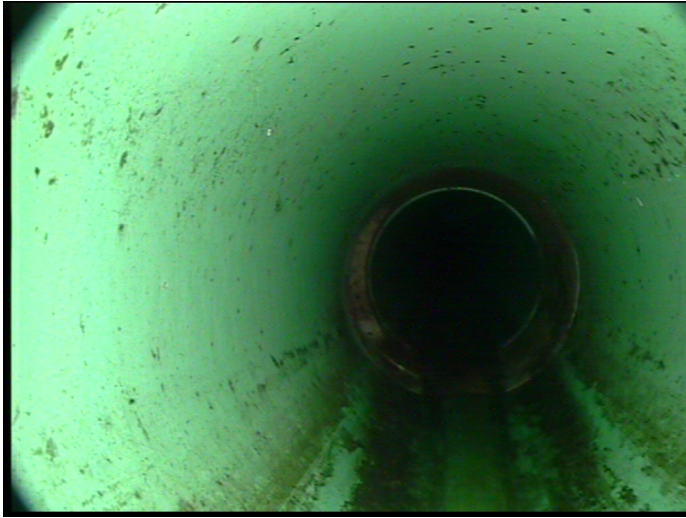
Code:	AMH
Description:	Manhole
Distance (ft):	.0
Structural Grade:	0
O&M Grade:	0
Clock Start/From:	
Clock To:	
1st Value:	
2nd Value:	
Value Percent:	
Continuous Index:	
Within 8" of Joint:	NO
Remarks:	M-705-030

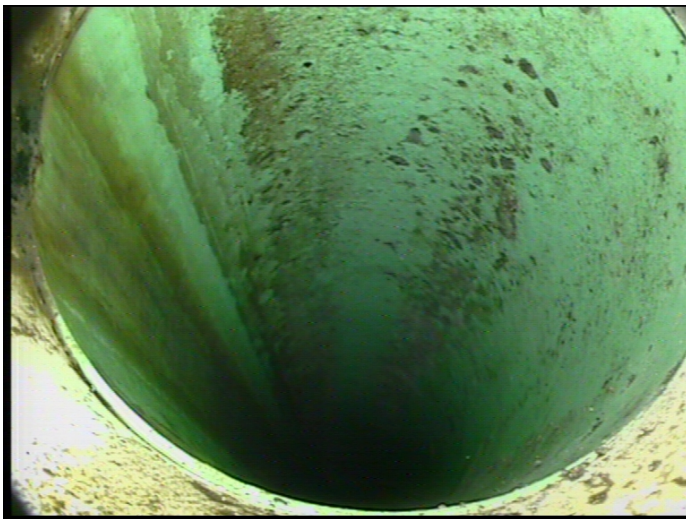
Code:	MWL
Description:	Water Level
Distance (ft):	.0
Structural Grade:	0
O&M Grade:	0
Clock Start/From:	
Clock To:	
1st Value:	
2nd Value:	
Value Percent:	5.000
Continuous Index:	
Within 8" of Joint:	NO
Remarks:

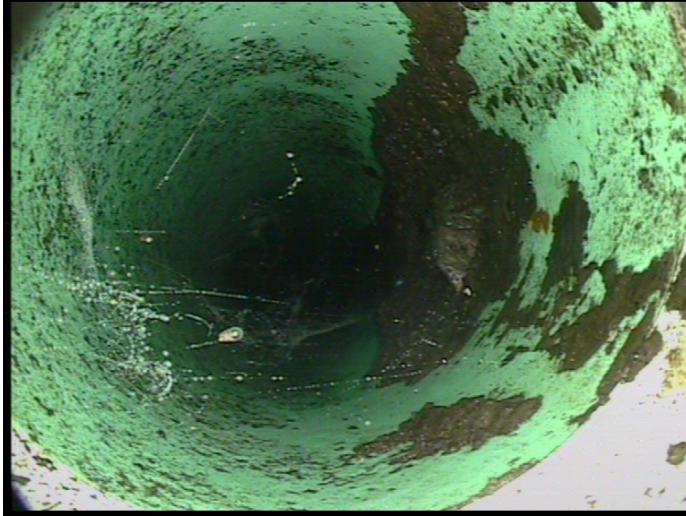
Code:	TF
Description:	Tap Factory
Distance (ft):	4.8
Structural Grade:	0
O&M Grade:	0
Clock Start/From:	9
Clock To:	
1st Value:	4.000
2nd Value:	
Value Percent:	
Continuous Index:	
Within 8" of Joint:	NO
Remarks:

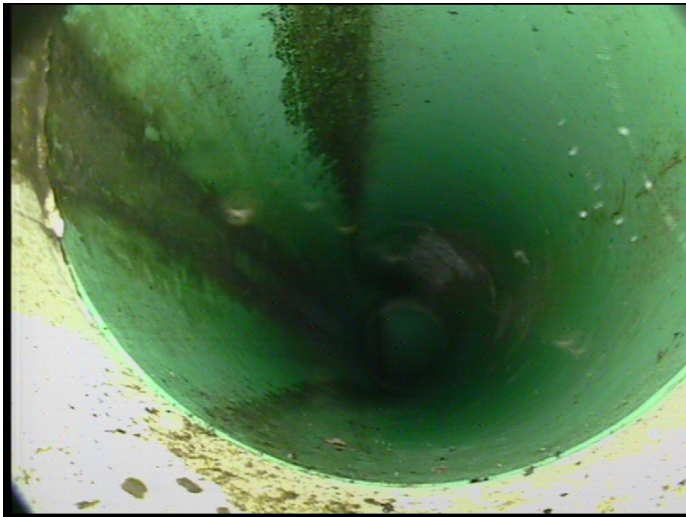
Code: **TF**
Description: **Tap Factory**

Distance (ft): **16.6**
Structural Grade: **0**
O&M Grade: **0**
Clock Start/From: **3**
Clock To:
1st Value: **4.000**
2nd Value:
Value Percent:
Continuous Index:
Within 8" of Joint: **NO**
Remarks:

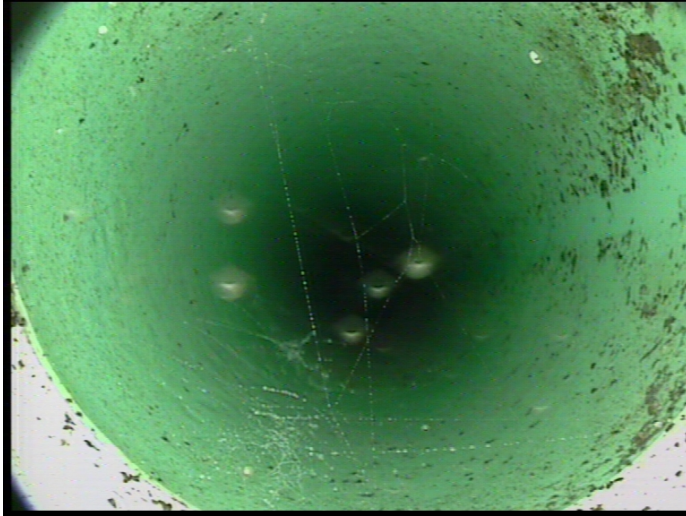
Code: **TF**
Description: **Tap Factory**

Distance (ft): **30.7**
Structural Grade: **0**
O&M Grade: **0**
Clock Start/From: **9**
Clock To:
1st Value: **4.000**
2nd Value:
Value Percent:
Continuous Index:
Within 8" of Joint: **NO**
Remarks:

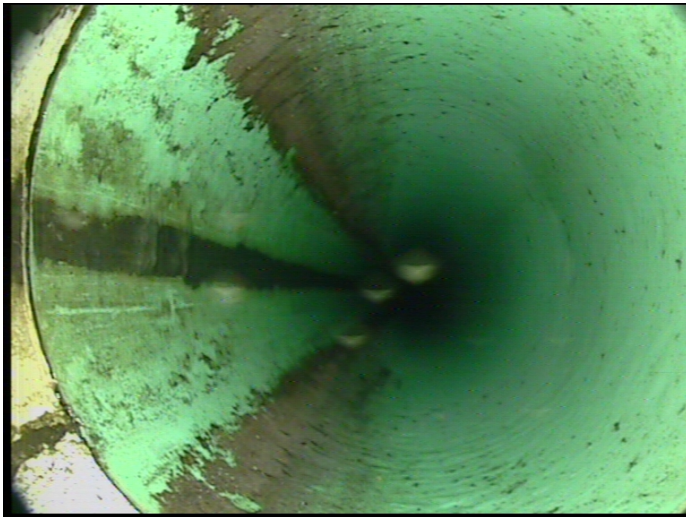
Code: **TF**
Description: **Tap Factory**

Distance (ft): **48.2**
Structural Grade: **0**
O&M Grade: **0**
Clock Start/From: **3**
Clock To:
1st Value: **4.000**
2nd Value:
Value Percent:
Continuous Index:
Within 8" of Joint: **NO**
Remarks:

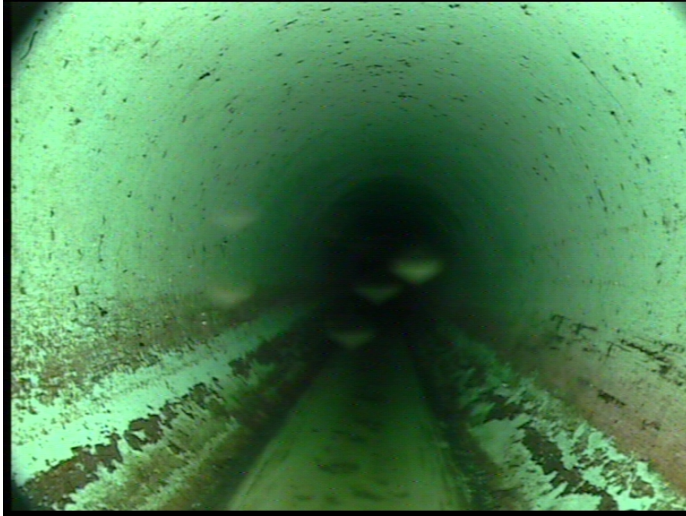
Code: **TF**
Description: **Tap Factory**

Distance (ft): **56.0**
Structural Grade: **0**
O&M Grade: **0**
Clock Start/From: **9**
Clock To:
1st Value: **4.000**
2nd Value:
Value Percent:
Continuous Index:
Within 8" of Joint: **NO**
Remarks:
