Profile/Photo Observation Report

Street:	East 8th Street	Flow Control:	
City:	Hobart, IN	Year Renewed:	
Location:	Light Highway	Tape/Media #:	920
Purpose:	Routine Assessment	Dia/Height:	24"
Use:	Sanitary	Material:	RCP
Drain Area:		Lining:	
Category:	NA		
Comment:

Location Details:		Direction of Survey:	Upstream
US MH:	M-706-015	DS MH:	M-706-012
		Total Length Surveyed (ft):	127.3

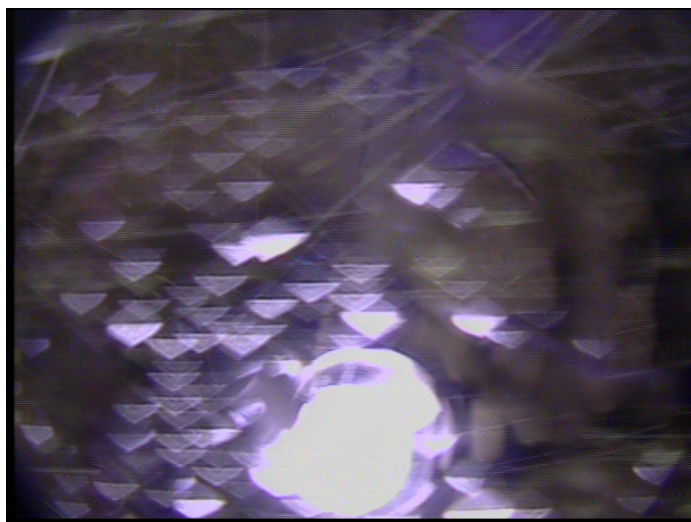
Code: **AMH**
Description: **Manhole**

Distance (ft): **.0**
Structural Grade: **0**
O&M Grade: **0**
Clock Start/From:
Clock To:
1st Value:
2nd Value:
Value Percent:
Continuous Index:
Within 8" of Joint: **NO**
Remarks: **M-706-012**

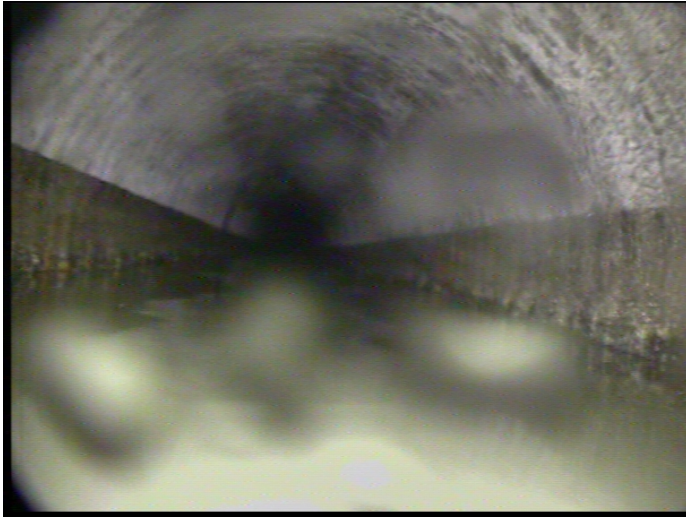
Code:	MWL
Description:	Water Level
Distance (ft):	.0
Structural Grade:	0
O&M Grade:	0
Clock Start/From:	
Clock To:	
1st Value:	
2nd Value:	
Value Percent:	15.000
Continuous Index:	
Within 8" of Joint:	NO
Remarks:

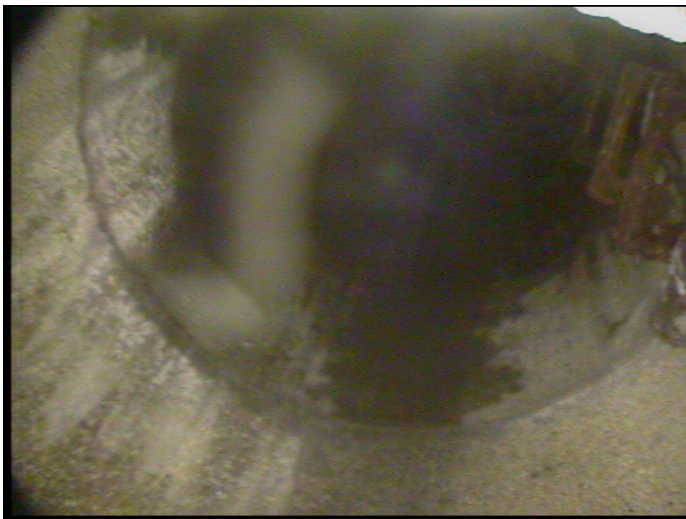
Code:	AMH
Description:	Manhole
Distance (ft):	127.3
Structural Grade:	0
O&M Grade:	0
Clock Start/From:	
Clock To:	
1st Value:	
2nd Value:	
Value Percent:	
Continuous Index:	
Within 8" of Joint:	NO
Remarks:	M-706-015
