## Profile/Photo Observation Report

Date:	<b>10/21/2021</b>	Weather:		Coding:	<b>PACP 6.0</b>
Pipe Length (ft):		Owner:	<b>Hobart, IN</b>	Pre Clean:	<b>Not Known</b>
P.O.#:	<b>925_1</b>	Surveyor:	<b>M. Pielacha</b>	PSR:	<b>M-706-037_M-706-035.5</b>
Customer:	<b>Hobart, IN</b>	Clean Date:		Shape:	<b>C</b>

Street:	<b>Lake Street</b>	Flow Control:	
City:	<b>Hobart, IN</b>	Year Renewed:	
Location:	<b>Light Highway</b>	Tape/Media #:	<b>925</b>
Purpose:	<b>Routine Assessment</b>	Dia/Height:	<b>10"</b>
Use:	<b>Sanitary</b>	Material:	<b>PVC</b>
Drain Area:		Lining:	
Category:	<b>NA</b>

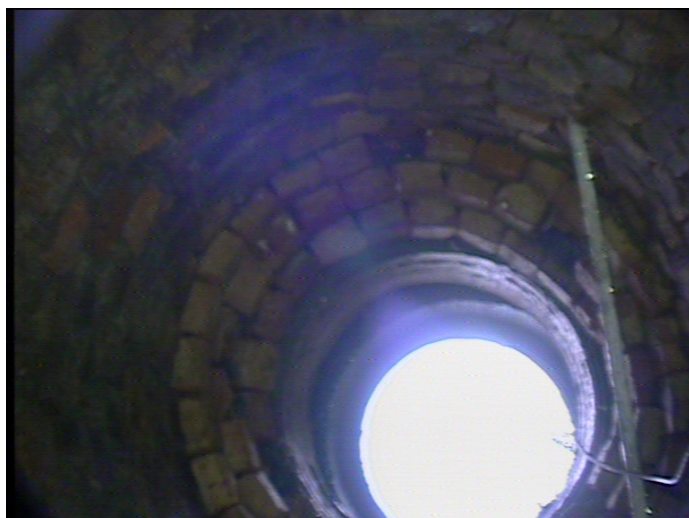
Code: **AMH**  
Description: **Manhole**

Distance (ft): **.0**  
Structural Grade: **0**  
O&M Grade: **0**  
Clock Start/From:  
Clock To:  
1st Value:  
2nd Value:  
Value Percent:  
Continuous Index:  
Within 8" of Joint: **NO**  
Remarks: **M-706-035.5**

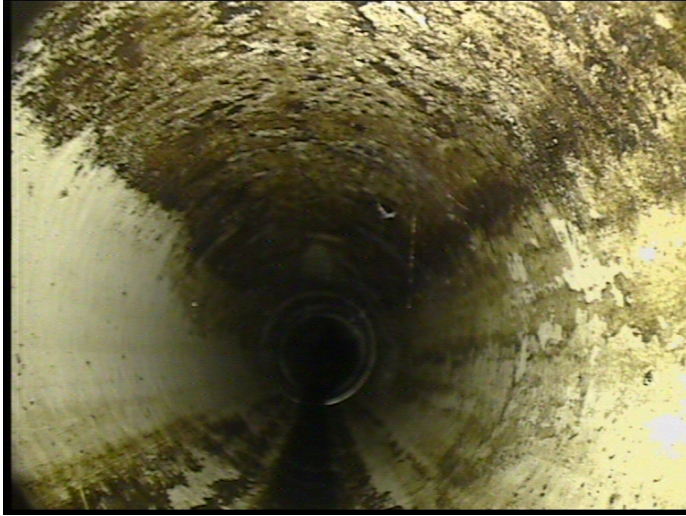
Code:	<b>MWL</b>
Description:	<b>Water Level</b>
Distance (ft):	<b>.0</b>
Structural Grade:	<b>0</b>
O&M Grade:	<b>0</b>
Clock Start/From:	
Clock To:	
1st Value:	
2nd Value:	
Value Percent:	<b>5.000</b>
Continuous Index:	
Within 8" of Joint:	<b>NO</b>
Remarks:

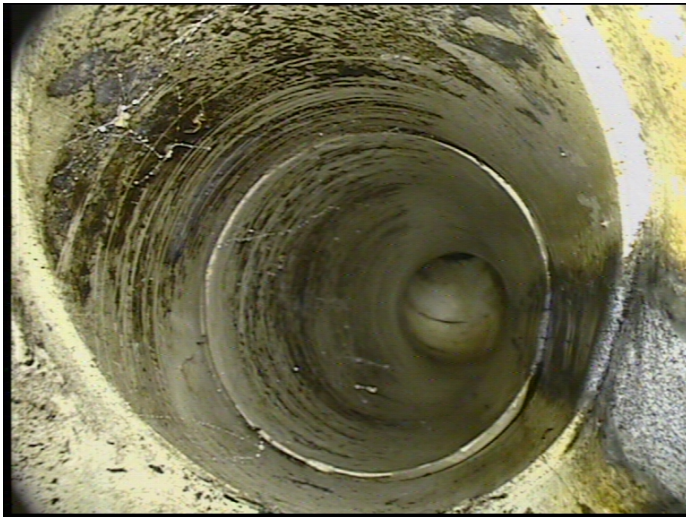
Code:	<b>TF</b>
Description:	<b>Tap Factory</b>
Distance (ft):	<b>8.3</b>
Structural Grade:	<b>0</b>
O&M Grade:	<b>0</b>
Clock Start/From:	<b>3</b>
Clock To:	
1st Value:	<b>4.000</b>
2nd Value:	
Value Percent:	
Continuous Index:	
Within 8" of Joint:	<b>NO</b>
Remarks:

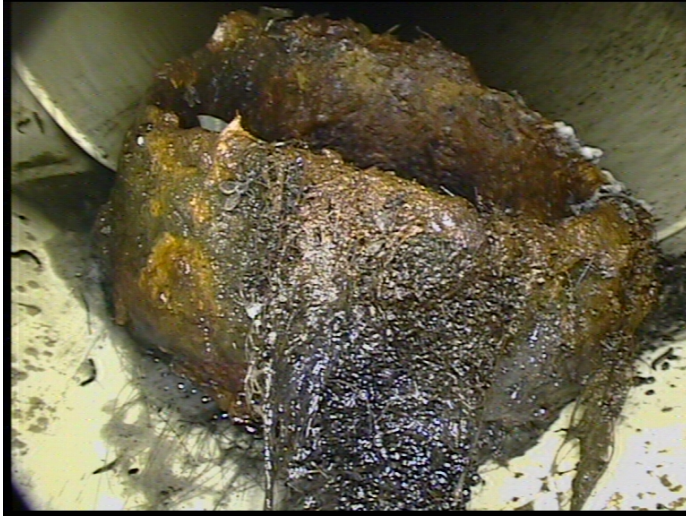
Code: **OBZ**  
Description: **Obstacle Other**

Distance (ft): **20.5**  
Structural Grade: **0**  
O&M Grade: **3**  
Clock Start/From: **4**  
Clock To: **8**  
1st Value:  
2nd Value:  
Value Percent: **15.000**  
Continuous Index:  
Within 8" of Joint: **NO**  
Remarks: **Debris**

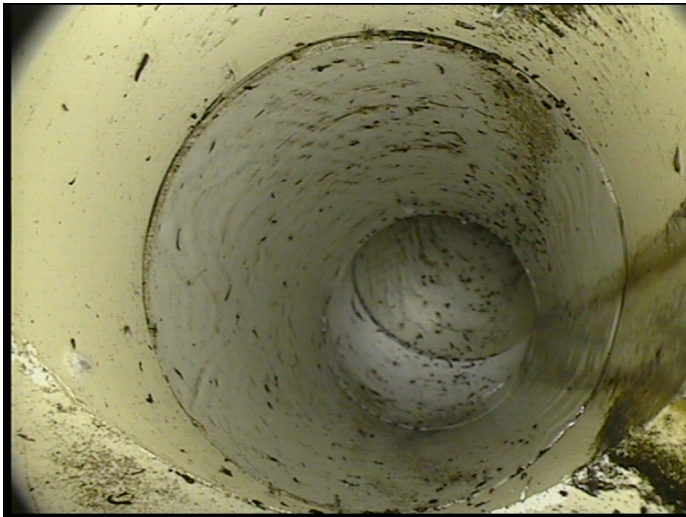
Code: **TF**  
Description: **Tap Factory**

Distance (ft): **64.1**  
Structural Grade: **0**  
O&M Grade: **0**  
Clock Start/From: **3**  
Clock To:  
1st Value: **4.000**  
2nd Value:  
Value Percent:  
Continuous Index:  
Within 8" of Joint: **NO**  
Remarks:

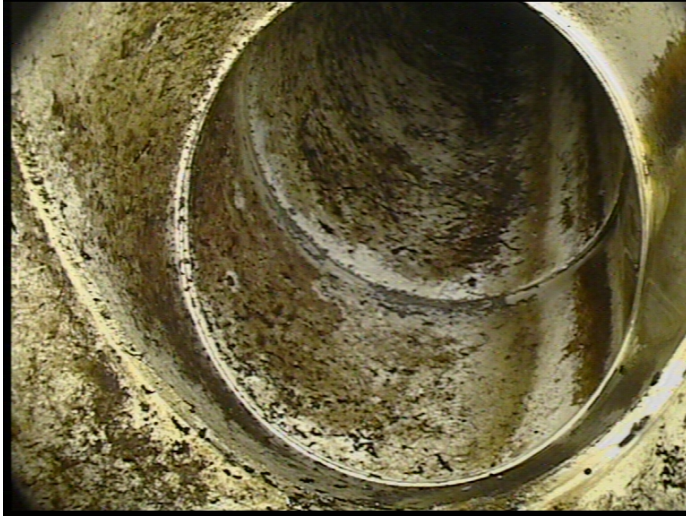
Code:	<b>TF</b>
Description:	<b>Tap Factory</b>
Distance (ft):	<b>146.4</b>
Structural Grade:	<b>0</b>
O&M Grade:	<b>0</b>
Clock Start/From:	<b>3</b>
Clock To:	
1st Value:	<b>4.000</b>
2nd Value:	
Value Percent:	
Continuous Index:	
Within 8" of Joint:	<b>NO</b>
Remarks:

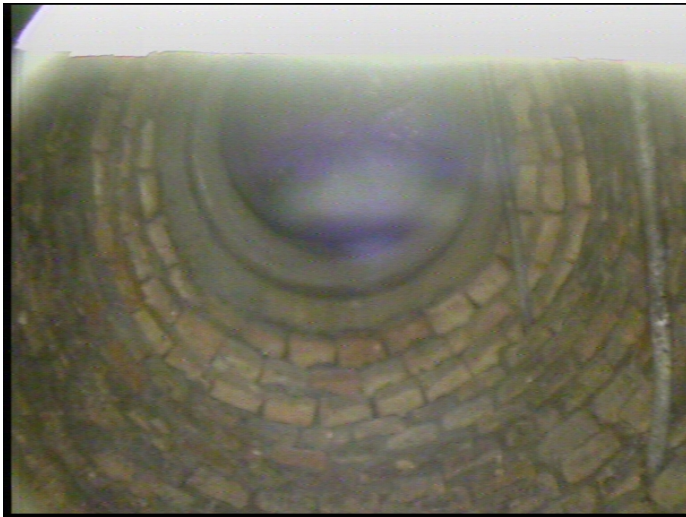
Code:	<b>AMH</b>
Description:	<b>Manhole</b>
Distance (ft):	<b>159.6</b>
Structural Grade:	<b>0</b>
O&M Grade:	<b>0</b>
Clock Start/From:	
Clock To:	
1st Value:	
2nd Value:	
Value Percent:	
Continuous Index:	
Within 8" of Joint:	<b>NO</b>
Remarks:	<b>M-706-037</b>
