Profile/Photo Observation Report

Street:	Lincoln Street	Flow Control:	
City:	Hobart, IN	Year Renewed:	
Location:	Light Highway	Tape/Media #:	978
Purpose:	Routine Assessment	Dia/Height:	8"
Use:	Sanitary	Material:	VCP
Drain Area:		Lining:	
Category:	NA

US MH: **M-707-021** DS MH: **M-707-022** Total Length Surveyed (ft): **6.8**

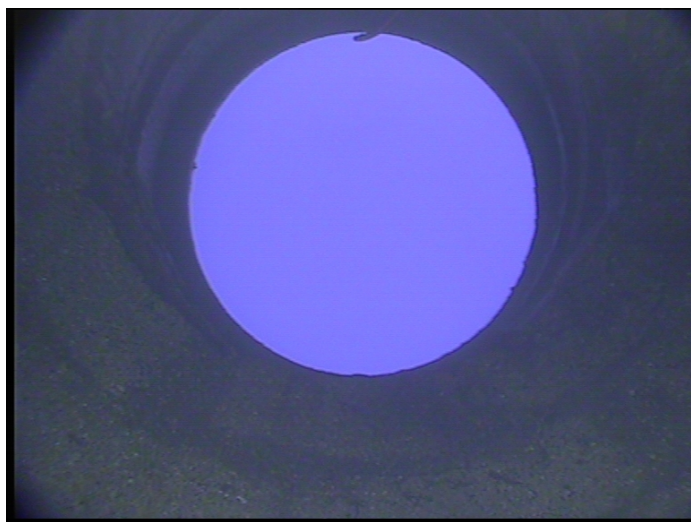
Code: **AMH**
Description: **Manhole**

Distance (ft): **.0**
Structural Grade: **0**
O&M Grade: **0**
Clock Start/From:
Clock To:
1st Value:
2nd Value:
Value Percent:
Continuous Index:
Within 8" of Joint: **NO**
Remarks: **M-707-021**

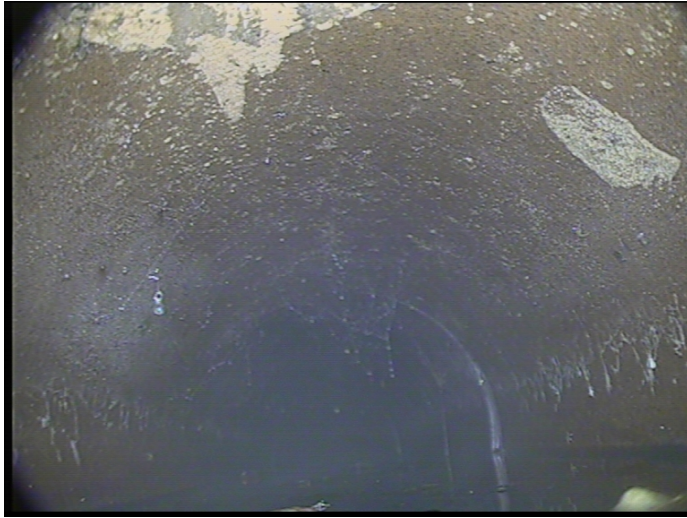
Code: **MWL**
Description: **Water Level**

Distance (ft): **.0**
Structural Grade: **0**
O&M Grade: **0**
Clock Start/From:
Clock To:
1st Value:
2nd Value:
Value Percent: **10.000**
Continuous Index:
Within 8" of Joint: **NO**
Remarks:

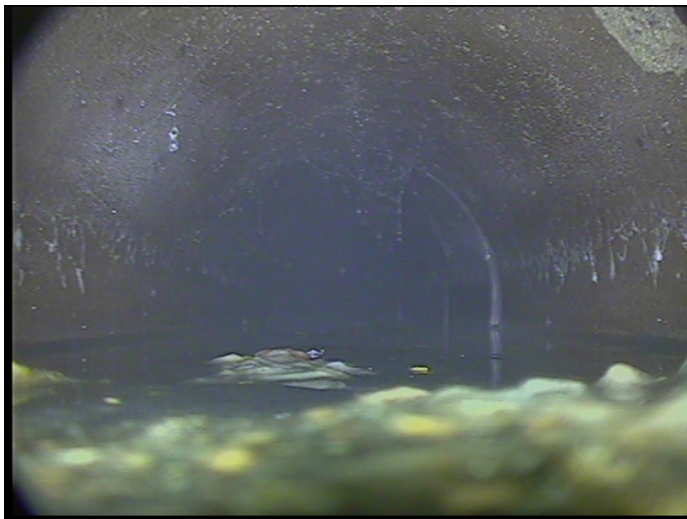
Code: **DSF**
Description: **Deposits Settled Fine**

Distance (ft): **.0**
Structural Grade: **0**
O&M Grade: **3**
Clock Start/From: **4**
Clock To: **8**
1st Value:
2nd Value:
Value Percent: **15.000**
Continuous Index: **S01**
Within 8" of Joint: **YES**
Remarks:

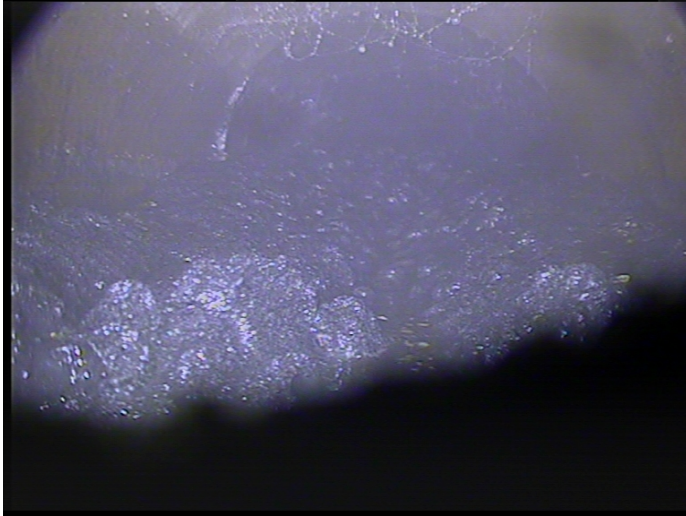
Code:	DSF
Description:	Deposits Settled Fine
Distance (ft):	6.8
Structural Grade:	0
O&M Grade:	4
Clock Start/From:	4
Clock To:	8
1st Value:	
2nd Value:	
Value Percent:	30.000
Continuous Index:	F01
Within 8" of Joint:	NO
Remarks:

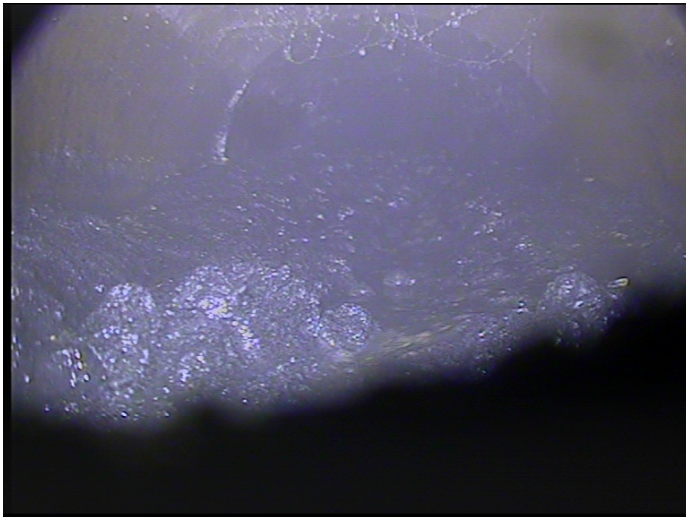
Code:	MSA
Description:	Abandoned Survey
Distance (ft):	6.8
Structural Grade:	0
O&M Grade:	0
Clock Start/From:	
Clock To:	
1st Value:	
2nd Value:	
Value Percent:	
Continuous Index:	
Within 8" of Joint:	NO
Remarks:	deep sediment
