Profile/Photo Observation Report

Street:	East 10th Street	Flow Control:	Not Controlled
City:	Hobart, IN	Year Renewed:	
Location:	Sidewalk	Tape/Media #:	DEP257
Purpose:	Routine Assessment	Dia/Height:	15"
Use:	Sanitary	Material:	PVC
Drain Area:		Lining:	
Category:	NA		
Comment:	5-21-2018

Location Details:		Direction of Survey:	Downstream
US MH:	M-806-047	DS MH:	M-806-062
		Total Length Surveyed (ft):	162.1

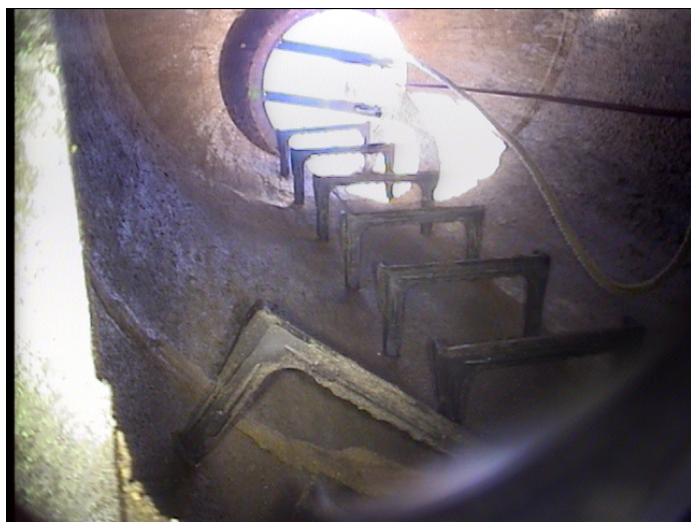
Code: **AMH**
Description: **Manhole**

Distance (ft): **.0**
Structural Grade: **0**
O&M Grade: **0**
Clock Start/From:
Clock To:
1st Value:
2nd Value:
Value Percent:
Continuous Index:
Within 8" of Joint: **NO**
Remarks: **M-806-047**

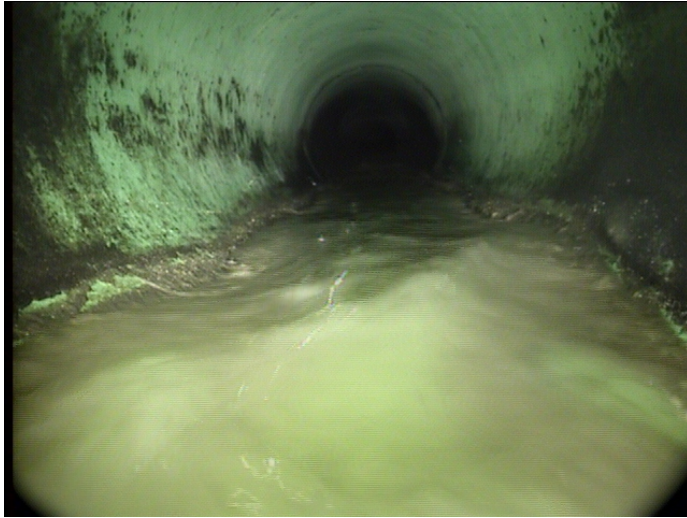
Code: **MWL**
Description: **Water Level**

Distance (ft): **.0**
Structural Grade: **0**
O&M Grade: **0**
Clock Start/From:
Clock To:
1st Value:
2nd Value:
Value Percent: **5.000**
Continuous Index:
Within 8" of Joint: **NO**
Remarks:

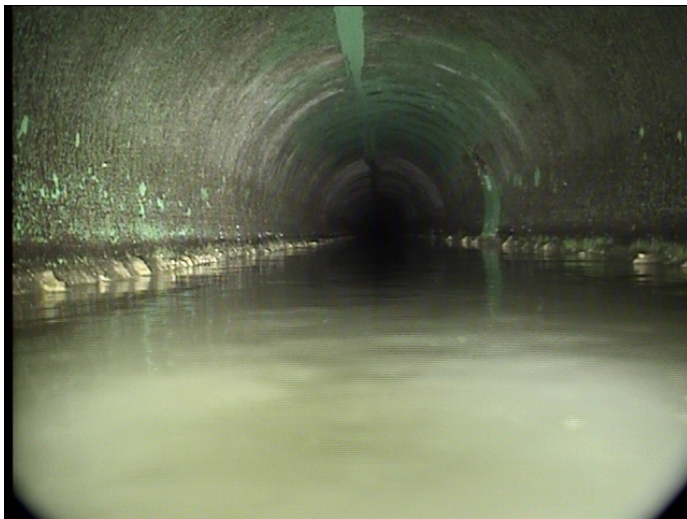
Code: **MSA**
Description: **Abandoned Survey**

Distance (ft): **162.1**
Structural Grade: **0**
O&M Grade: **0**
Clock Start/From:
Clock To:
1st Value:
2nd Value:
Value Percent:
Continuous Index:
Within 8" of Joint: **NO**
Remarks: **Dots connected**
