## Profile/Photo Observation Report

Street:	<b>Drexel Dr.</b>	Flow Control:	<b>Not Controlled</b>
City:	<b>Hobart, IN</b>	Year Renewed:	
Location:	<b>Other</b>	Tape/Media #:	
Purpose:	<b>Not Known</b>	Dia/Height:	<b>8"</b>
Use:	<b>Sanitary</b>	Material:	<b>PVC</b>
Drain Area:	<b>NA</b>	Lining:	
Category:	<b>NA</b>		
Comment:

Location Details:		Direction of Survey:	<b>Downstream</b>
US MH:	<b>M-1004-016</b>	DS MH:	<b>M-1004-017</b>
		Total Length Surveyed (ft):	<b>194.5</b>

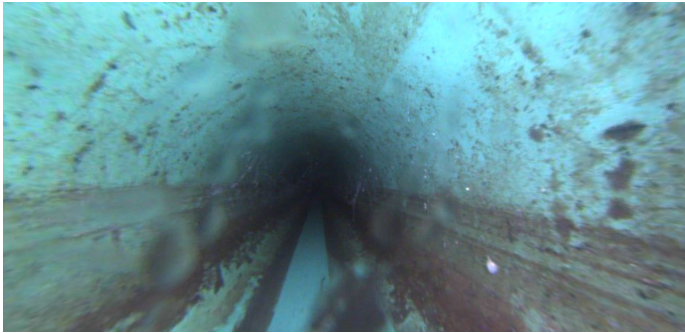
Code:	<b>MWL</b>
Description:	<b>Water Level</b>

Distance (ft):	<b>.0</b>
Structural Grade:	<b>0</b>
O&M Grade:	<b>0</b>
Clock Start/From:	
Clock To:	
1st Value:	
2nd Value:	
Value Percent:	<b>5.000</b>
Continuous Index:	
Within 8" of Joint:	<b>NO</b>
Remarks:

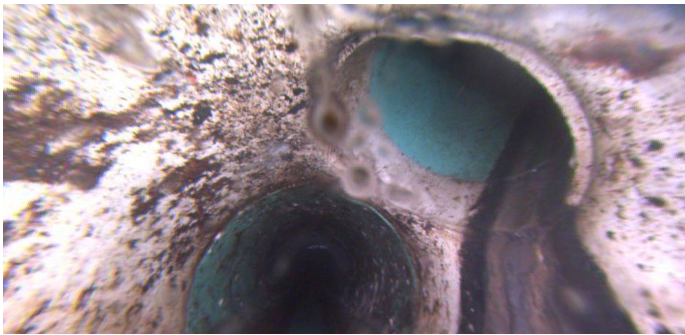
Code:	<b>TFA</b>
Description:	<b>Tap Factory Active</b>

Distance (ft):	<b>76.7</b>
Structural Grade:	<b>0</b>
O&M Grade:	<b>0</b>
Clock Start/From:	<b>1</b>
Clock To:	
1st Value:	<b>4.000</b>
2nd Value:	
Value Percent:	
Continuous Index:	
Within 8" of Joint:	
Remarks:

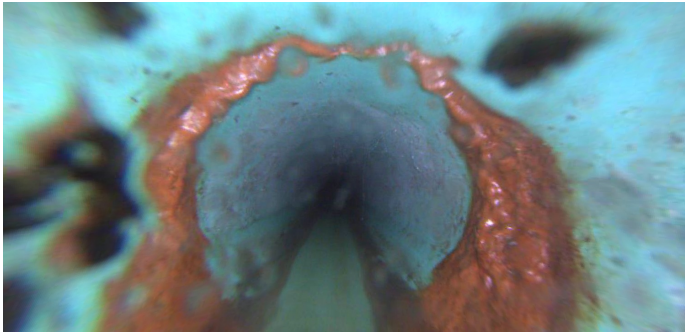
Code: **DAE**  
Description: **Deposits Attached Encrustation**

Distance (ft): **135.9**  
Structural Grade: **0**  
O&M Grade: **2**  
Clock Start/From: **7**  
Clock To: **5**  
1st Value:  
2nd Value:  
Value Percent: **5.000**  
Continuous Index:  
Within 8" of Joint: **YES**  
Remarks:

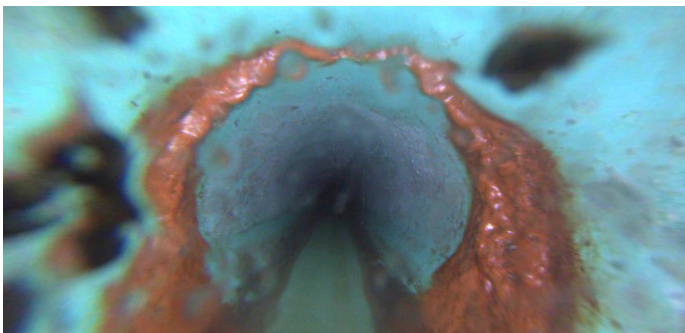
Code: **IW**  
Description: **Infil Weeper**

Distance (ft): **135.9**  
Structural Grade: **0**  
O&M Grade: **2**  
Clock Start/From: **8**  
Clock To: **4**  
1st Value:  
2nd Value:  
Value Percent:  
Continuous Index:  
Within 8" of Joint: **YES**  
Remarks:

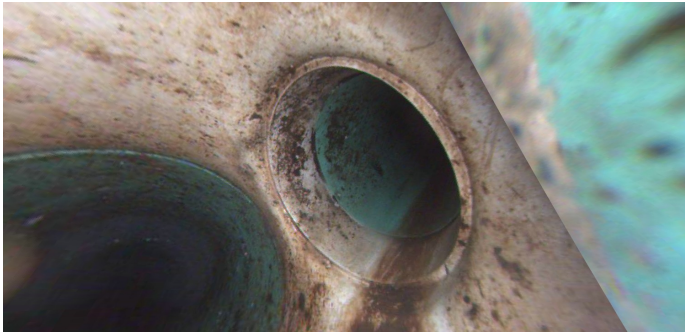
Code: **TF**  
Description: **Tap Factory**

Distance (ft): **186.1**  
Structural Grade: **0**  
O&M Grade: **0**  
Clock Start/From: **10**  
Clock To:  
1st Value: **4.000**  
2nd Value:  
Value Percent:  
Continuous Index:  
Within 8" of Joint:  
Remarks:

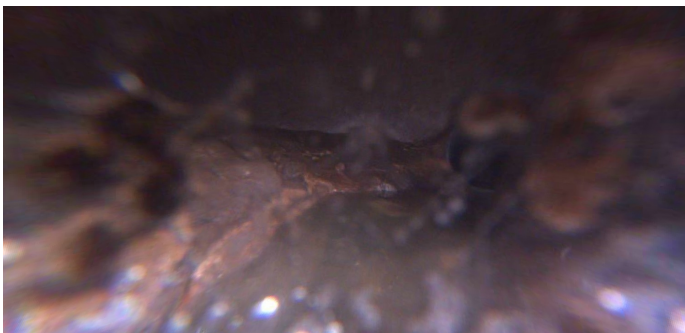
Code: **AMH**  
Description: **Manhole**

Distance (ft): **194.5**  
Structural Grade: **0**  
O&M Grade: **0**  
Clock Start/From:  
Clock To:  
1st Value:  
2nd Value:  
Value Percent:  
Continuous Index:  
Within 8" of Joint: **NO**  
Remarks: **M-1004-017**
