Profile/Photo Observation Report

Date:	04/14/2018	Weather:		Coding:	PACP 6.0
Pipe Length (ft):	306.9	Owner:	NA	Pre Clean:	Not Known
P.O.#:		Surveyor:	Jen Costello	PSR:	P-1004-027-028
Customer:		Clean Date:	01/01/1900	Shape:	C

Street:	E CLEVELAND AVE	Flow Control:	Not Controlled
City:	Hobart, IN	Year Renewed:	
Location:	Other	Tape/Media #:	
Purpose:	Not Known	Dia/Height:	8"
Use:	Sanitary	Material:	PVC
Drain Area:	NA	Lining:	
Category:	NA		
Comment:

Location Details:		Direction of Survey:	Upstream
US MH:	M-1004-027	DS MH:	M-1004-028
		Total Length Surveyed (ft):	292.1

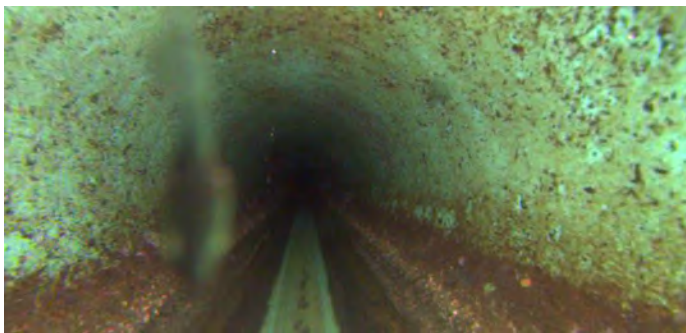
Code: **AMH**
Description: **Manhole**

Distance (ft): **.0**
Structural Grade: **0**
O&M Grade: **0**
Clock Start/From:
Clock To:
1st Value:
2nd Value:
Value Percent:
Continuous Index:
Within 8" of Joint: **NO**
Remarks: **M-1004-028**

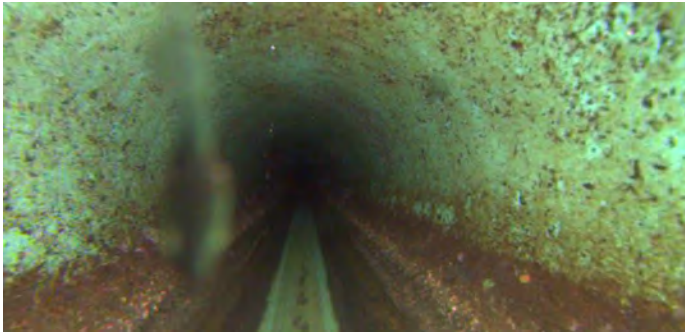
Code:	MWL
Description:	Water Level

Distance (ft):	.0
Structural Grade:	0
O&M Grade:	0
Clock Start/From:	
Clock To:	
1st Value:	
2nd Value:	
Value Percent:	5.000
Continuous Index:	
Within 8" of Joint:	NO
Remarks:

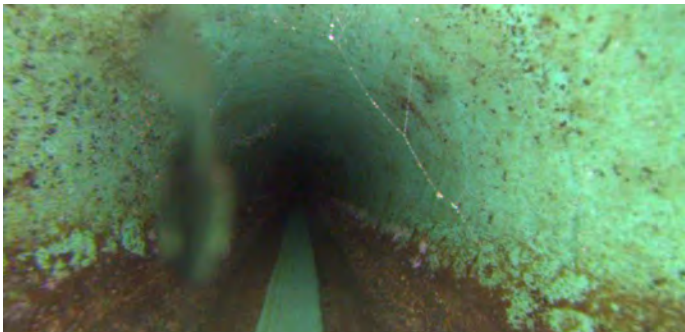
Code:	DAZ
Description:	Deposits Attached Other

Distance (ft):	4.7
Structural Grade:	0
O&M Grade:	2
Clock Start/From:	4
Clock To:	8
1st Value:	
2nd Value:	
Value Percent:	5.000
Continuous Index:	S01
Within 8" of Joint:	NO
Remarks:

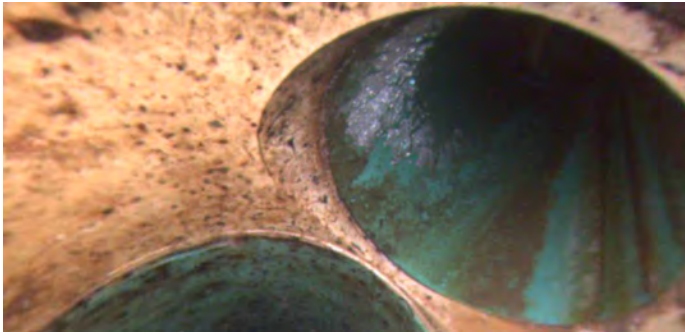
Code: **TF**
Description: **Tap Factory**

Distance (ft): **38.3**
Structural Grade: **0**
O&M Grade: **0**
Clock Start/From: **11**
Clock To:
1st Value: **4.000**
2nd Value:
Value Percent:
Continuous Index:
Within 8" of Joint:
Remarks:

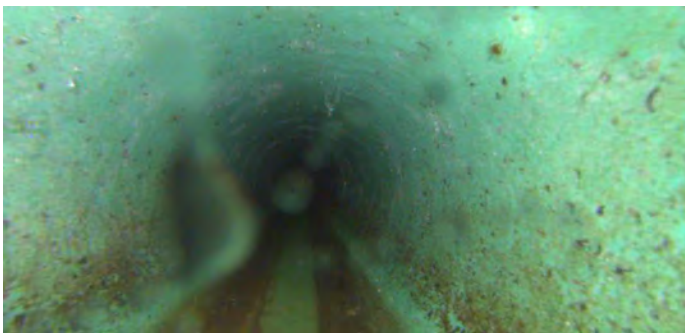
Code: **DAZ**
Description: **Deposits Attached Other**

Distance (ft): **86.9**
Structural Grade: **0**
O&M Grade: **2**
Clock Start/From: **4**
Clock To: **8**
1st Value:
2nd Value:
Value Percent: **5.000**
Continuous Index: **F01**
Within 8" of Joint: **NO**
Remarks:

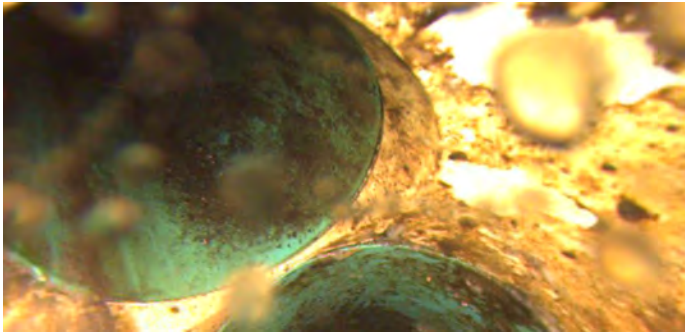
Code: **TF**
Description: **Tap Factory**

Distance (ft): **120.9**
Structural Grade: **0**
O&M Grade: **0**
Clock Start/From: **11**
Clock To:
1st Value: **4.000**
2nd Value:
Value Percent:
Continuous Index:
Within 8" of Joint:
Remarks:

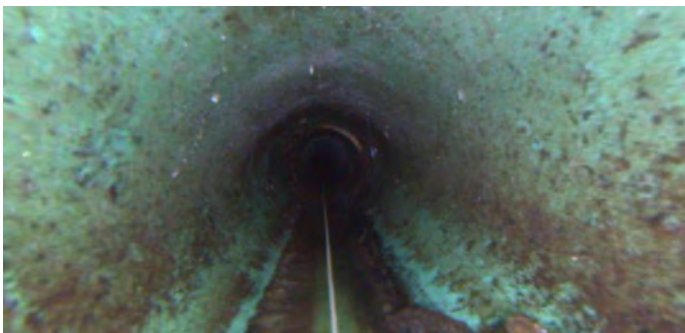
Code: **MGO**
Description: **General Observation**

Distance (ft): **123.8**
Structural Grade: **0**
O&M Grade: **0**
Clock Start/From:
Clock To:
1st Value:
2nd Value:
Value Percent:
Continuous Index:
Within 8" of Joint: **NO**
Remarks: **REAR CAMERA**

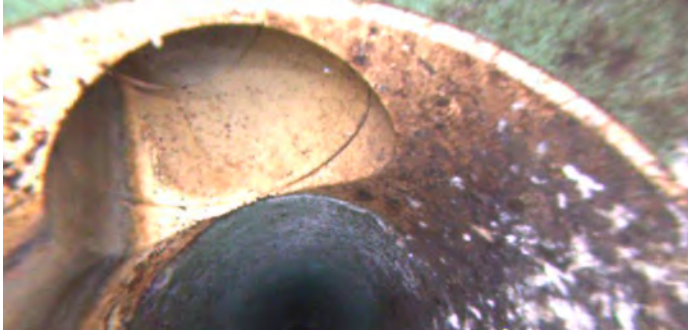
Code: **TF**
Description: **Tap Factory**

Distance (ft): **159.1**
Structural Grade: **0**
O&M Grade: **0**
Clock Start/From: **1**
Clock To:
1st Value: **4.000**
2nd Value:
Value Percent:
Continuous Index:
Within 8" of Joint:
Remarks:

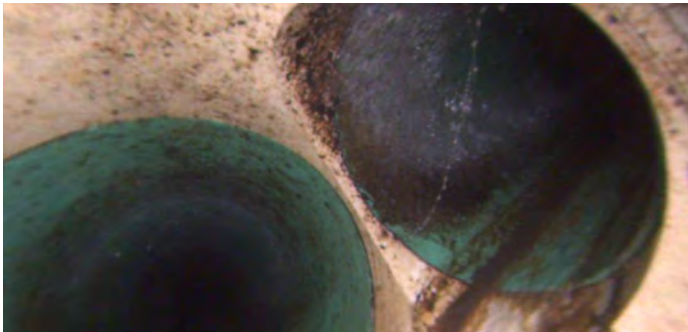
Code: **TFA**
Description: **Tap Factory Active**

Distance (ft): **192.2**
Structural Grade: **0**
O&M Grade: **0**
Clock Start/From: **10**
Clock To:
1st Value: **4.000**
2nd Value:
Value Percent:
Continuous Index:
Within 8" of Joint:
Remarks:

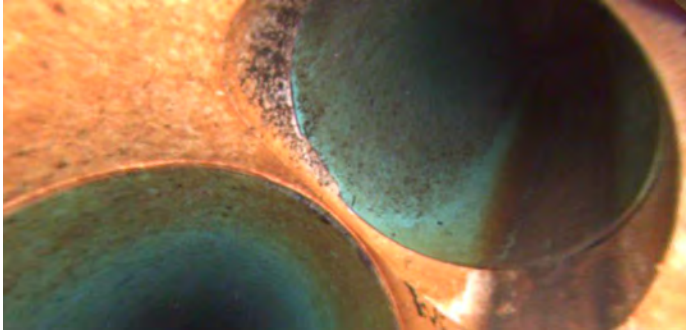
Code: **TF**
Description: **Tap Factory**

Distance (ft): **214.7**
Structural Grade: **0**
O&M Grade: **0**
Clock Start/From: **11**
Clock To:
1st Value: **4.000**
2nd Value:
Value Percent:
Continuous Index:
Within 8" of Joint:
Remarks:

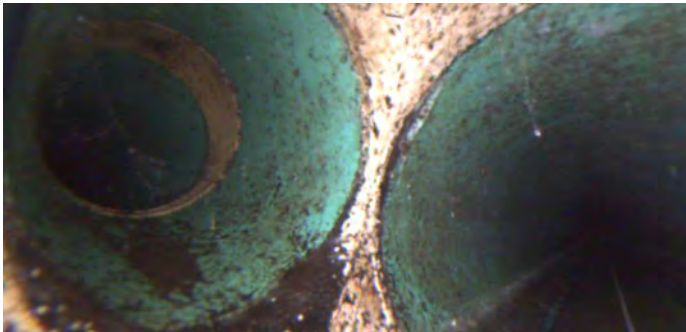
Code: **TF**
Description: **Tap Factory**

Distance (ft): **278.2**
Structural Grade: **0**
O&M Grade: **0**
Clock Start/From: **2**
Clock To:
1st Value: **4.000**
2nd Value:
Value Percent:
Continuous Index:
Within 8" of Joint:
Remarks:

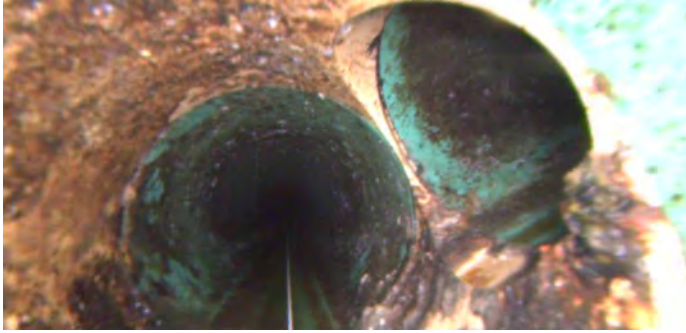
Code: **TF**
Description: **Tap Factory**

Distance (ft): **288.7**
Structural Grade: **0**
O&M Grade: **0**
Clock Start/From: **10**
Clock To:
1st Value: **4.000**
2nd Value:
Value Percent:
Continuous Index:
Within 8" of Joint:
Remarks:

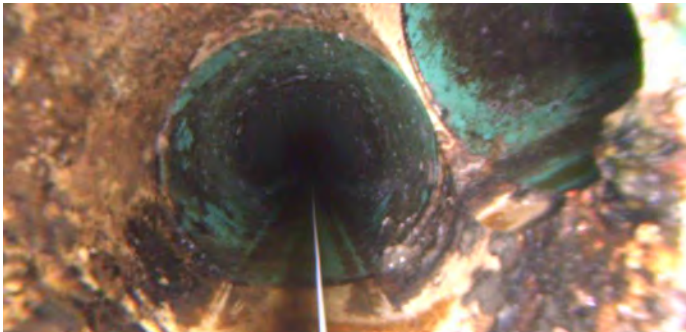
Code: **DAGS**
Description: **Deposits Attached Grease**

Distance (ft): **288.7**
Structural Grade: **0**
O&M Grade: **2**
Clock Start/From: **8**
Clock To: **4**
1st Value:
2nd Value:
Value Percent: **5.000**
Continuous Index:
Within 8" of Joint: **NO**
Remarks:

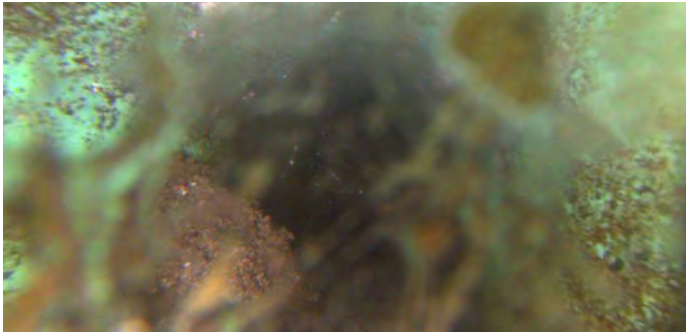
Code: **DAZ**
Description: **Deposits Attached Other**

Distance (ft): **291.2**
Structural Grade: **0**
O&M Grade: **2**
Clock Start/From: **6**
Clock To: **9**
1st Value:
2nd Value:
Value Percent: **10.000**
Continuous Index:
Within 8" of Joint: **YES**
Remarks:

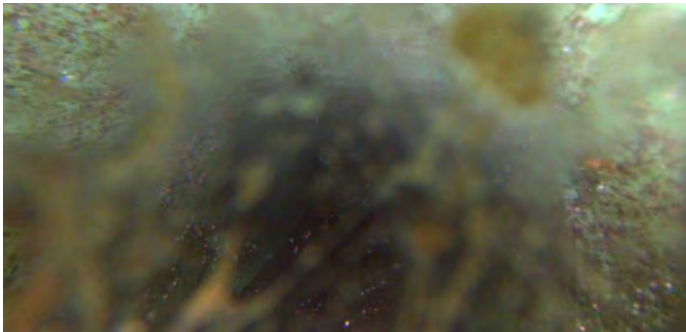
Code: **MSA**
Description: **Abandoned Survey**

Distance (ft): **292.1**
Structural Grade: **0**
O&M Grade: **0**
Clock Start/From:
Clock To:
1st Value:
2nd Value:
Value Percent:
Continuous Index:
Within 8" of Joint: **NO**
Remarks: **DAZ**
