## Profile/Photo Observation Report

Date:	<b>10/05/2018</b>	Weather:		Coding:	<b>PACP 6.0</b>
Pipe Length (ft):	<b>306.9</b>	Owner:	<b>NA</b>	Pre Clean:	<b>Not Known</b>
P.O.#:		Surveyor:	<b>Michael Carlino</b>	PSR:	<b>P-1004-027-028</b>
Customer:		Clean Date:	<b>01/01/1900</b>	Shape:	<b>C</b>

Street:	<b>Cleveland Ave.</b>	Flow Control:	<b>Not Controlled</b>
City:	<b>Hobart, IN</b>	Year Renewed:	
Location:	<b>Light Highway</b>	Tape/Media #:	
Purpose:	<b>Routine Assessment</b>	Dia/Height:	<b>10"</b>
Use:	<b>Sanitary</b>	Material:	<b>PVC</b>
Drain Area:	<b>NA</b>	Lining:	
Category:	<b>NA</b>		
Comment:

Location Details:		Direction of Survey:	<b>Upstream</b>
US MH:	<b>M-1004-027</b>	DS MH:	<b>M-1004-028</b>
		Total Length Surveyed (ft):	<b>4.0</b>

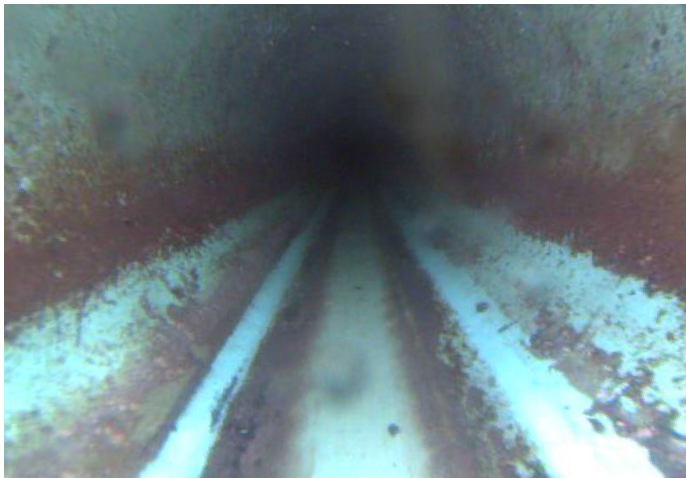
Code:	AMH
Description:	Manhole
Distance (ft):	.0
Structural Grade:	0
O&M Grade:	0
Clock Start/From:	
Clock To:	
1st Value:	
2nd Value:	
Value Percent:	
Continuous Index:	
Within 8" of Joint:	NO
Remarks:	M-1004-028

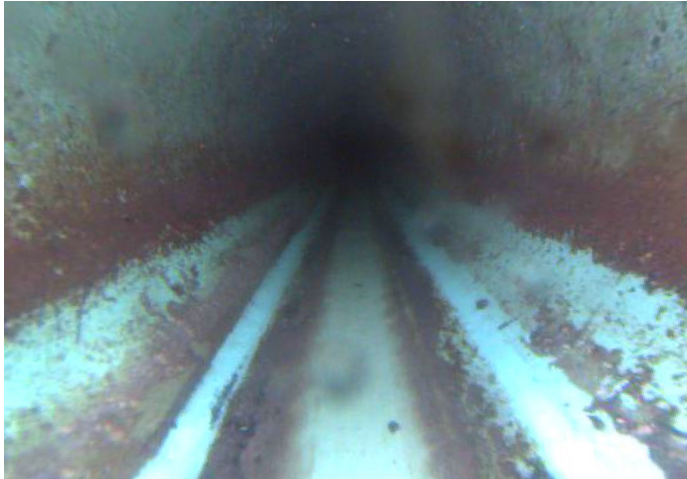
Code: **MWL**  
Description: **Water Level**

Distance (ft): **.0**  
Structural Grade: **0**  
O&M Grade: **0**  
Clock Start/From:  
Clock To:  
1st Value:  
2nd Value:  
Value Percent: **5.000**  
Continuous Index:  
Within 8" of Joint: **NO**  
Remarks:

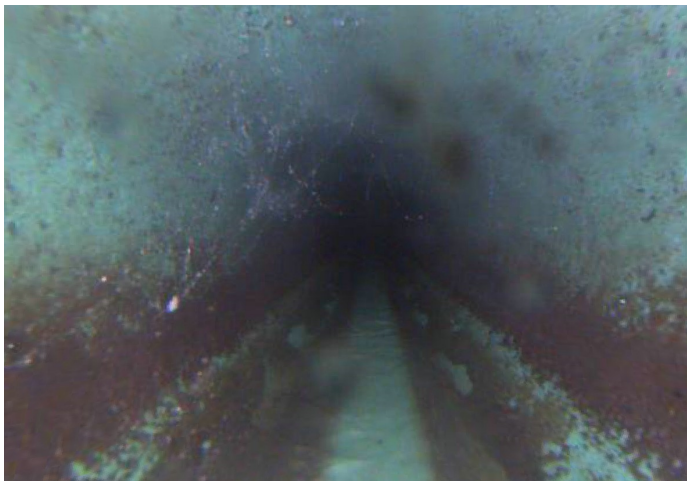
Code: **MSA**  
Description: **Abandoned Survey**

Distance (ft): **4.0**  
Structural Grade: **0**  
O&M Grade: **0**  
Clock Start/From:  
Clock To:  
1st Value:  
2nd Value:  
Value Percent:  
Continuous Index:  
Within 8" of Joint: **NO**  
Remarks: **Unknown**
