Profile/Photo Observation Report

Date:	04/14/2018	Weather:		Coding:	PACP 6.0
Pipe Length (ft):	353.6	Owner:	NA	Pre Clean:	Not Known
P.O.#:		Surveyor:	Jen Costello	PSR:	P-1004-028-029
Customer:		Clean Date:	01/01/1900	Shape:	C

Street:	E CLEVELAND AVE	Flow Control:	Not Controlled
City:	Hobart, IN	Year Renewed:	
Location:	Other	Tape/Media #:	
Purpose:	Not Known	Dia/Height:	8"
Use:	Sanitary	Material:	PVC
Drain Area:	NA	Lining:	
Category:	NA		
Comment:

Location Details:		Direction of Survey:	Downstream
US MH:	M-1004-028	DS MH:	M-1004-029
		Total Length Surveyed (ft):	346.7

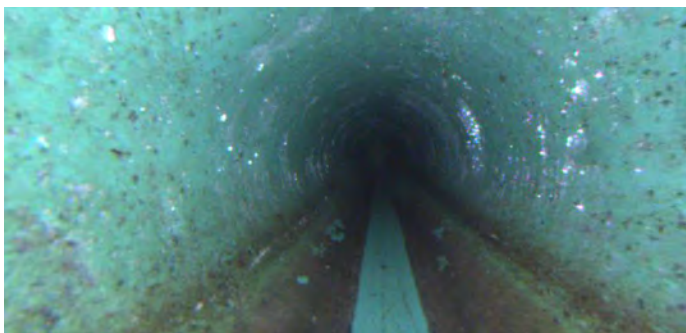
Code: **AMH**
Description: **Manhole**

Distance (ft): **.0**
Structural Grade: **0**
O&M Grade: **0**
Clock Start/From:
Clock To:
1st Value:
2nd Value:
Value Percent:
Continuous Index:
Within 8" of Joint: **NO**
Remarks: **M-1004-028**

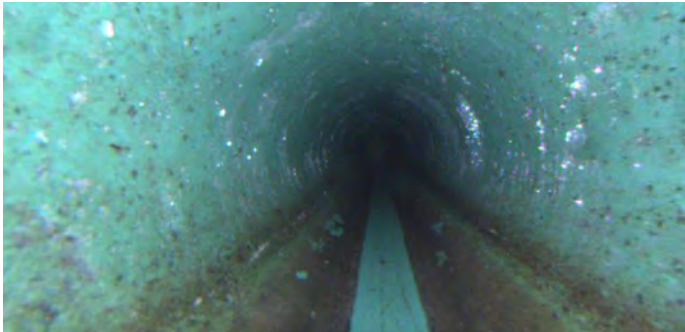
Code:	MWL
Description:	Water Level

Distance (ft):	.0
Structural Grade:	0
O&M Grade:	0
Clock Start/From:	
Clock To:	
1st Value:	
2nd Value:	
Value Percent:	5.000
Continuous Index:	
Within 8" of Joint:	NO
Remarks:

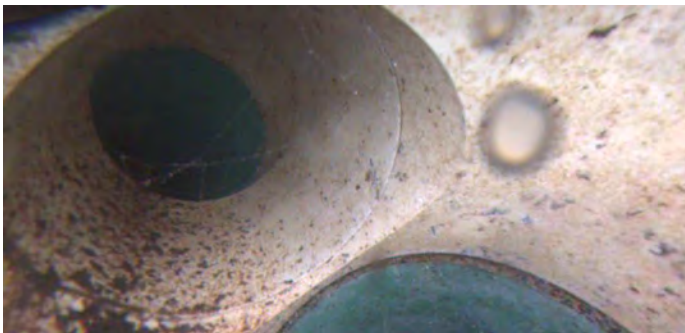
Code:	TF
Description:	Tap Factory

Distance (ft):	11.3
Structural Grade:	0
O&M Grade:	0
Clock Start/From:	11
Clock To:	
1st Value:	4.000
2nd Value:	
Value Percent:	
Continuous Index:	
Within 8" of Joint:	
Remarks:

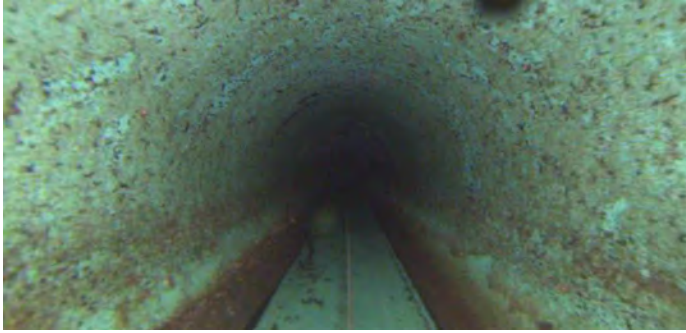
Code: **MGO**
Description: **General Observation**

Distance (ft): **53.1**
Structural Grade: **0**
O&M Grade: **0**
Clock Start/From:
Clock To:
1st Value:
2nd Value:
Value Percent:
Continuous Index:
Within 8" of Joint: **NO**
Remarks: **rear camera**

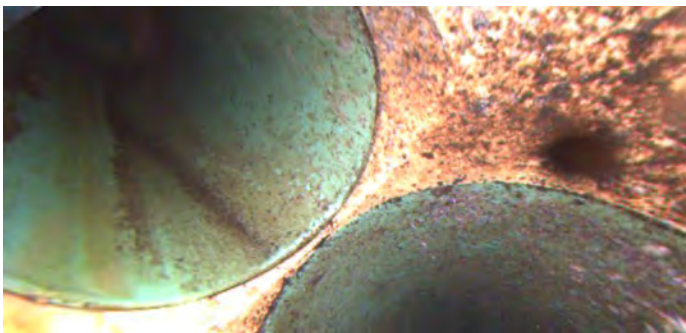
Code: **TF**
Description: **Tap Factory**

Distance (ft): **57.1**
Structural Grade: **0**
O&M Grade: **0**
Clock Start/From: **2**
Clock To:
1st Value: **4.000**
2nd Value:
Value Percent:
Continuous Index:
Within 8" of Joint:
Remarks:

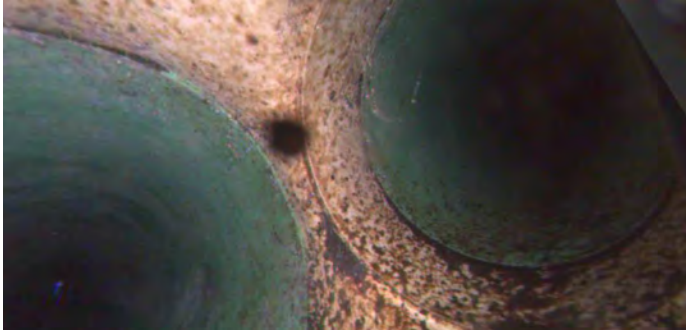
Code: **TF**
Description: **Tap Factory**

Distance (ft): **107.8**
Structural Grade: **0**
O&M Grade: **0**
Clock Start/From: **11**
Clock To:
1st Value: **4.000**
2nd Value:
Value Percent:
Continuous Index:
Within 8" of Joint:
Remarks:

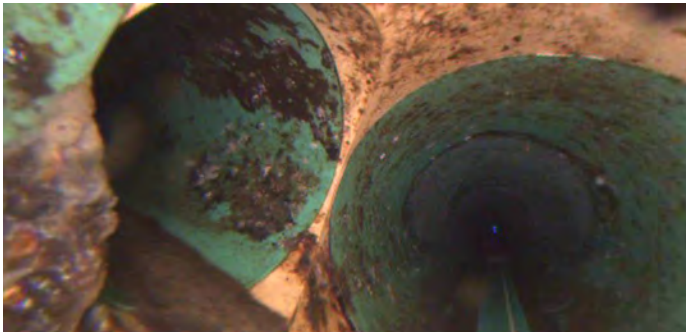
Code: **TFA**
Description: **Tap Factory Active**

Distance (ft): **145.8**
Structural Grade: **0**
O&M Grade: **0**
Clock Start/From: **3**
Clock To:
1st Value: **4.000**
2nd Value:
Value Percent:
Continuous Index:
Within 8" of Joint:
Remarks:

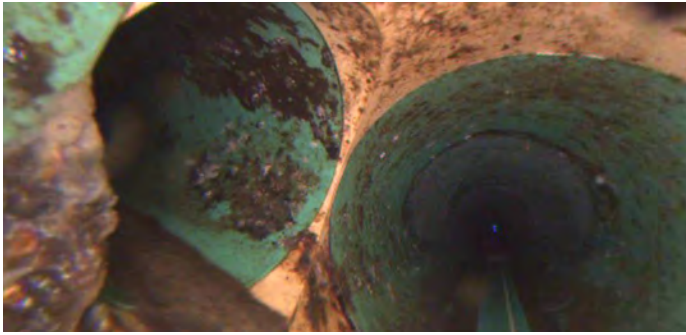
Code: **DAGS**
Description: **Deposits Attached Grease**

Distance (ft): **145.8**
Structural Grade: **0**
O&M Grade: **2**
Clock Start/From: **3**
Clock To: **4**
1st Value:
2nd Value:
Value Percent: **5.000**
Continuous Index:
Within 8" of Joint: **NO**
Remarks:

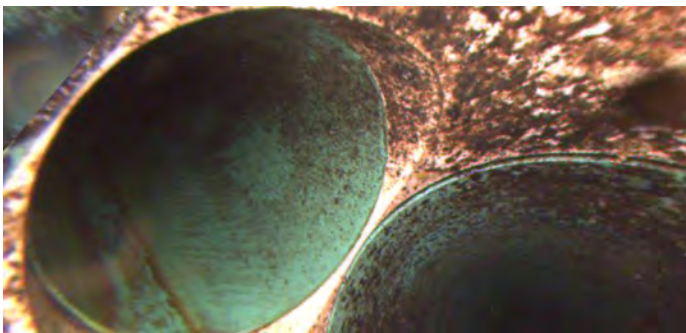
Code: **TF**
Description: **Tap Factory**

Distance (ft): **161.1**
Structural Grade: **0**
O&M Grade: **0**
Clock Start/From: **2**
Clock To:
1st Value: **4.000**
2nd Value:
Value Percent:
Continuous Index:
Within 8" of Joint:
Remarks:

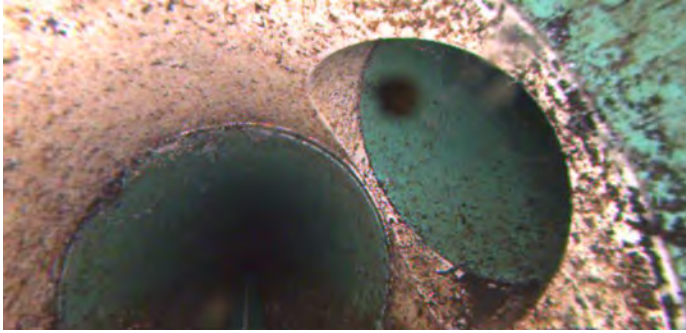
Code: **TF**
Description: **Tap Factory**

Distance (ft): **173.9**
Structural Grade: **0**
O&M Grade: **0**
Clock Start/From: **10**
Clock To:
1st Value: **4.000**
2nd Value:
Value Percent:
Continuous Index:
Within 8" of Joint:
Remarks:

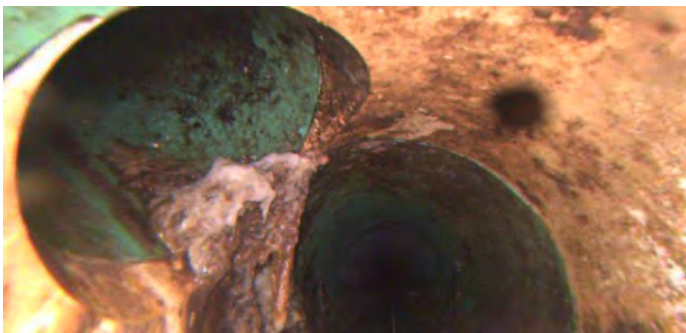
Code: **TFD**
Description: **Tap Factory Defective**

Distance (ft): **232.8**
Structural Grade: **0**
O&M Grade: **2**
Clock Start/From: **2**
Clock To:
1st Value: **4.000**
2nd Value:
Value Percent:
Continuous Index:
Within 8" of Joint:
Remarks: **dags**

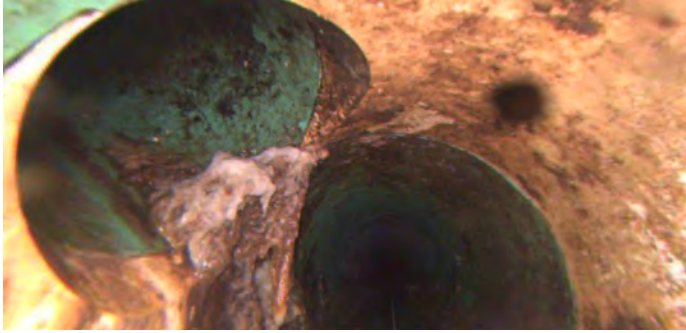
Code:	DAGS
Description:	Deposits Attached Grease
Distance (ft):	232.8
Structural Grade:	0
O&M Grade:	2
Clock Start/From:	1
Clock To:	3
1st Value:	
2nd Value:	
Value Percent:	5.000
Continuous Index:	
Within 8" of Joint:	NO
Remarks:

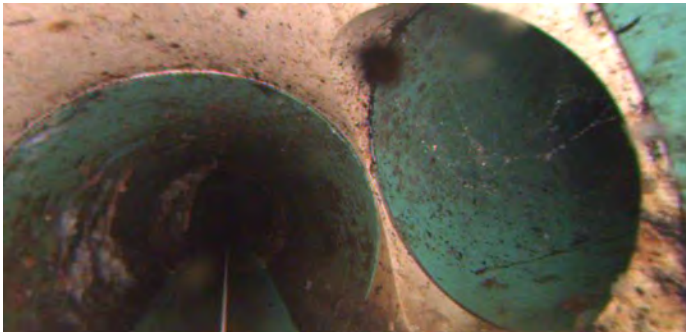
Code:	TF
Description:	Tap Factory
Distance (ft):	234.4
Structural Grade:	0
O&M Grade:	0
Clock Start/From:	9
Clock To:	
1st Value:	4.000
2nd Value:	
Value Percent:	
Continuous Index:	
Within 8" of Joint:	
Remarks:

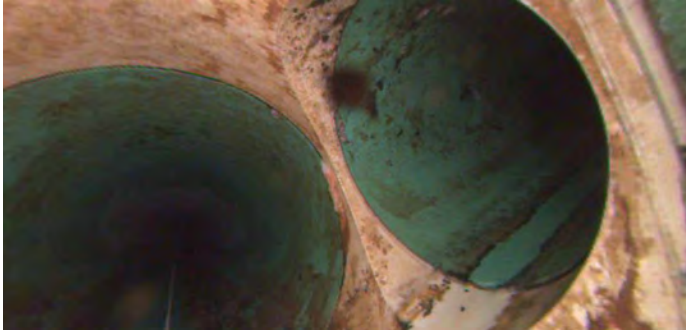
Code: **TFA**
Description: **Tap Factory Active**

Distance (ft): **293.4**
Structural Grade: **0**
O&M Grade: **0**
Clock Start/From: **9**
Clock To:
1st Value: **4.000**
2nd Value:
Value Percent:
Continuous Index:
Within 8" of Joint:
Remarks:

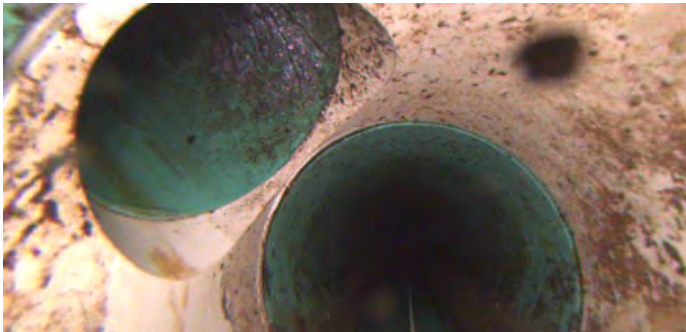
Code: **TF**
Description: **Tap Factory**

Distance (ft): **309.4**
Structural Grade: **0**
O&M Grade: **0**
Clock Start/From: **2**
Clock To:
1st Value: **4.000**
2nd Value:
Value Percent:
Continuous Index:
Within 8" of Joint:
Remarks:
