Profile/Photo Observation Report

Street:	E Cleveland Ave.	Flow Control:	Not Controlled
City:	Hobart, IN	Year Renewed:	
Location:	Other	Tape/Media #:	
Purpose:	Not Known	Dia/Height:	8"
Use:	Sanitary	Material:	PVC
Drain Area:	NA	Lining:	
Category:	NA		
Comment:

Location Details:		Direction of Survey:	Downstream
US MH:	M-1004-028	DS MH:	M-1004-029
		Total Length Surveyed (ft):	346.7

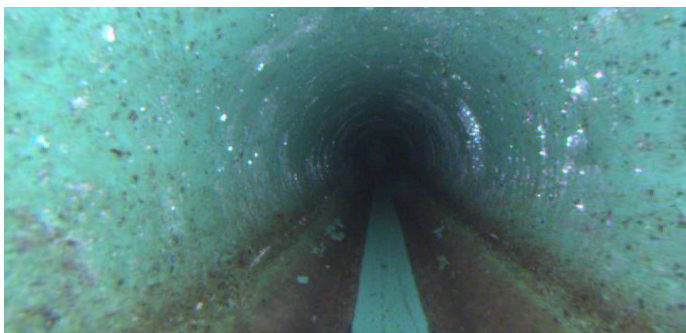
Code: **AMH**
Description: **Manhole**

Distance (ft): **.0**
Structural Grade: **0**
O&M Grade: **0**
Clock Start/From:
Clock To:
1st Value:
2nd Value:
Value Percent:
Continuous Index:
Within 8" of Joint: **NO**
Remarks: **M-1004-028**

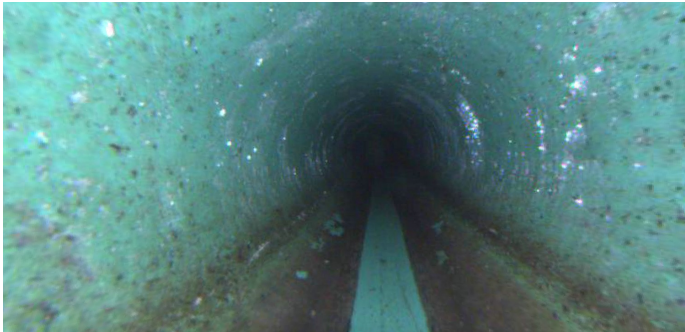
Code:	MWL
Description:	Water Level

Distance (ft):	.0
Structural Grade:	0
O&M Grade:	0
Clock Start/From:	
Clock To:	
1st Value:	
2nd Value:	
Value Percent:	5.000
Continuous Index:	
Within 8" of Joint:	NO
Remarks:

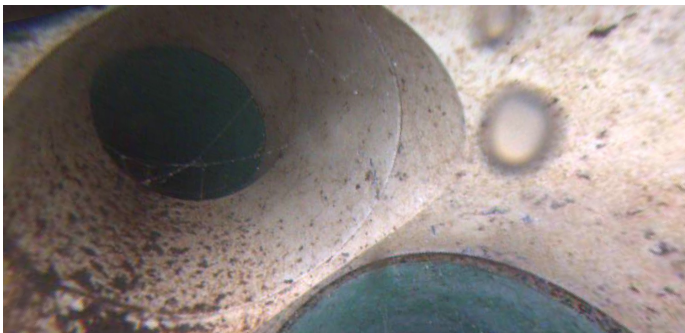
Code:	TF
Description:	Tap Factory

Distance (ft):	11.3
Structural Grade:	0
O&M Grade:	0
Clock Start/From:	11
Clock To:	
1st Value:	4.000
2nd Value:	
Value Percent:	
Continuous Index:	
Within 8" of Joint:	
Remarks:

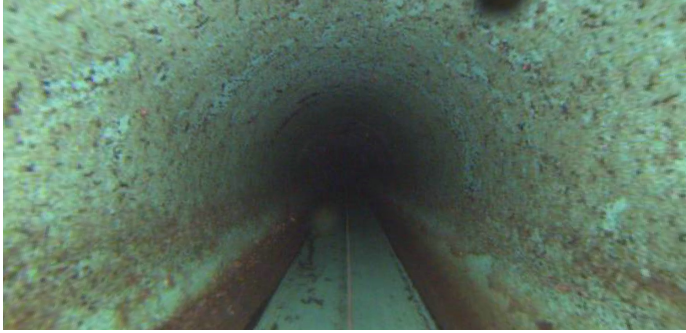
Code: **MGO**
Description: **General Observation**

Distance (ft): **53.1**
Structural Grade: **0**
O&M Grade: **0**
Clock Start/From:
Clock To:
1st Value:
2nd Value:
Value Percent:
Continuous Index:
Within 8" of Joint: **NO**
Remarks: **rear camera**

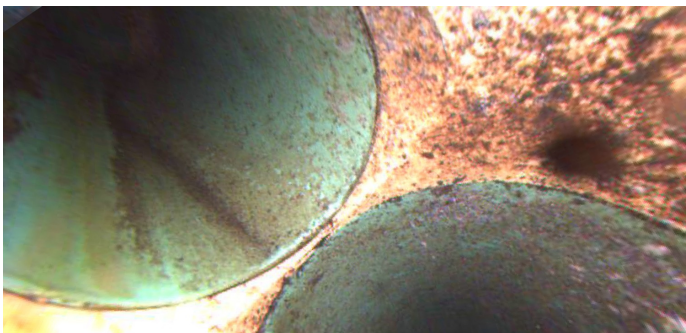
Code: **TF**
Description: **Tap Factory**

Distance (ft): **57.1**
Structural Grade: **0**
O&M Grade: **0**
Clock Start/From: **2**
Clock To:
1st Value: **4.000**
2nd Value:
Value Percent:
Continuous Index:
Within 8" of Joint:
Remarks:

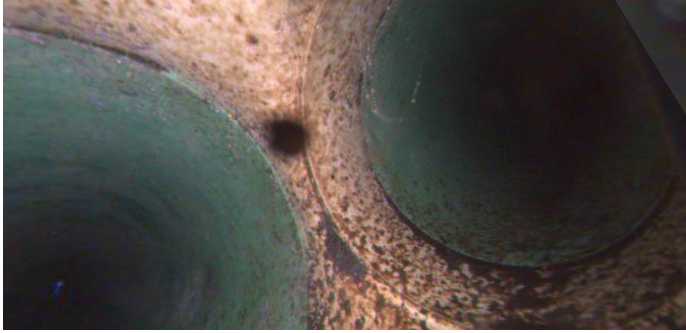
Code: **TF**
Description: **Tap Factory**

Distance (ft): **107.8**
Structural Grade: **0**
O&M Grade: **0**
Clock Start/From: **11**
Clock To:
1st Value: **4.000**
2nd Value:
Value Percent:
Continuous Index:
Within 8" of Joint:
Remarks:

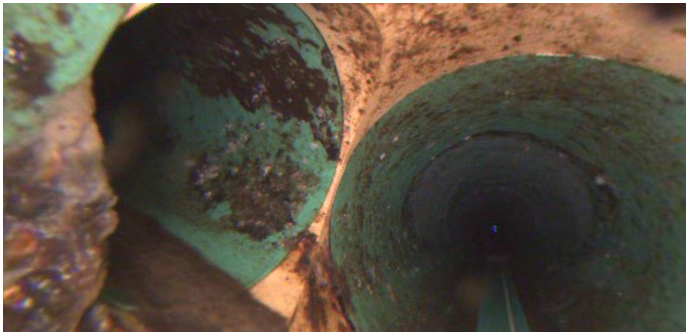
Code: **TFA**
Description: **Tap Factory Active**

Distance (ft): **145.8**
Structural Grade: **0**
O&M Grade: **0**
Clock Start/From: **3**
Clock To:
1st Value: **4.000**
2nd Value:
Value Percent:
Continuous Index:
Within 8" of Joint:
Remarks:

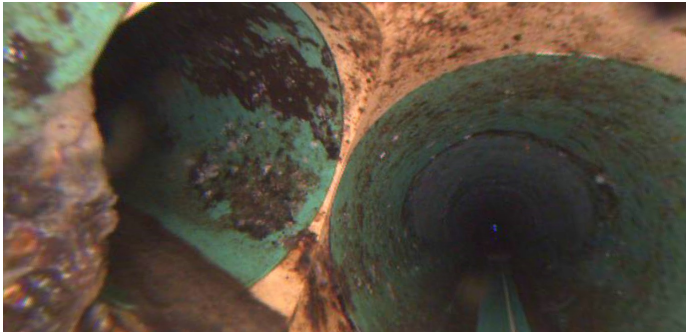
Code: **DAGS**
Description: **Deposits Attached Grease**

Distance (ft): **145.8**
Structural Grade: **0**
O&M Grade: **2**
Clock Start/From: **3**
Clock To: **4**
1st Value:
2nd Value:
Value Percent: **5.000**
Continuous Index:
Within 8" of Joint: **NO**
Remarks:

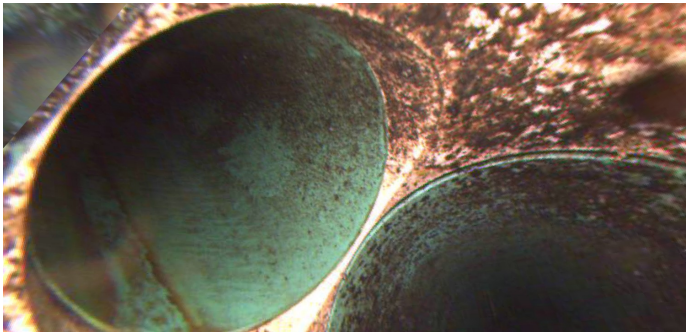
Code: **TF**
Description: **Tap Factory**

Distance (ft): **161.1**
Structural Grade: **0**
O&M Grade: **0**
Clock Start/From: **2**
Clock To:
1st Value: **4.000**
2nd Value:
Value Percent:
Continuous Index:
Within 8" of Joint:
Remarks:

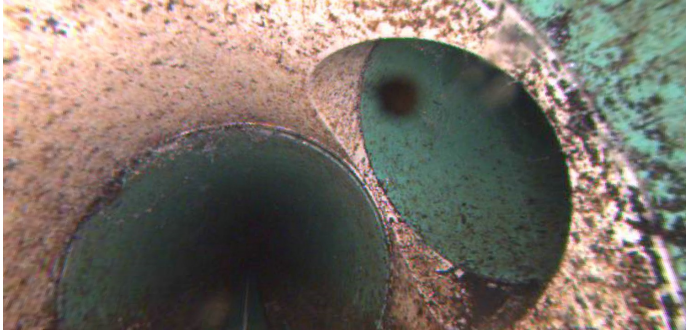
Code: **TF**
Description: **Tap Factory**

Distance (ft): **173.9**
Structural Grade: **0**
O&M Grade: **0**
Clock Start/From: **10**
Clock To:
1st Value: **4.000**
2nd Value:
Value Percent:
Continuous Index:
Within 8" of Joint:
Remarks:

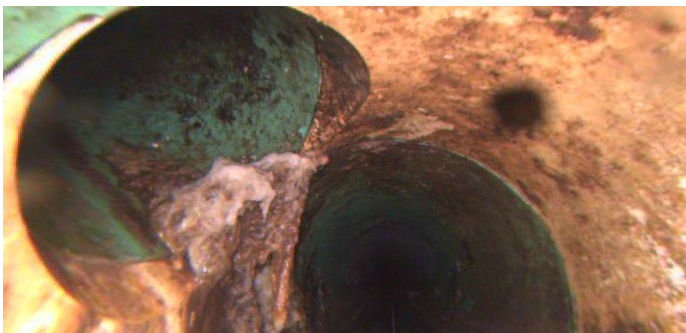
Code: **TFD**
Description: **Tap Factory Defective**

Distance (ft): **232.8**
Structural Grade: **0**
O&M Grade: **2**
Clock Start/From: **2**
Clock To:
1st Value: **4.000**
2nd Value:
Value Percent:
Continuous Index:
Within 8" of Joint:
Remarks: **dags**

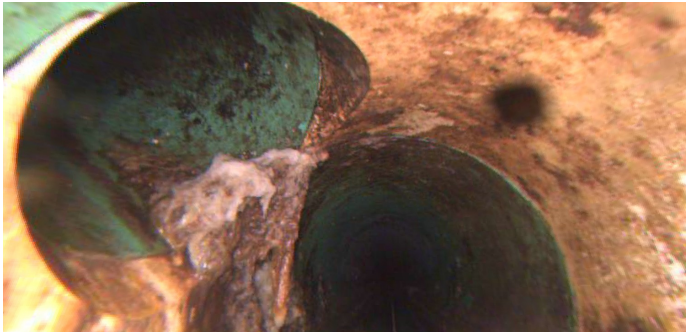
Code: **DAGS**
Description: **Deposits Attached Grease**

Distance (ft): **232.8**
Structural Grade: **0**
O&M Grade: **2**
Clock Start/From: **1**
Clock To: **3**
1st Value:
2nd Value:
Value Percent: **5.000**
Continuous Index:
Within 8" of Joint: **NO**
Remarks:

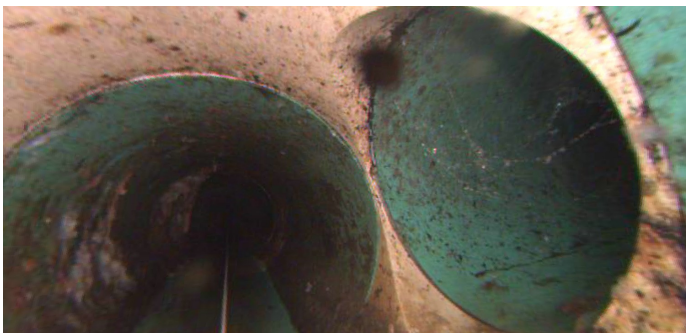
Code: **TF**
Description: **Tap Factory**

Distance (ft): **234.4**
Structural Grade: **0**
O&M Grade: **0**
Clock Start/From: **9**
Clock To:
1st Value: **4.000**
2nd Value:
Value Percent:
Continuous Index:
Within 8" of Joint:
Remarks:

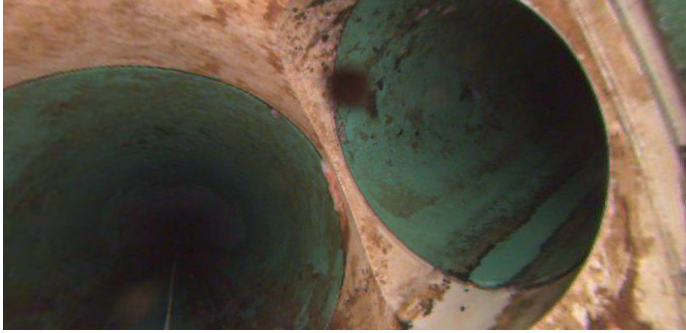
Code: **TFA**
Description: **Tap Factory Active**

Distance (ft): **293.4**
Structural Grade: **0**
O&M Grade: **0**
Clock Start/From: **9**
Clock To:
1st Value: **4.000**
2nd Value:
Value Percent:
Continuous Index:
Within 8" of Joint:
Remarks:

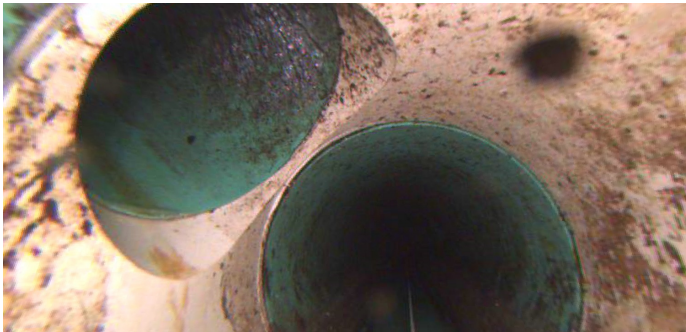
Code: **TF**
Description: **Tap Factory**

Distance (ft): **309.4**
Structural Grade: **0**
O&M Grade: **0**
Clock Start/From: **2**
Clock To:
1st Value: **4.000**
2nd Value:
Value Percent:
Continuous Index:
Within 8" of Joint:
Remarks:

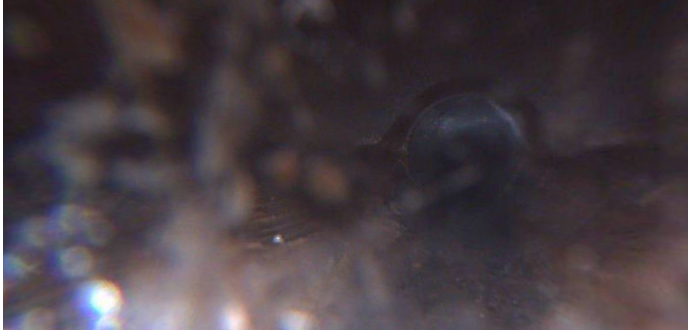
Code:	AMH
Description:	Manhole
Distance (ft):	346.7
Structural Grade:	0
O&M Grade:	0
Clock Start/From:	
Clock To:	
1st Value:	
2nd Value:	
Value Percent:	
Continuous Index:	
Within 8" of Joint:	NO
Remarks:	M-1004-029
