## Profile/Photo Observation Report

Street:	<b>Hillcrest Ave.</b>	Flow Control:	<b>Not Controlled</b>
City:	<b>Hobart, IN</b>	Year Renewed:	
Location:	<b>Other</b>	Tape/Media #:	
Purpose:	<b>Not Known</b>	Dia/Height:	<b>10"</b>
Use:	<b>Sanitary</b>	Material:	<b>PVC</b>
Drain Area:	<b>NA</b>	Lining:	
Category:	<b>NA</b>		
Comment:

Location Details:		Direction of Survey:	<b>Upstream</b>
US MH:	<b>M-1004-031</b>	DS MH:	<b>M-1004-034</b>
		Total Length Surveyed (ft):	<b>360.8</b>

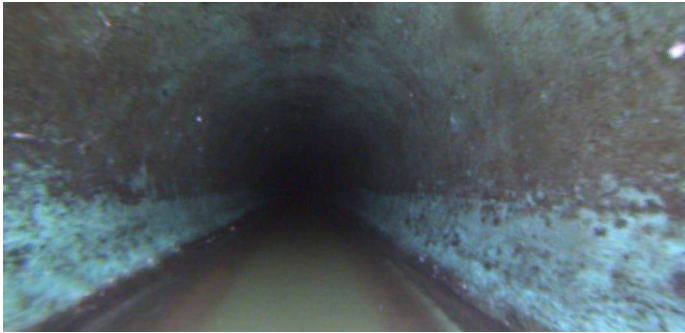
Code:	<b>MWL</b>
Description:	<b>Water Level</b>

Distance (ft):	<b>.0</b>
Structural Grade:	<b>0</b>
O&M Grade:	<b>0</b>
Clock Start/From:	
Clock To:	
1st Value:	
2nd Value:	
Value Percent:	<b>10.000</b>
Continuous Index:	
Within 8" of Joint:	<b>NO</b>
Remarks:

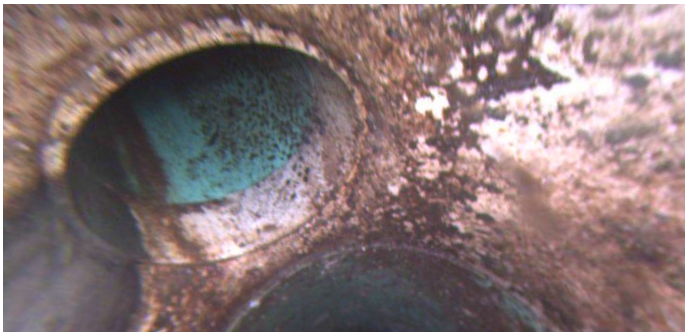
Code:	<b>TF</b>
Description:	<b>Tap Factory</b>

Distance (ft):	<b>103.7</b>
Structural Grade:	<b>0</b>
O&M Grade:	<b>0</b>
Clock Start/From:	<b>11</b>
Clock To:	
1st Value:	<b>4.000</b>
2nd Value:	
Value Percent:	
Continuous Index:	
Within 8" of Joint:	
Remarks:

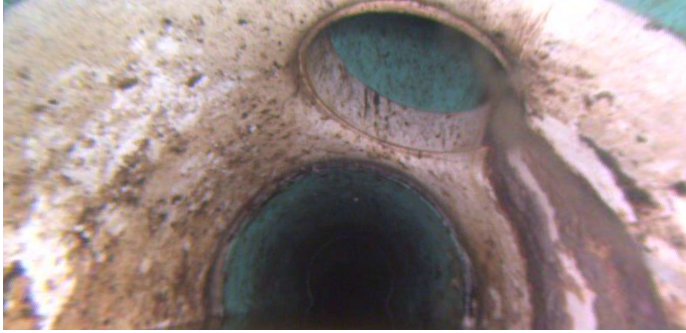
Code: **TF**  
Description: **Tap Factory**

Distance (ft): **107.1**  
Structural Grade: **0**  
O&M Grade: **0**  
Clock Start/From: **1**  
Clock To:  
1st Value: **4.000**  
2nd Value:  
Value Percent:  
Continuous Index:  
Within 8" of Joint:  
Remarks:

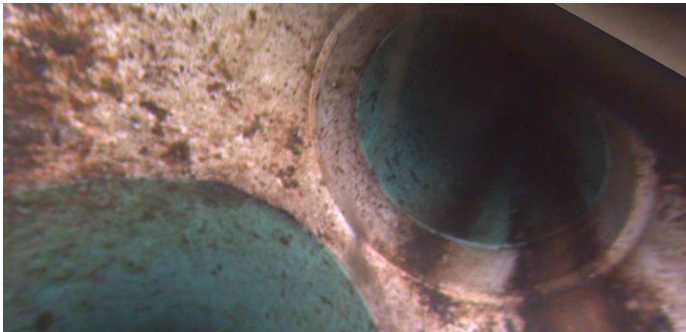
Code: **TF**  
Description: **Tap Factory**

Distance (ft): **129.7**  
Structural Grade: **0**  
O&M Grade: **0**  
Clock Start/From: **2**  
Clock To:  
1st Value: **4.000**  
2nd Value:  
Value Percent:  
Continuous Index:  
Within 8" of Joint:  
Remarks:

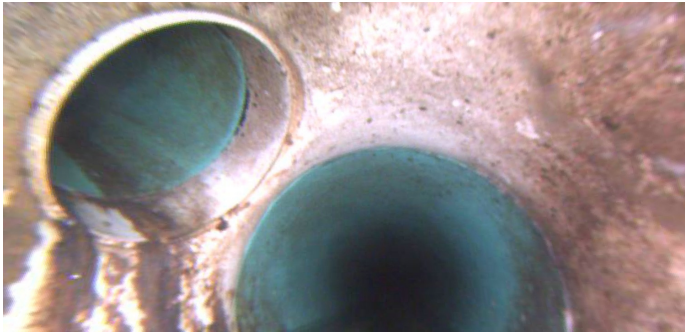
Code: **TF**  
Description: **Tap Factory**

Distance (ft): **175.1**  
Structural Grade: **0**  
O&M Grade: **0**  
Clock Start/From: **10**  
Clock To:  
1st Value: **4.000**  
2nd Value:  
Value Percent:  
Continuous Index:  
Within 8" of Joint:  
Remarks:

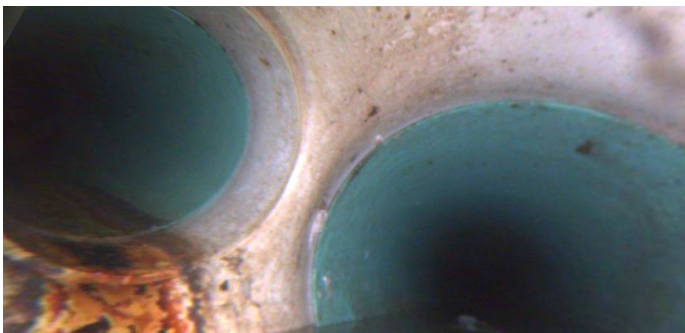
Code: **TFA**  
Description: **Tap Factory Active**

Distance (ft): **258.0**  
Structural Grade: **0**  
O&M Grade: **0**  
Clock Start/From: **9**  
Clock To:  
1st Value: **4.000**  
2nd Value:  
Value Percent:  
Continuous Index:  
Within 8" of Joint:  
Remarks:

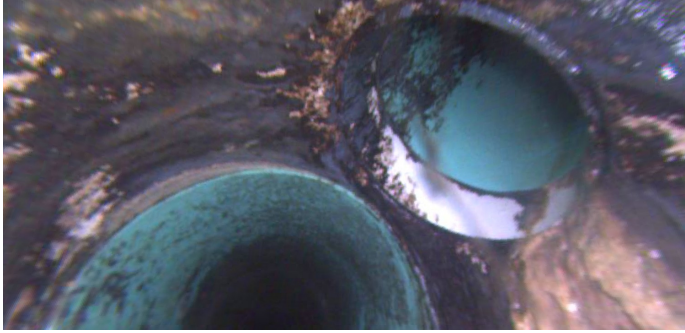
Code: **TF**  
Description: **Tap Factory**

Distance (ft): **279.6**  
Structural Grade: **0**  
O&M Grade: **0**  
Clock Start/From: **1**  
Clock To:  
1st Value: **4.000**  
2nd Value:  
Value Percent:  
Continuous Index:  
Within 8" of Joint:  
Remarks:

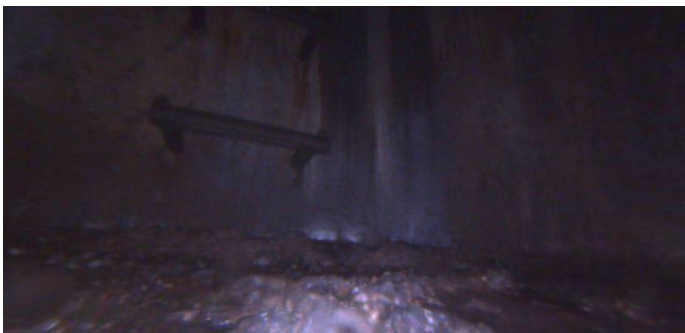
Code: **AMH**  
Description: **Manhole**

Distance (ft): **360.8**  
Structural Grade: **0**  
O&M Grade: **0**  
Clock Start/From:  
Clock To:  
1st Value:  
2nd Value:  
Value Percent:  
Continuous Index:  
Within 8" of Joint: **NO**  
Remarks: **M-1004-031**
