## **Profile/Photo Observation Report**

Profile/Photo Observation Report							
Date: Pipe Length (ft): P.O.#: Customer:	05/04/2018 381.4 2004 Red Zone	Weather: Owner: Surveyor: Clean Date:	City of Ho	obart	Coding: Pre Clean: PSR: Shape:	PACP 4.2 No Pre-Cleaning P-1004-035-036 C	
Street:	166 Hillcrest Ave		Flow Contr	ol:	Not Controlled		
City:	Hobart In		Year Renev	wed:			
Location:	Easement/Right o	f Way	Tape/Medi	ia #:	Deliverable 1		
Purpose:	Routine Assessme	ent	Dia/Height	:	15"		
Use:	Sanitary		Material:		PVC		
Drain Area:	Northeast		Lining:				
Category:	NA						
Comment:	449-1						
Location Details:	Edge of field		Direction o	of Survey:	Downstream		
US MH: N	1-1004-035	DS MH:	M-1004-036		Total Length Surveyed (ft)	: <b>381.4</b>	
O&M Index:	2.00	O&M Quick:		2100	O&M Rating:	2.00	
Structural Index:	0.00	Structural Q	uick:	0000	Structural Rating:	0.00	
Overall Index:	2.00	Overall Quic	k:	2100	Overall Rating:	2.00

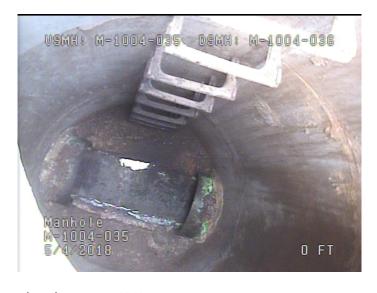
Code:	AMH		
Description:	Manhole		
•			
Distance (ft):	.0		
Structural Grade:	0		
O&M Grade:	0		
Clock Start/From:			
Clock To:			
1st Value:			
2nd Value:			
Value Percent:			
Continuous Index:			
Within 8" of Joint:	NO		
Remarks:	M-1004-035

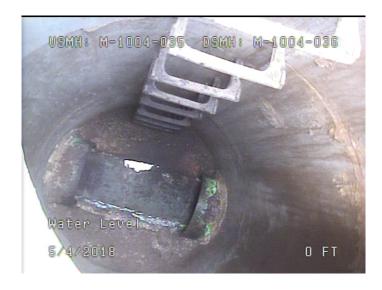
Code: MWL

Description: Water Level

Value Percent: 10.000

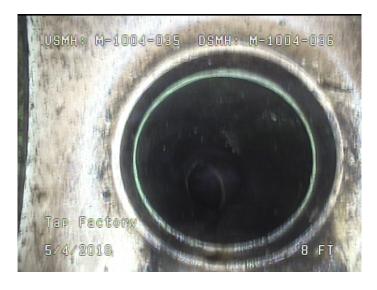
Code: **TF**

Description: Tap Factory

Distance (ft): 8.0
Structural Grade: 0
O&M Grade: 0
Clock Start/From: 11

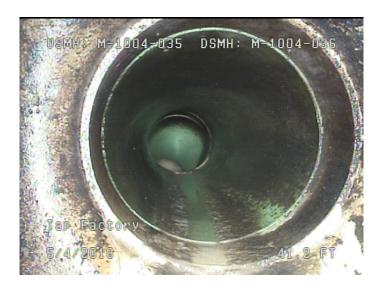
Code: TF
Description: Tap Factory

Distance (ft): 41.2
Structural Grade: 0

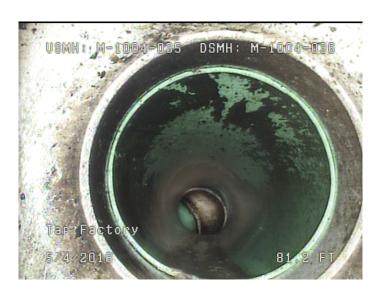
Code: **TF**

Description: Tap Factory

Distance (ft): 81.2
Structural Grade: 0

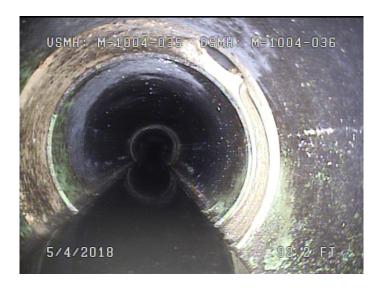
Code: **TF**

Description: Tap Factory

Distance (ft): 92.4
Structural Grade: 0

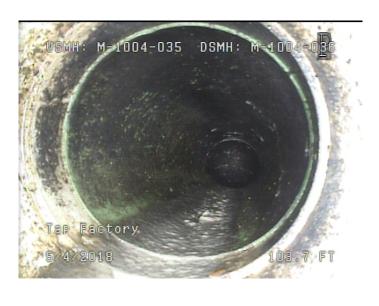
Code: **TF**

Description: Tap Factory

Distance (ft): 103.7
Structural Grade: 0

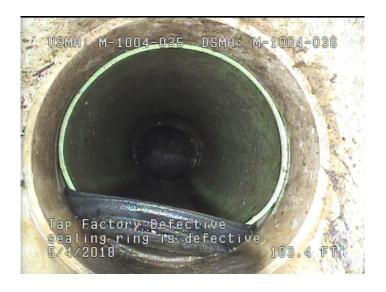
Code: **TFD**

Description: Tap Factory Defective

Distance (ft): 183.4
Structural Grade: 0
O&M Grade: 2
Clock Start/From: 10

Remarks: sealing ring is defective

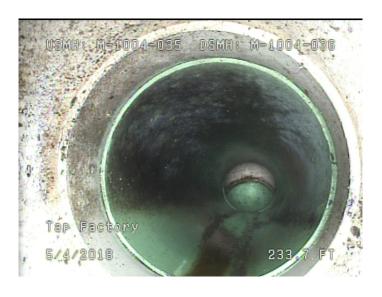
Code: TF

Description: Tap Factory

Distance (ft): 233.7
Structural Grade: 0
O&M Grade: 0
Clock Start/From: 2

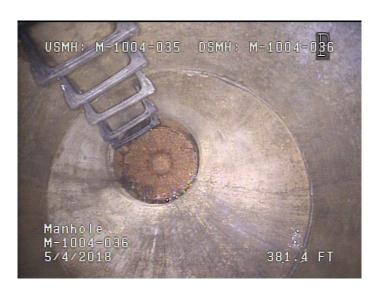
Code: AMH
Description: Manhole

Distance (ft): 381.4
Structural Grade: 0

Remarks: M-1004-036
