## Profile/Photo Observation Report

Date:	<b>04/19/2018</b>	Weather:		Coding:	<b>PACP 4.2</b>
Pipe Length (ft):	<b>370.4</b>	Owner:	<b>City of Hobart</b>	Pre Clean:	<b>No Pre-Cleaning</b>
P.O.#:	<b>2004</b>	Surveyor:	<b>SAN</b>	PSR:	<b>P-1004-016-040</b>
Customer:	<b>Red Zone</b>	Clean Date:		Shape:	<b>C</b>

Street:	<b>2936 Coral Dr</b>	Flow Control:	<b>Not Controlled</b>
City:	<b>Hobart In</b>	Year Renewed:	
Location:	<b>Light Highway</b>	Tape/Media #:	<b>Deliverable 1</b>
Purpose:	<b>Routine Assessment</b>	Dia/Height:	<b>15"</b>
Use:	<b>Sanitary</b>	Material:	<b>PVC</b>
Drain Area:	<b>Northeast</b>	Lining:	
Category:	<b>NA</b>		
Comment:	<b>418-2</b>		
Location Details:	<b>Center of street</b>	Direction of Survey:	<b>Downstream</b>
US MH:	<b>M-1004-016</b>	DS MH:	<b>M-1004-040</b>
		Total Length Surveyed (ft):	<b>370.4</b>

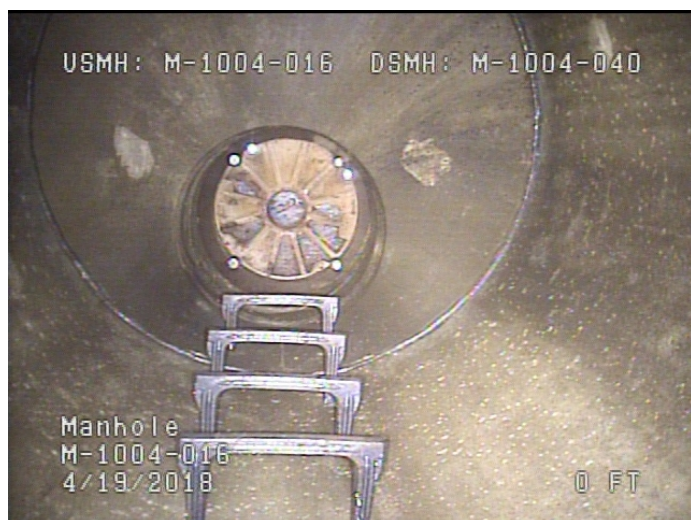
Code:	<b>AMH</b>
Description:	<b>Manhole</b>
Distance (ft):	<b>.0</b>
Structural Grade:	<b>0</b>
O&M Grade:	<b>0</b>
Clock Start/From:	
Clock To:	
1st Value:	
2nd Value:	
Value Percent:	
Continuous Index:	
Within 8" of Joint:	<b>NO</b>
Remarks:	<b>M-1004-016</b>

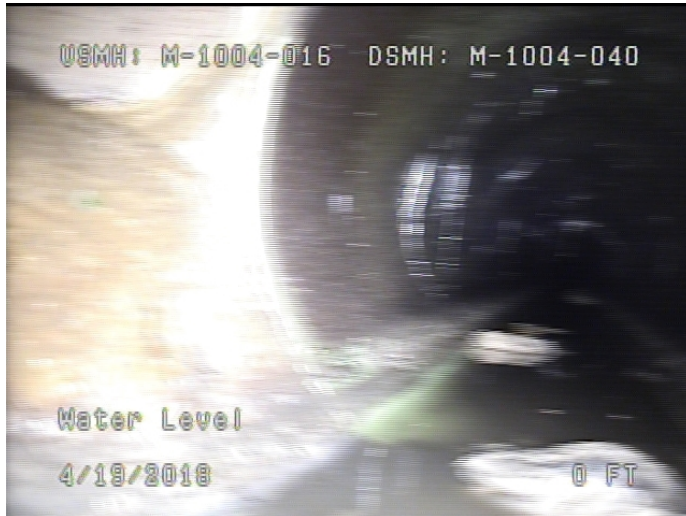
Code:	<b>MWL</b>
Description:	<b>Water Level</b>
Distance (ft):	<b>.0</b>
Structural Grade:	<b>0</b>
O&M Grade:	<b>0</b>
Clock Start/From:	
Clock To:	
1st Value:	
2nd Value:	
Value Percent:	<b>5.000</b>
Continuous Index:	
Within 8" of Joint:	<b>NO</b>
Remarks:

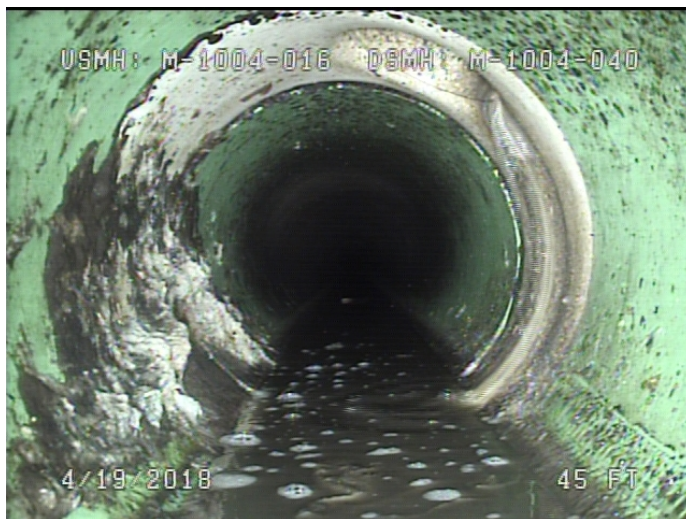
Code:	<b>TFA</b>
Description:	<b>Tap Factory Active</b>
Distance (ft):	<b>45.0</b>
Structural Grade:	<b>0</b>
O&M Grade:	<b>0</b>
Clock Start/From:	<b>1</b>
Clock To:	
1st Value:	<b>4.000</b>
2nd Value:	
Value Percent:	
Continuous Index:	
Within 8" of Joint:	<b>NO</b>
Remarks:

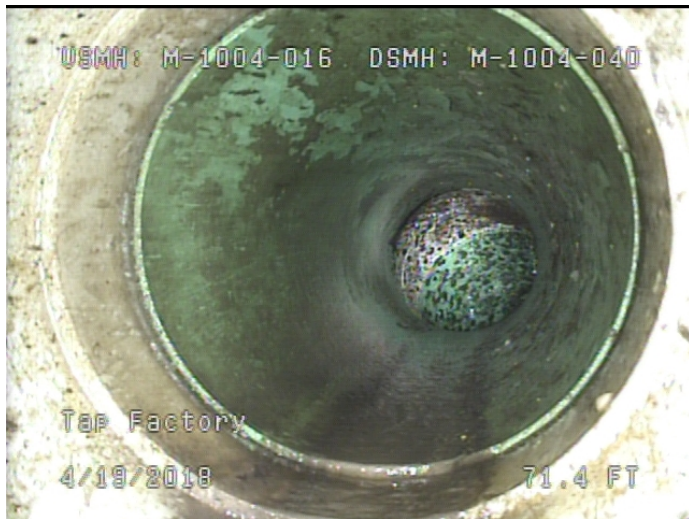
Code:	TF
Description:	Tap Factory
Distance (ft):	71.4
Structural Grade:	0
O&M Grade:	0
Clock Start/From:	1
Clock To:	
1st Value:	4.000
2nd Value:	
Value Percent:	
Continuous Index:	
Within 8" of Joint:	NO
Remarks:

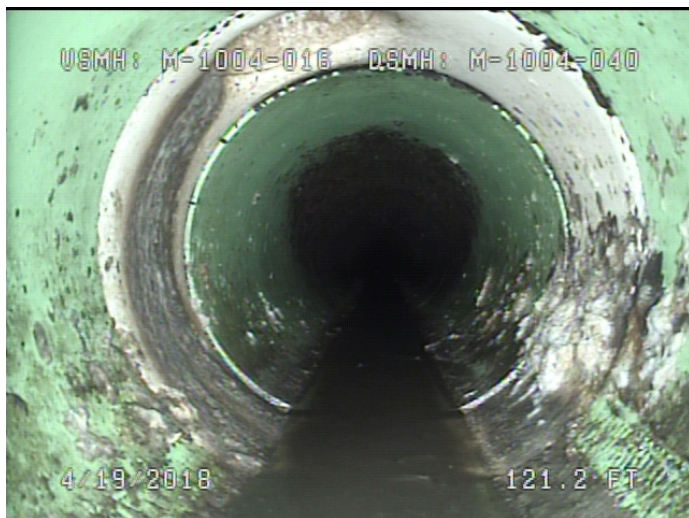
Code:	TF
Description:	Tap Factory
Distance (ft):	121.2
Structural Grade:	0
O&M Grade:	0
Clock Start/From:	11
Clock To:	
1st Value:	4.000
2nd Value:	
Value Percent:	
Continuous Index:	
Within 8" of Joint:	NO
Remarks:

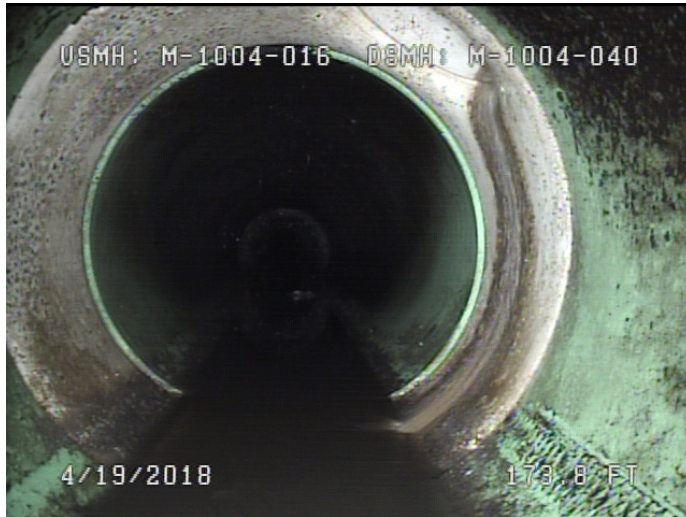
Code: **TF**  
 Description: **Tap Factory**

Distance (ft): **173.8**  
 Structural Grade: **0**  
 O&M Grade: **0**  
 Clock Start/From: **1**  
 Clock To:  
 1st Value: **4.000**  
 2nd Value:  
 Value Percent:  
 Continuous Index:  
 Within 8" of Joint: **NO**  
 Remarks:

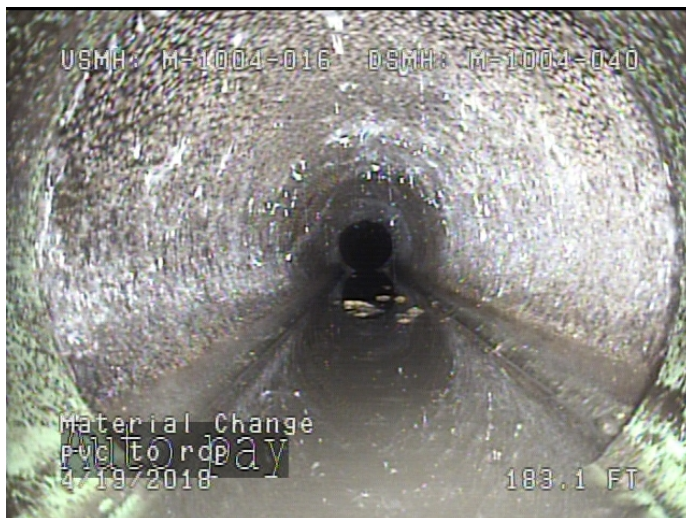
Code: **MMC**  
 Description: **Material Change**

Distance (ft): **183.1**  
 Structural Grade: **0**  
 O&M Grade: **0**  
 Clock Start/From:  
 Clock To:  
 1st Value:  
 2nd Value:  
 Value Percent:  
 Continuous Index:  
 Within 8" of Joint: **NO**  
 Remarks: **pvc to rcp**

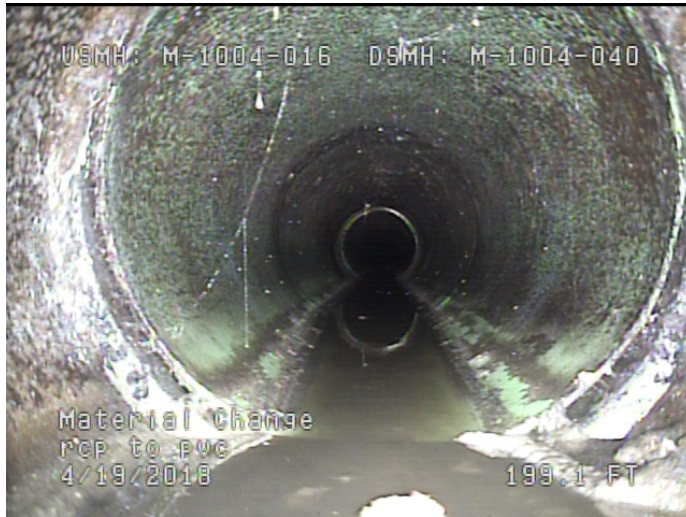
Code:	<b>MMC</b>
Description:	<b>Material Change</b>
Distance (ft):	<b>199.1</b>
Structural Grade:	<b>0</b>
O&M Grade:	<b>0</b>
Clock Start/From:	
Clock To:	
1st Value:	
2nd Value:	
Value Percent:	
Continuous Index:	
Within 8" of Joint:	<b>NO</b>
Remarks:	<b>rcp to pvc</b>

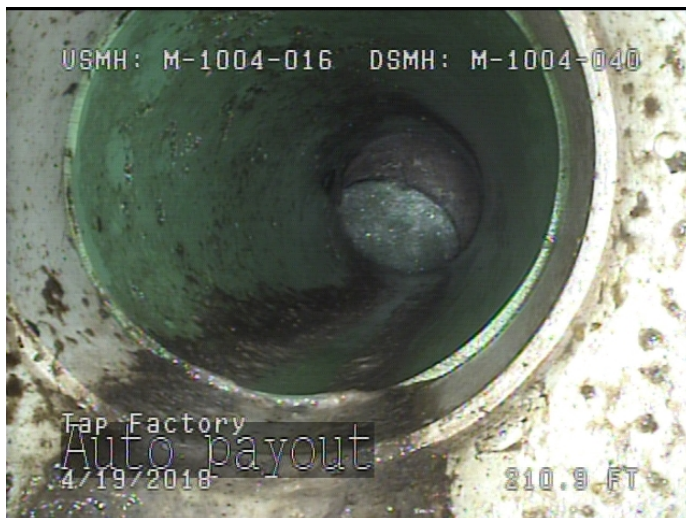
Code:	<b>TF</b>
Description:	<b>Tap Factory</b>
Distance (ft):	<b>210.9</b>
Structural Grade:	<b>0</b>
O&M Grade:	<b>0</b>
Clock Start/From:	<b>1</b>
Clock To:	
1st Value:	<b>4.000</b>
2nd Value:	
Value Percent:	
Continuous Index:	
Within 8" of Joint:	<b>NO</b>
Remarks:

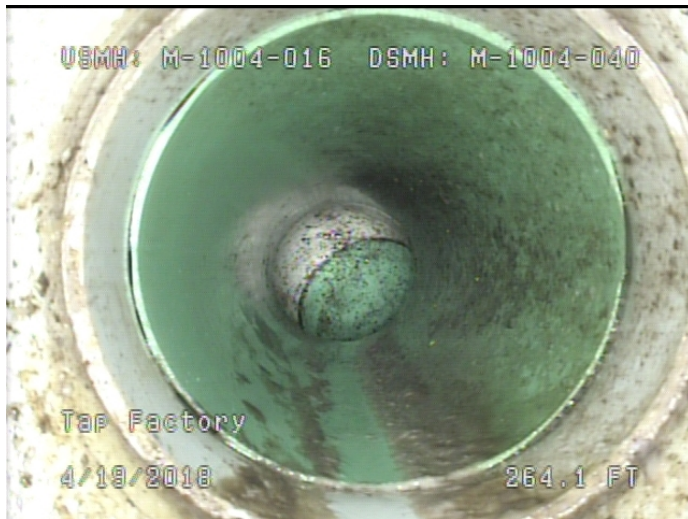
Code: **TF**  
 Description: **Tap Factory**

Distance (ft): **264.1**  
 Structural Grade: **0**  
 O&M Grade: **0**  
 Clock Start/From: **11**  
 Clock To:  
 1st Value: **4.000**  
 2nd Value:  
 Value Percent:  
 Continuous Index:  
 Within 8" of Joint: **NO**  
 Remarks:

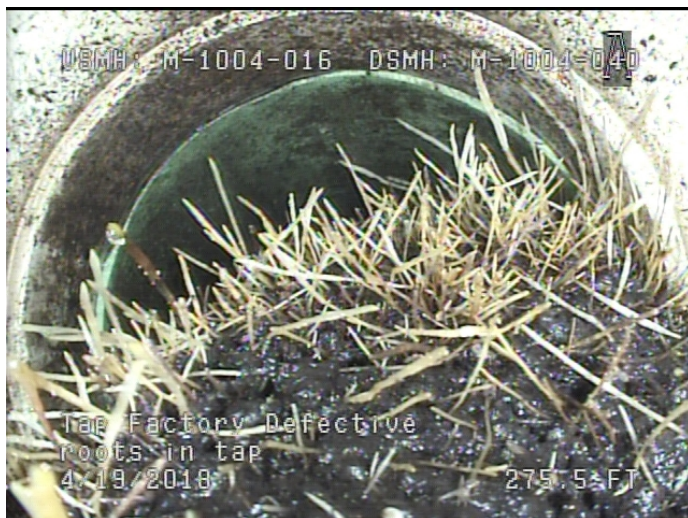
Code: **TFD**  
 Description: **Tap Factory Defective**

Distance (ft): **275.5**  
 Structural Grade: **0**  
 O&M Grade: **2**  
 Clock Start/From: **2**  
 Clock To:  
 1st Value: **4.000**  
 2nd Value:  
 Value Percent:  
 Continuous Index:  
 Within 8" of Joint: **NO**  
 Remarks: **roots in tap**

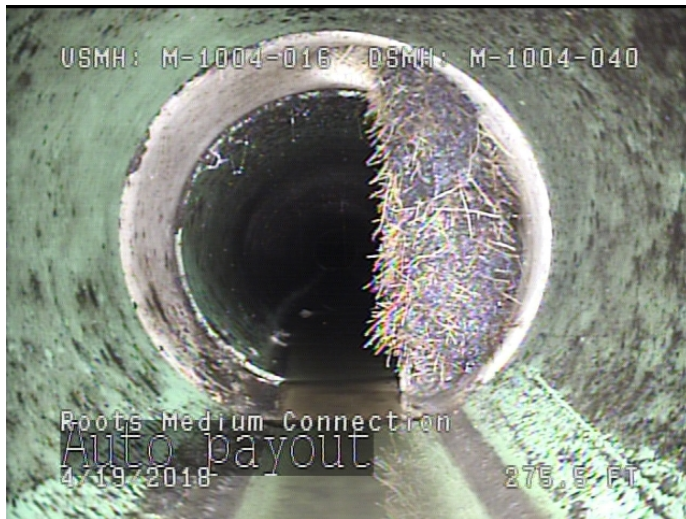
Code:	<b>RMC</b>
Description:	<b>Roots Medium Connection</b>
Distance (ft):	<b>275.5</b>
Structural Grade:	<b>0</b>
O&M Grade:	<b>3</b>
Clock Start/From:	<b>1</b>
Clock To:	<b>5</b>
1st Value:	
2nd Value:	
Value Percent:	<b>20.000</b>
Continuous Index:	
Within 8" of Joint:	<b>NO</b>
Remarks:

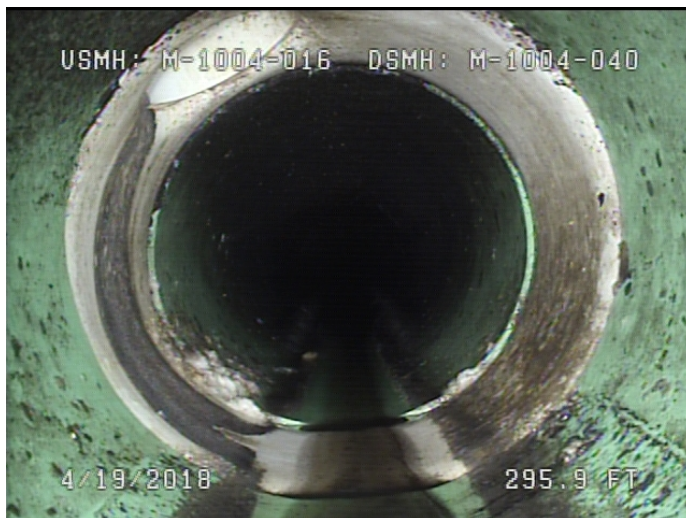
Code:	<b>TF</b>
Description:	<b>Tap Factory</b>
Distance (ft):	<b>295.9</b>
Structural Grade:	<b>0</b>
O&M Grade:	<b>0</b>
Clock Start/From:	<b>11</b>
Clock To:	
1st Value:	<b>4.000</b>
2nd Value:	
Value Percent:	
Continuous Index:	
Within 8" of Joint:	<b>NO</b>
Remarks:

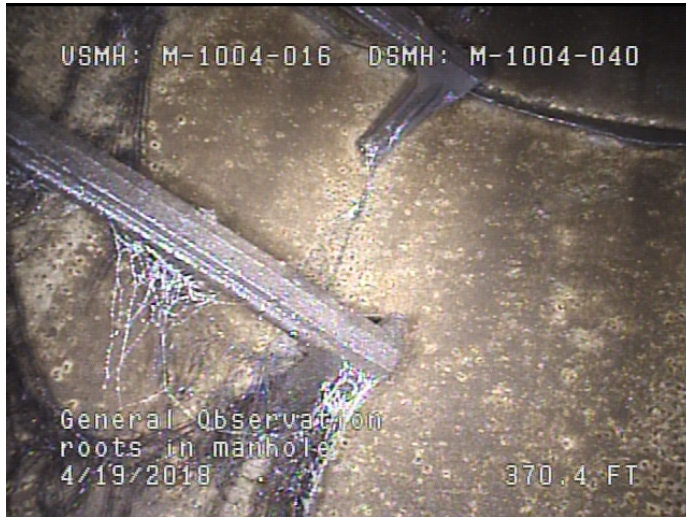
Code:	<b>MGO</b>
Description:	<b>General Observation</b>
Distance (ft):	<b>370.4</b>
Structural Grade:	<b>0</b>
O&M Grade:	<b>0</b>
Clock Start/From:	
Clock To:	
1st Value:	
2nd Value:	
Value Percent:	
Continuous Index:	
Within 8" of Joint:	<b>NO</b>
Remarks:	<b>roots in manhole</b>

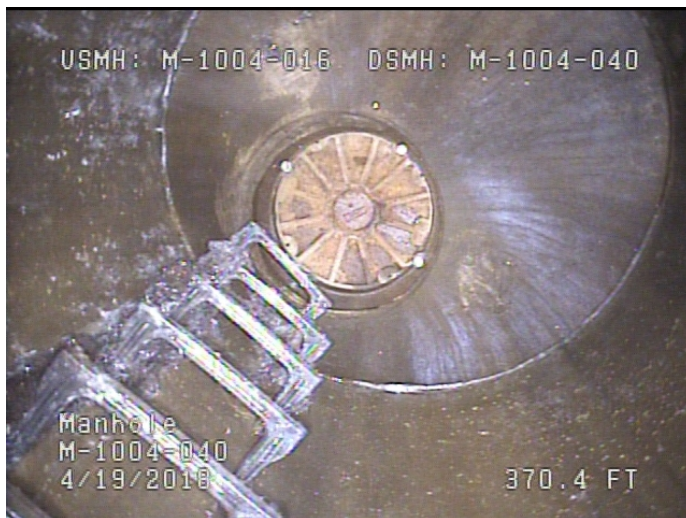
Code:	<b>AMH</b>
Description:	<b>Manhole</b>
Distance (ft):	<b>370.4</b>
Structural Grade:	<b>0</b>
O&M Grade:	<b>0</b>
Clock Start/From:	
Clock To:	
1st Value:	
2nd Value:	
Value Percent:	
Continuous Index:	
Within 8" of Joint:	<b>NO</b>
Remarks:	<b>M-1004-040</b>
