## Profile/Photo Observation Report

Date:	<b>04/12/2018</b>	Weather:		Coding:	<b>PACP 6.0</b>
Pipe Length (ft):	<b>315.3</b>	Owner:	<b>NA</b>	Pre Clean:	<b>Not Known</b>
P.O.#:		Surveyor:	<b>Jen Costello</b>	PSR:	<b>P-1004-051-052</b>
Customer:		Clean Date:	<b>01/01/1900</b>	Shape:	<b>C</b>

Street:	<b>Barberry Dr.</b>	Flow Control:	<b>Not Controlled</b>
City:	<b>Hobart, IN</b>	Year Renewed:	
Location:	<b>Other</b>	Tape/Media #:	
Purpose:	<b>Not Known</b>	Dia/Height:	<b>10"</b>
Use:	<b>Sanitary</b>	Material:	<b>PVC</b>
Drain Area:	<b>NA</b>	Lining:	
Category:	<b>NA</b>		
Comment:

Location Details:		Direction of Survey:	<b>Upstream</b>
US MH:	<b>M-1004-051</b>	DS MH:	<b>M-1004-052</b>
		Total Length Surveyed (ft):	<b>223.6</b>

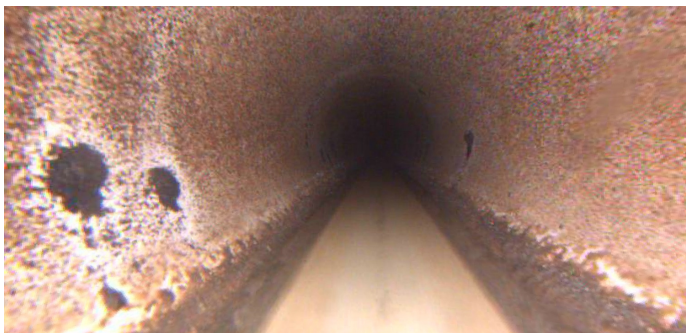
Code: **AMH**  
Description: **Manhole**

Distance (ft): **.0**  
Structural Grade: **0**  
O&M Grade: **0**  
Clock Start/From:  
Clock To:  
1st Value:  
2nd Value:  
Value Percent:  
Continuous Index:  
Within 8" of Joint: **NO**  
Remarks: **M-1004-052**

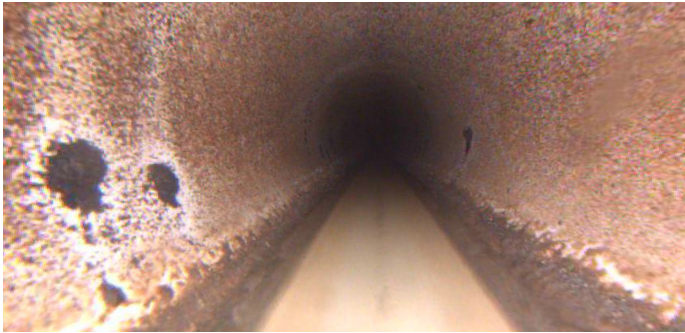
Code:	<b>MWL</b>
Description:	<b>Water Level</b>

Distance (ft):	<b>.0</b>
Structural Grade:	<b>0</b>
O&M Grade:	<b>0</b>
Clock Start/From:	
Clock To:	
1st Value:	
2nd Value:	
Value Percent:	<b>5.000</b>
Continuous Index:	
Within 8" of Joint:	<b>NO</b>
Remarks:

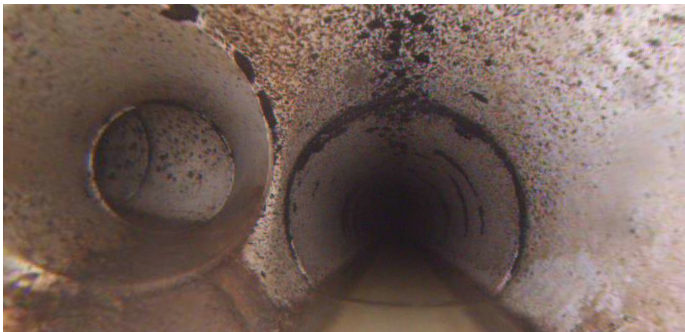
Code:	<b>TFA</b>
Description:	<b>Tap Factory Active</b>

Distance (ft):	<b>33.2</b>
Structural Grade:	<b>0</b>
O&M Grade:	<b>0</b>
Clock Start/From:	<b>9</b>
Clock To:	
1st Value:	<b>4.000</b>
2nd Value:	
Value Percent:	
Continuous Index:	
Within 8" of Joint:	
Remarks:

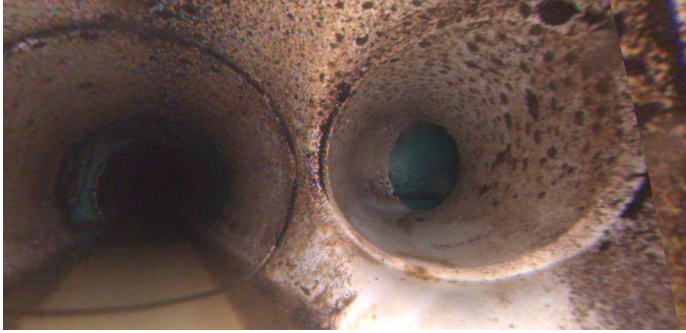
Code: **TF**  
Description: **Tap Factory**

Distance (ft): **103.6**  
Structural Grade: **0**  
O&M Grade: **0**  
Clock Start/From: **3**  
Clock To:  
1st Value: **4.000**  
2nd Value:  
Value Percent:  
Continuous Index:  
Within 8" of Joint:  
Remarks:

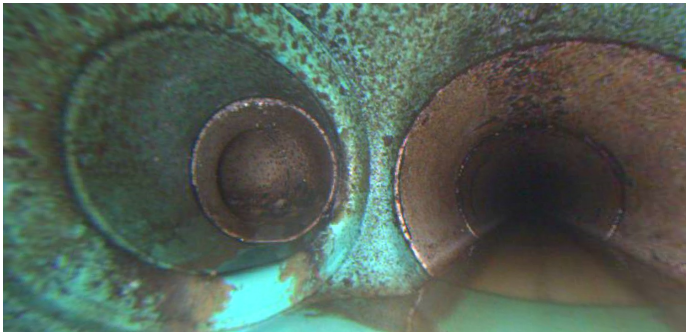
Code: **TF**  
Description: **Tap Factory**

Distance (ft): **105.7**  
Structural Grade: **0**  
O&M Grade: **0**  
Clock Start/From: **9**  
Clock To:  
1st Value: **4.000**  
2nd Value:  
Value Percent:  
Continuous Index:  
Within 8" of Joint:  
Remarks:

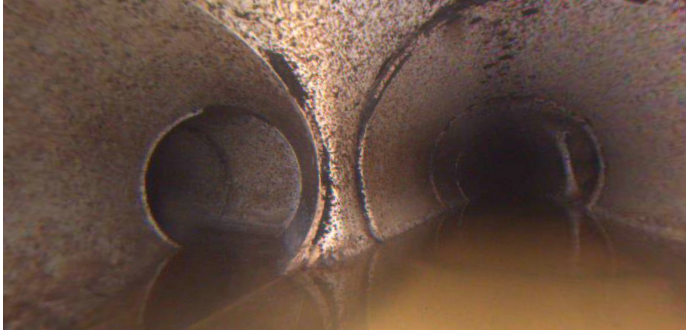
Code: **TFA**  
Description: **Tap Factory Active**

Distance (ft): **202.1**  
Structural Grade: **0**  
O&M Grade: **0**  
Clock Start/From: **9**  
Clock To:  
1st Value: **4.000**  
2nd Value:  
Value Percent:  
Continuous Index:  
Within 8" of Joint:  
Remarks:

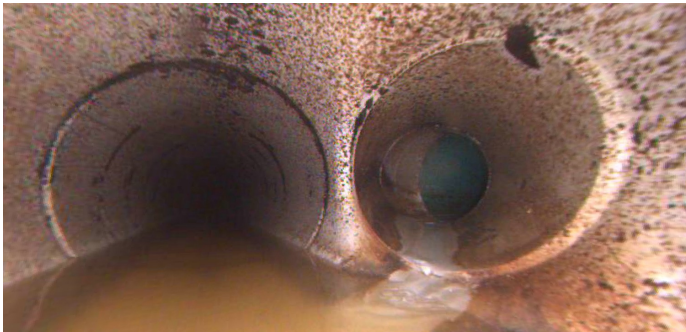
Code: **TFA**  
Description: **Tap Factory Active**

Distance (ft): **203.9**  
Structural Grade: **0**  
O&M Grade: **0**  
Clock Start/From: **3**  
Clock To:  
1st Value: **4.000**  
2nd Value:  
Value Percent:  
Continuous Index:  
Within 8" of Joint:  
Remarks:

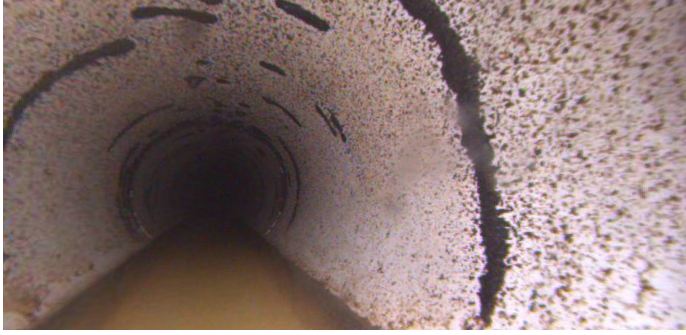
Code:	<b>MSA</b>
Description:	<b>Abandoned Survey</b>
Distance (ft):	<b>223.6</b>
Structural Grade:	<b>0</b>
O&M Grade:	<b>0</b>
Clock Start/From:	
Clock To:	
1st Value:	
2nd Value:	
Value Percent:	
Continuous Index:	
Within 8" of Joint:	<b>NO</b>
Remarks:	<b>debris under water</b>
